S-121
Phoenix Methodist Episcopal Church
Cash Corner vicinity
public worship

Maryland Historical Trust State Historic Sites Inventory Form

Survey No. S-121

historic Phoenix Methodist Episcopal Church

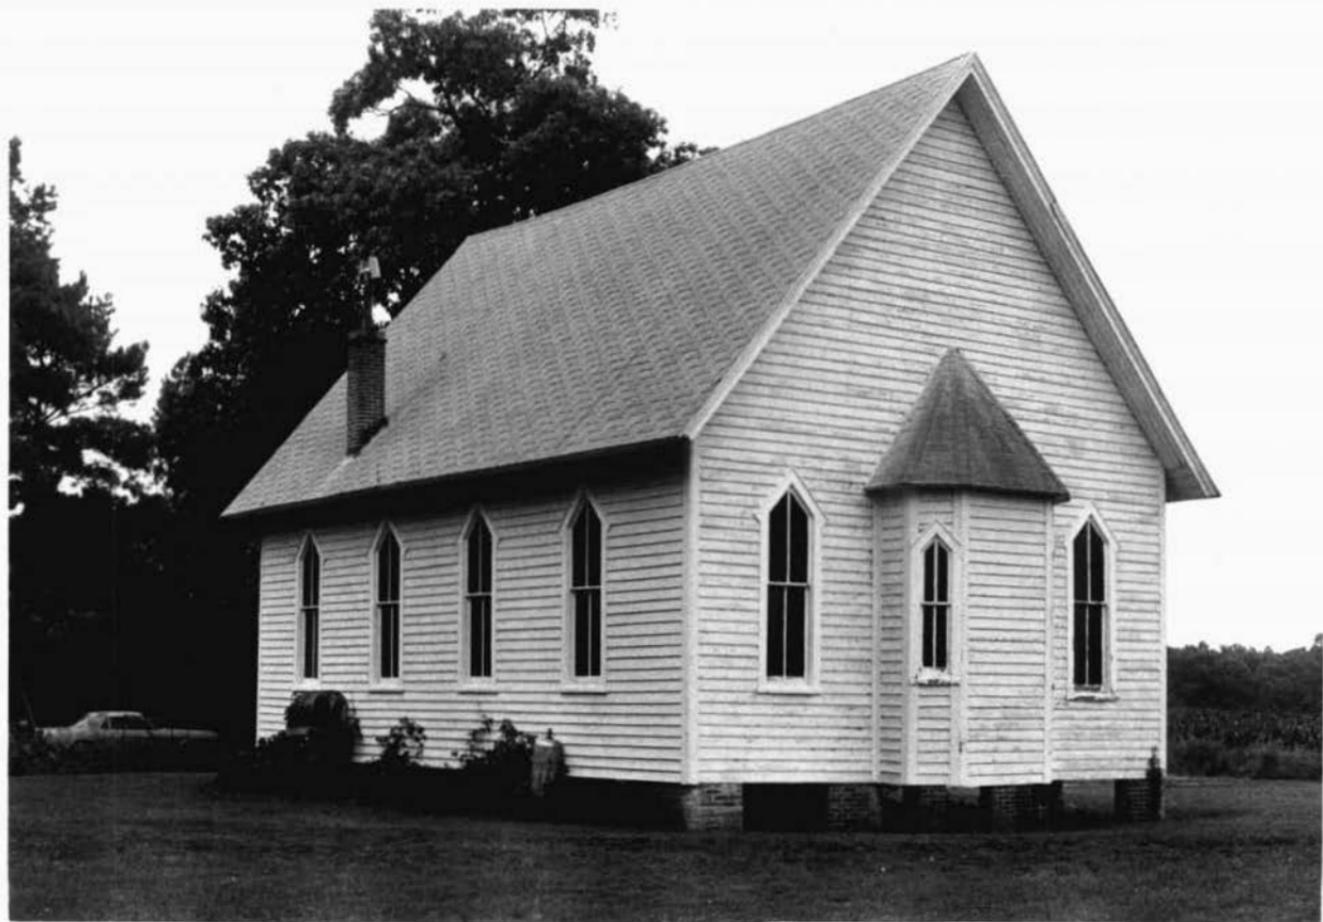
S-121

Phoenix Church
Near Parsonville, Somerset County
North Elevation
7/85 Photographer - Paul Touart
Neg/Maryland Historical Trust

The north gable end has a single-story three-sided apse lighted by two colored glass pointed arch sash windows.

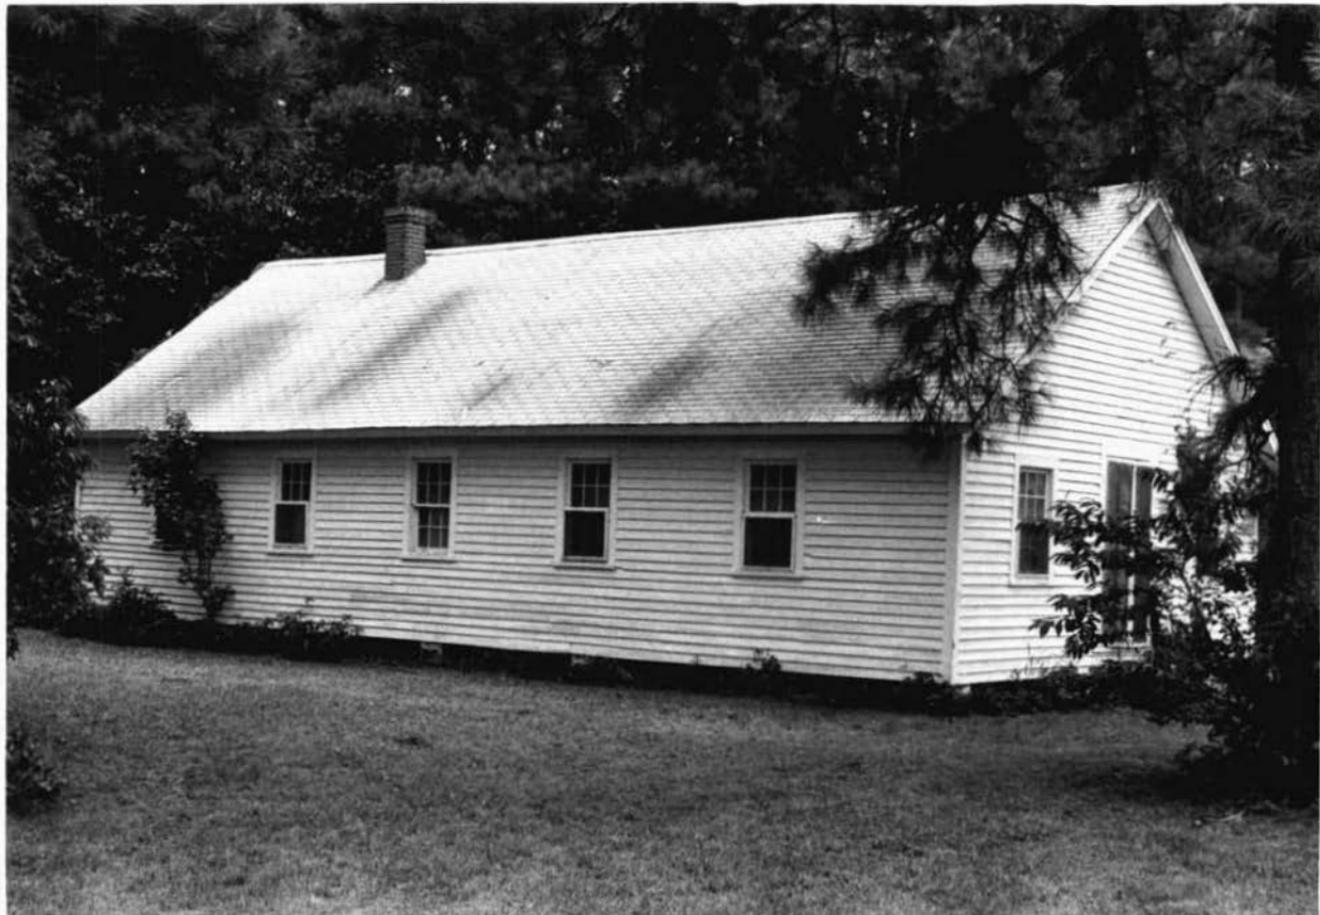
S-121

Church Hall - Northwest

Standing east of the church is a single-story three-bay by three-bay frame church hall with a gable-front entrance and six over one sash windows. The structure is sheathed with narrow weatherboards and covered by a medium sloped asphalt shingle roof.

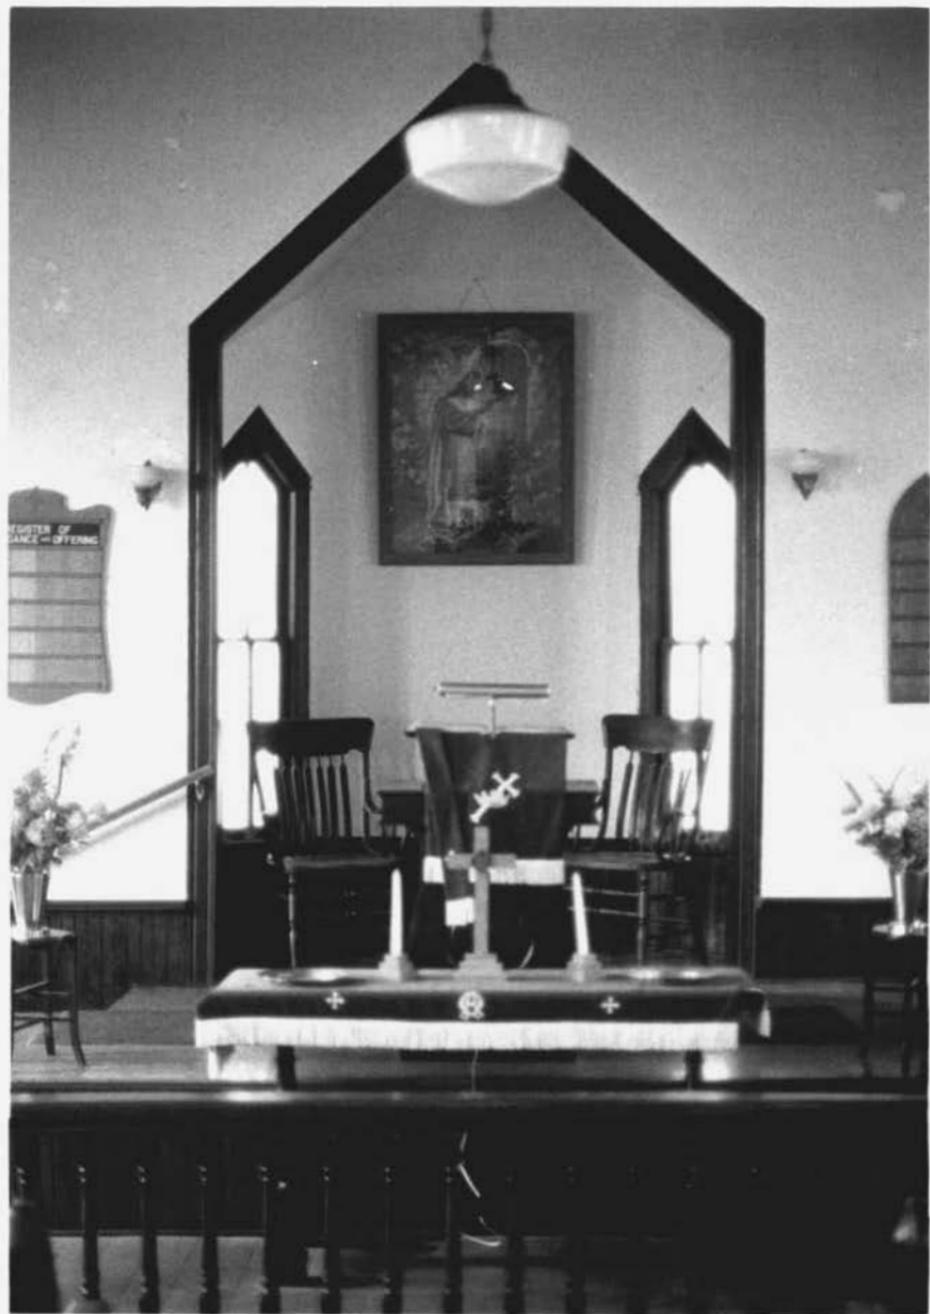
Phoenix Methodist Epis. Church S-121
Parsonville vicinity, Somerset County
Sanctuary
8/85, Paul Touart, Photographer
Neg./Md. Historical Trust

The one-room church interior has a high beaded board ceiling and milkglass chandeliers. The raised altar is divided from the sanctuary by a turned baluster railing, and the small apse is lighted by lavender glass windows. Victorian period choir chairs and sanctuary pews complete the significant interior furnishings.

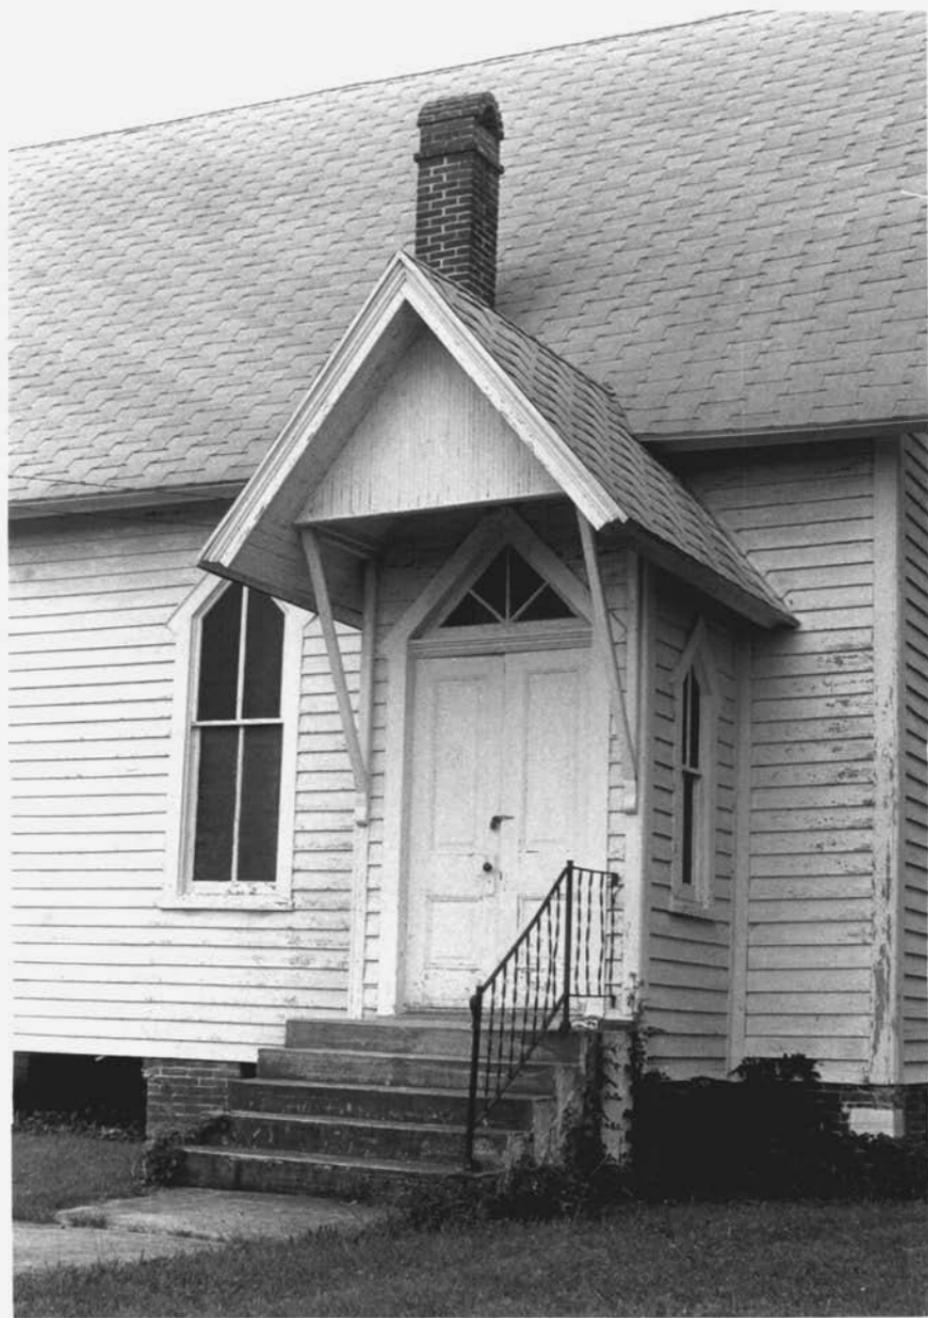
West Entrance

The west (main) facade is a four-bay elevation with a gabled entrance in the southernmost bay. A double door entrance is topped by a pointed arch transom filled with colored glass. The gabled entrance roof is extended and supported by stick brackets. A small lancet window marks each side of the entrance vestibule. The adjacent three bays are filled with pointed arch sash windows with colored glass. The marble datestone is located in the lower south corner and is inscribed, "Phoenix M.E. Church, 1897". Rising from the roof is a narrow brick stove stack.

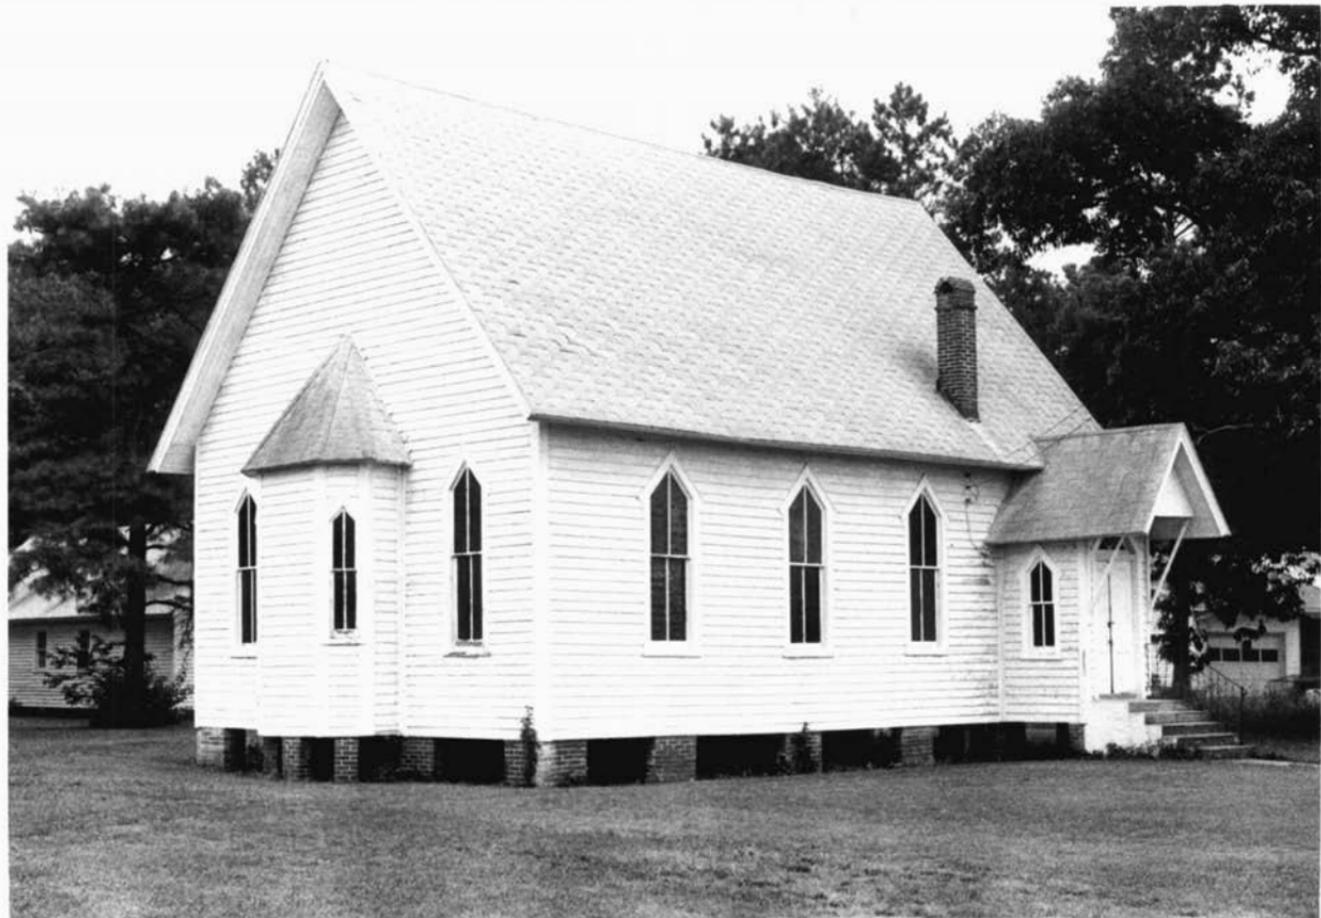
S-121

Phoenix Church
Near Parsonville, Somerset County
Northwest Elevation
7/85 Photographer - Paul Touart
Neg/Maryland Historical Trust
