Quindocqua Methodist Episcopal Church

National Register of Historic Places
Registration Form

historic name QUINDOCQUA UNITED METHODIST CHURCH

S-123

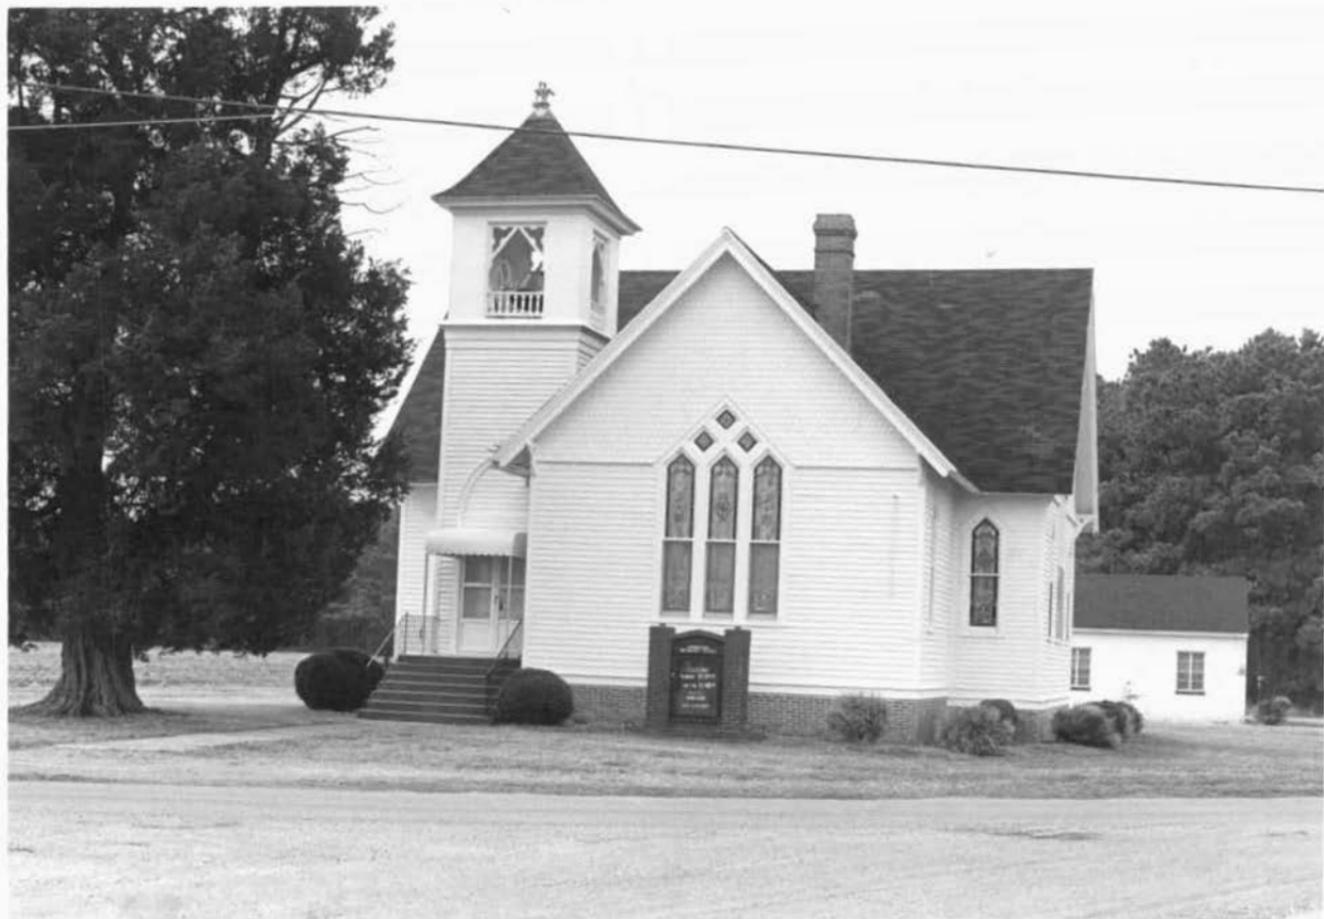
Quindocqua Methodist Church S-123
Near Tulls Corner, Somerset County
South Elevation
4/85, Photographer, Paul Touart
Neg./MD. Historical Trust

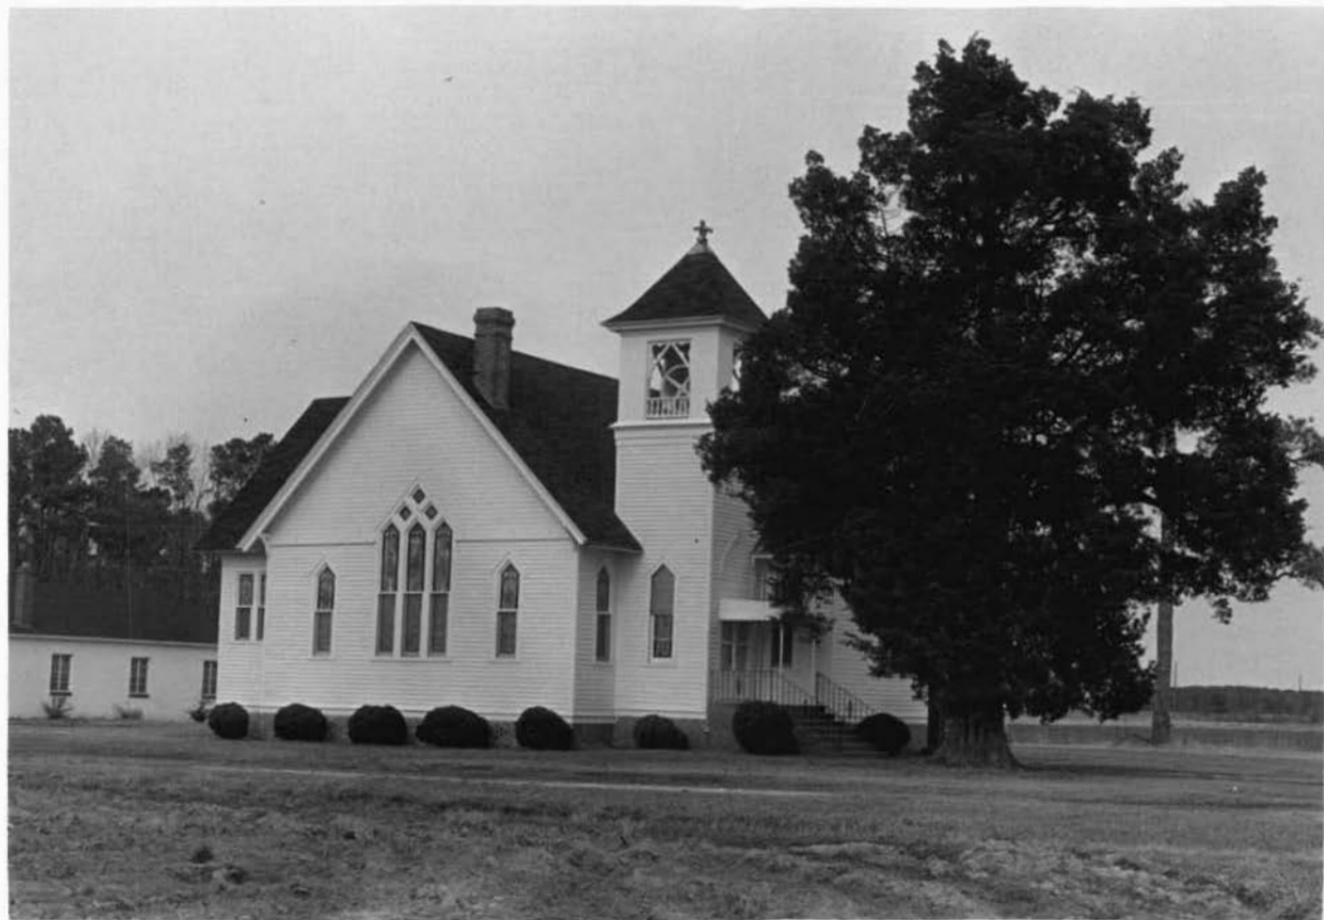
Quindocqua Methodist Church
Near Tulls Corner, Somerset County
Southwest Elevation
4/85, Photographer, Paul Touart
Neg/Md. Historical Trust

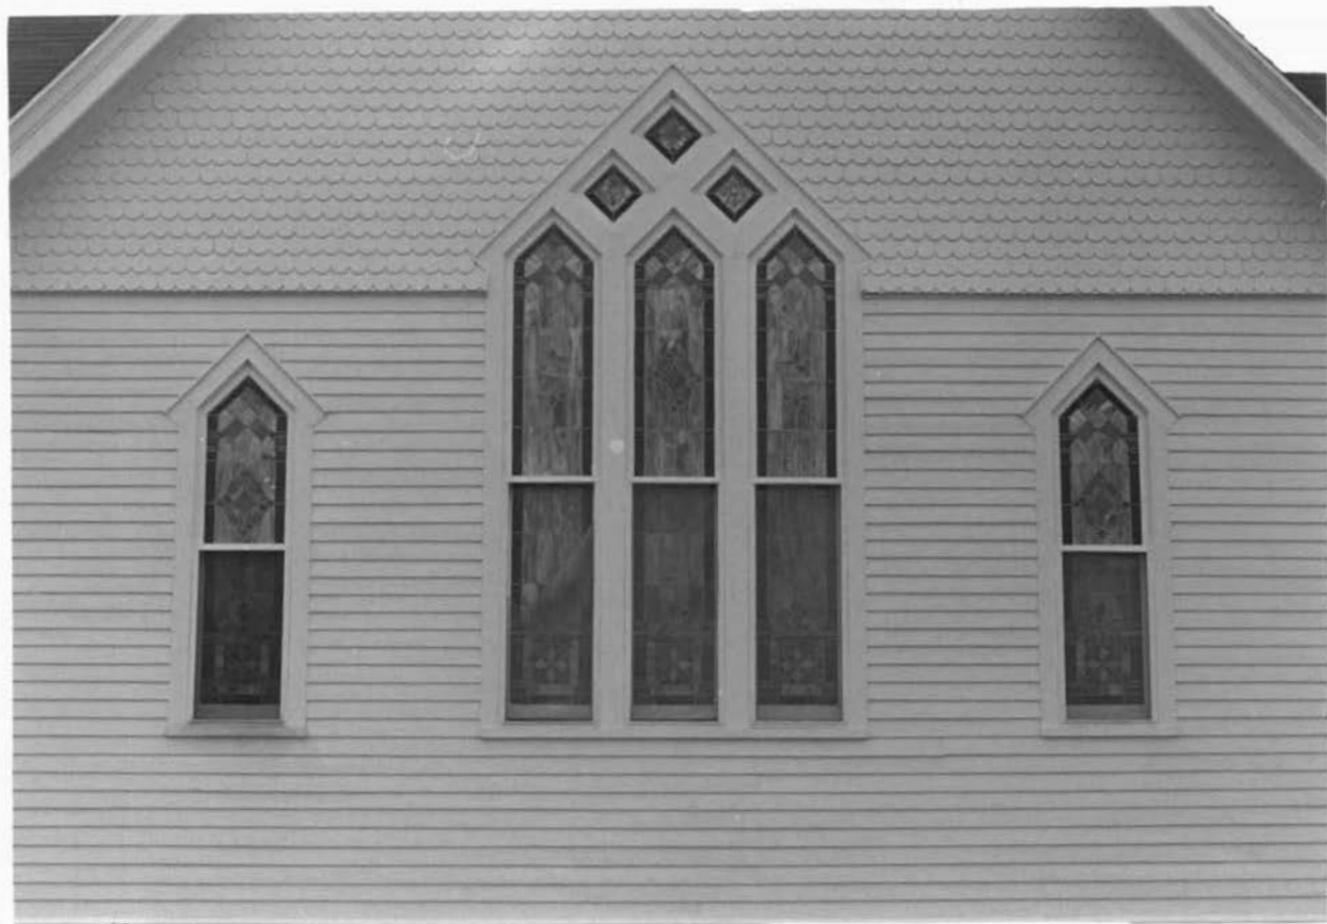
Quindocqua Methodist Church S-123
Near Tulls Corner, Somerset County
Window Details
4/85, Photographer, Paul Touart
Neg./MD. Historical Trust

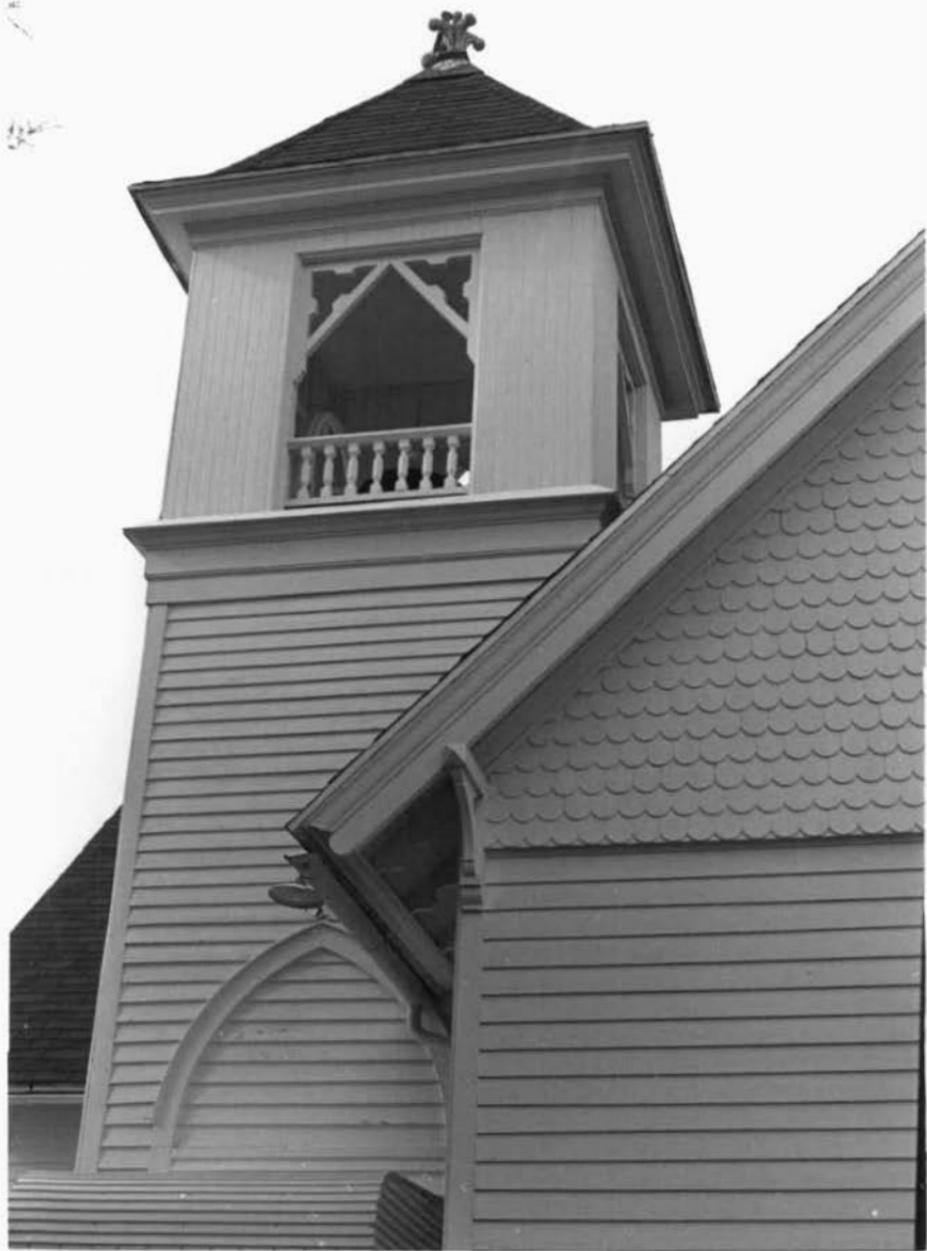
Quindocqua Methodist Church S-123
Near Tulls Corner, Somerset County
Bell Tower
4/85, Photographer, Paul Touart
Neg/Md. Historical Trust
