S-153
Centennial M.E. Church
Upper Fairmount
Public Worship

Maryland Historical Trust State Historic Sites Inventory Form

Survey No. S-153

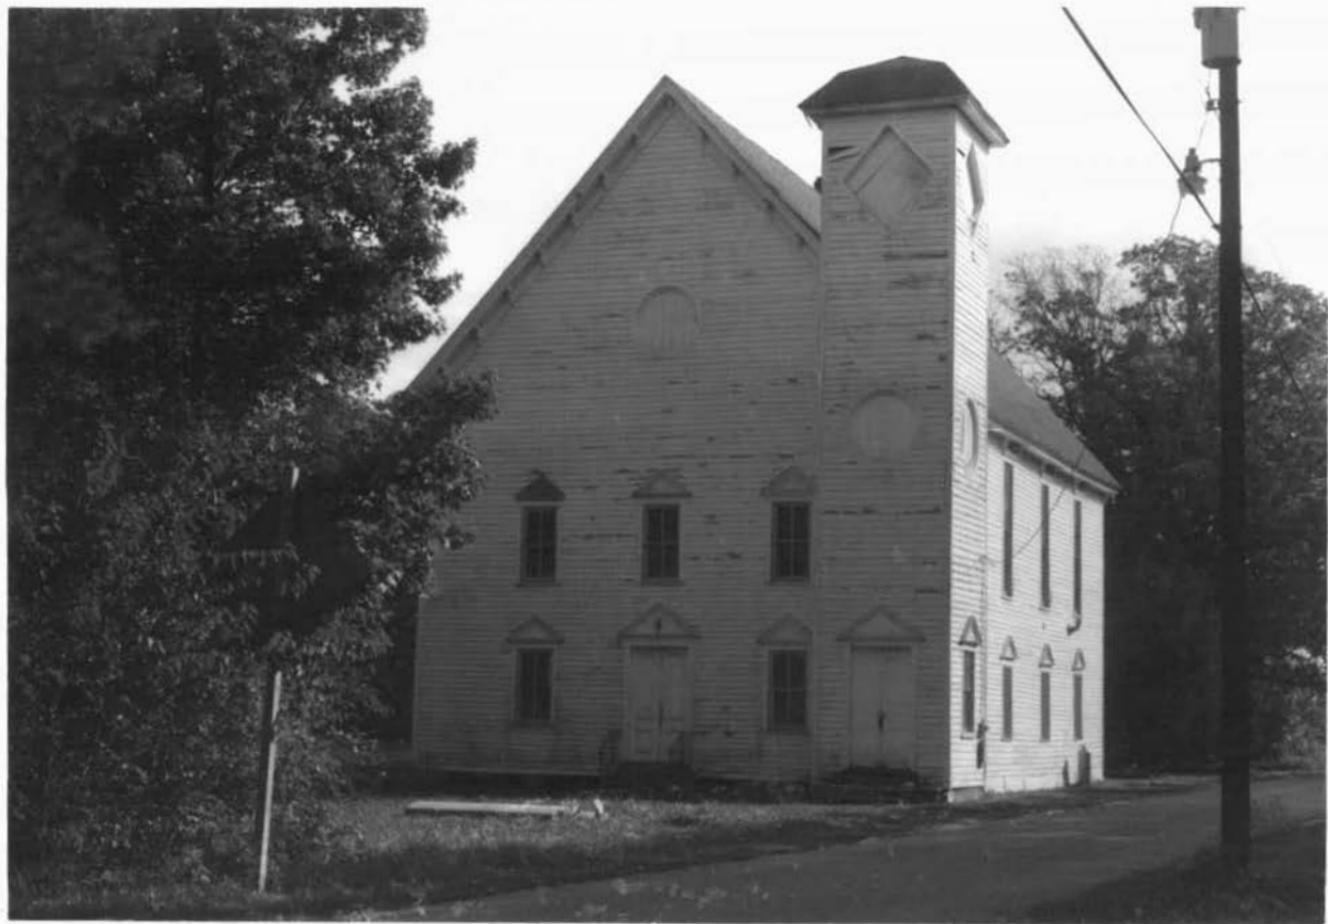
S-153

Centennial M. E. Church
Upper Fairmount, Somerset County
North Elevation
11/83 Paul Touart
Neg./Md. Historical Trust

The ^{north} facade of the main block is three bays across with a center double-door entrance and flanking 2/2 sash windows. Each opening on the first floor, as well as on the second, is topped by a molded pediment. A round opening in the attic has been boarded up. The bell tower has a double leaf door with molded pediment on the first floor, a round opening on the second floor and a diamond opening on the third floor. A small balustrade fills the lower corner of each diamond.

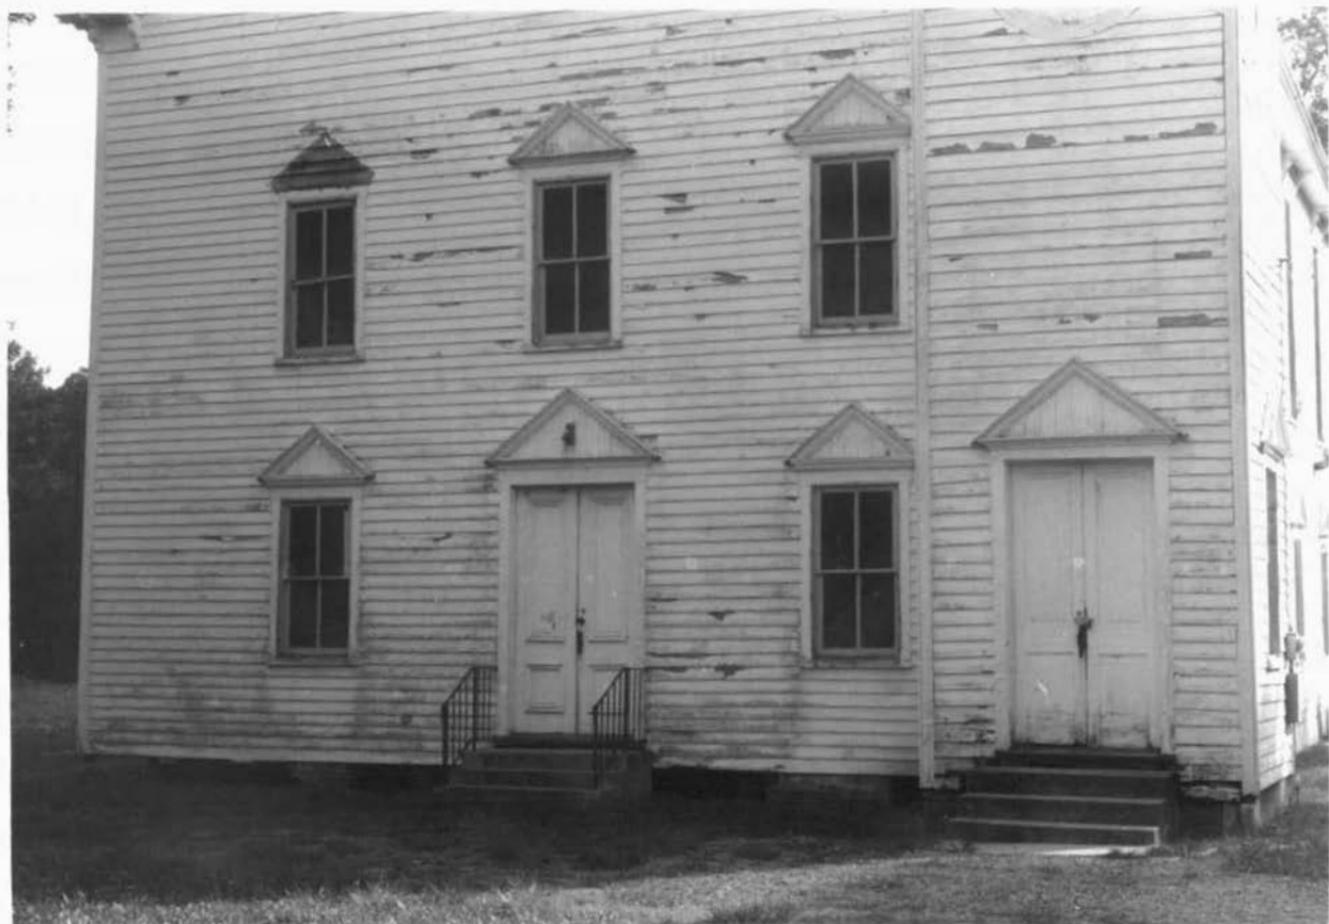
S-153

Centennial M. E. Church
Upper Fairmount, Somerset County
North Elevation
11/83 Paul Touart
Neg./Md. Historical Trust

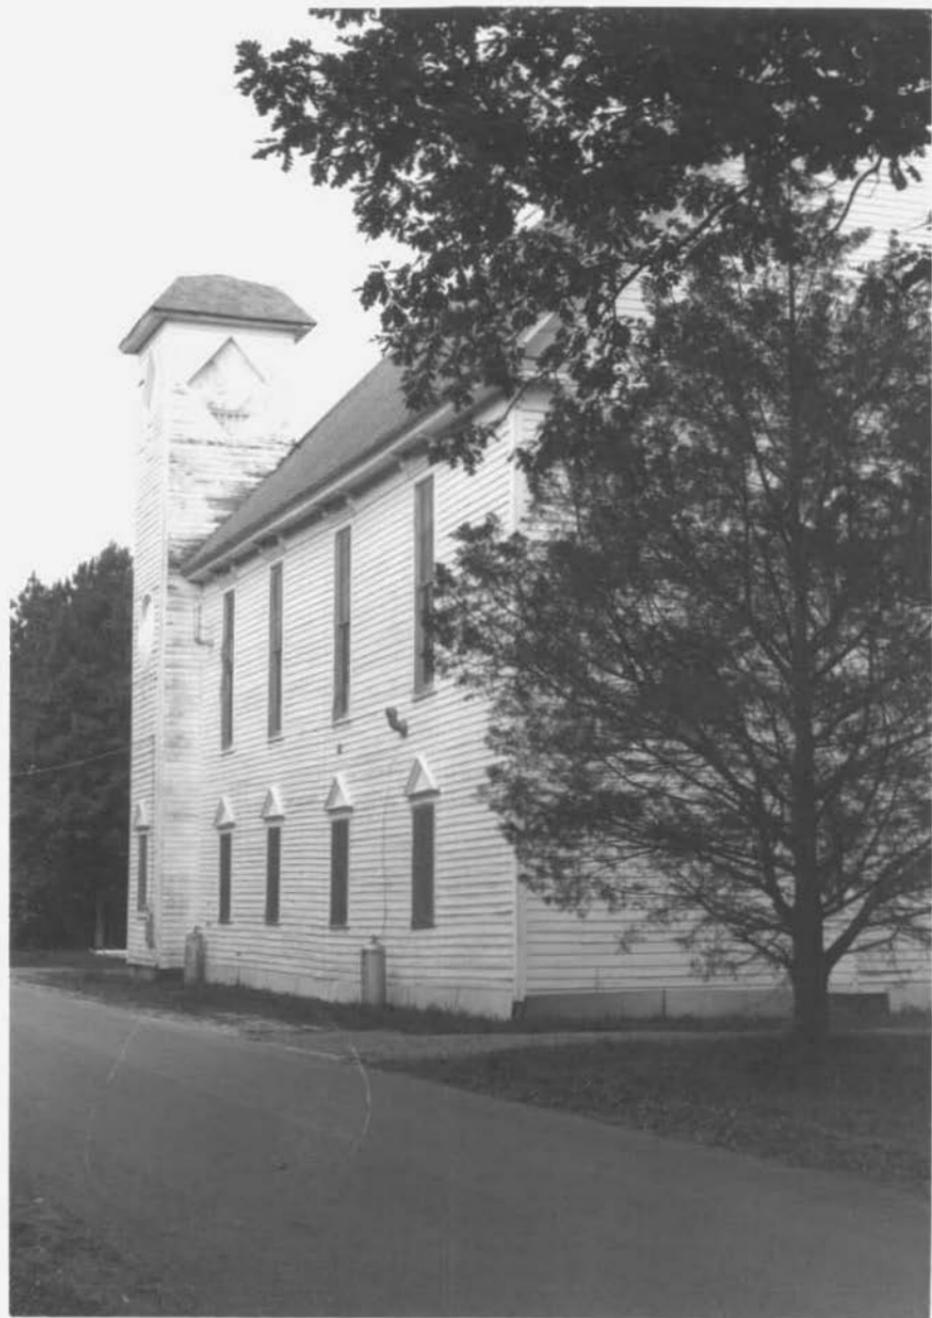
S-153

Centennial M. E. Church
Upper Fairmount, Somerset County
Southeast Elevation
11/83 Paul Touart
Neg./Md. Historical Trust

The east side is four bays across with pedimented 2/2 sash windows. There is one door opening on the first floor and four 4/4 tall, narrow sash windows on the second.

The south wall is distinguished by a shallow two-story apse with narrow shingle pane windows on each side.

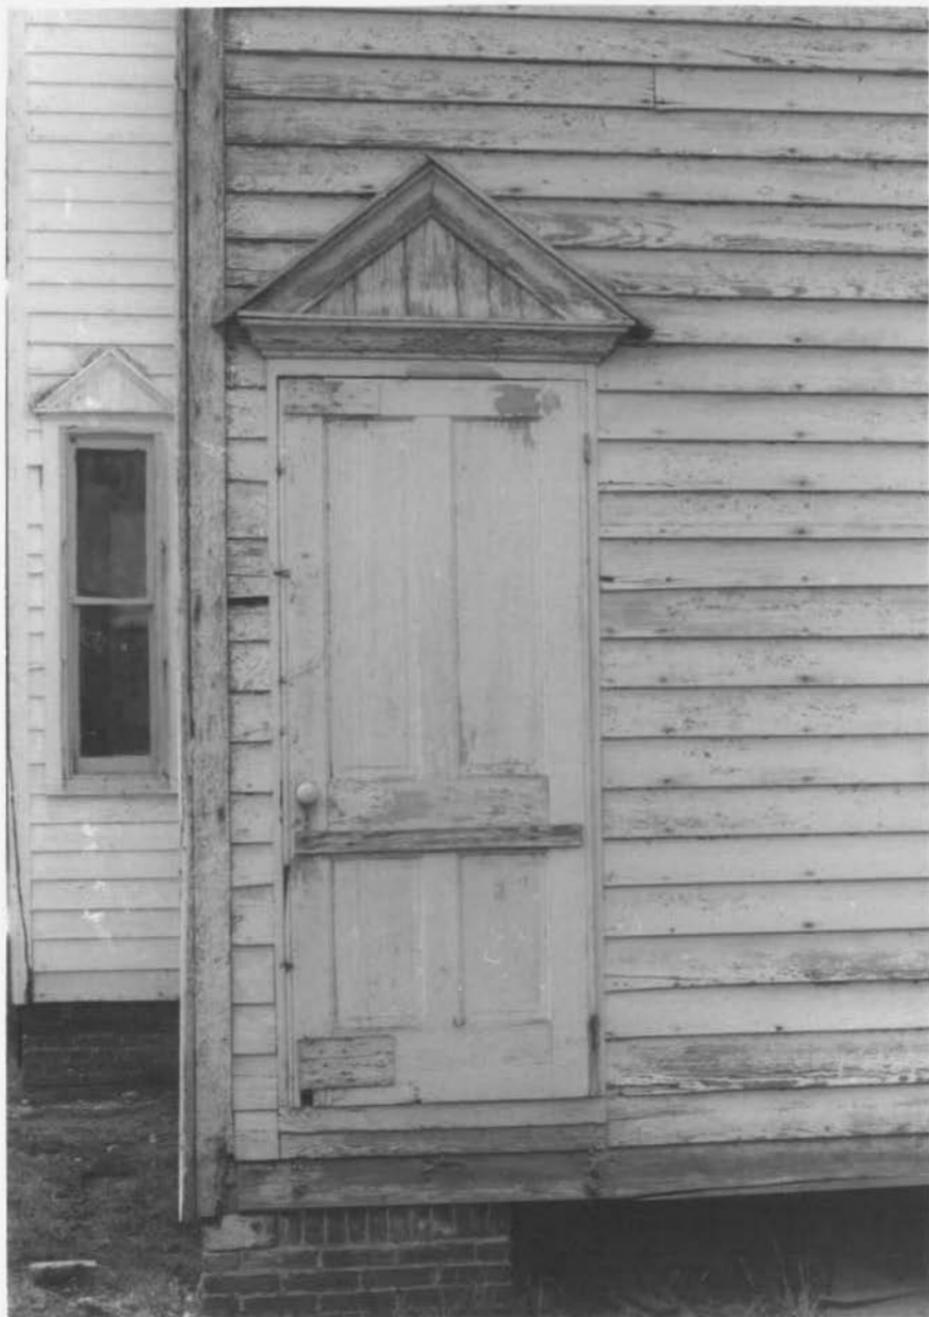
S-153

Centennial M. E. Church
Upper Fairmount, Somerset County
Door and Window Details
11/83 Paul Touart
Neg./Md. Historical Trust

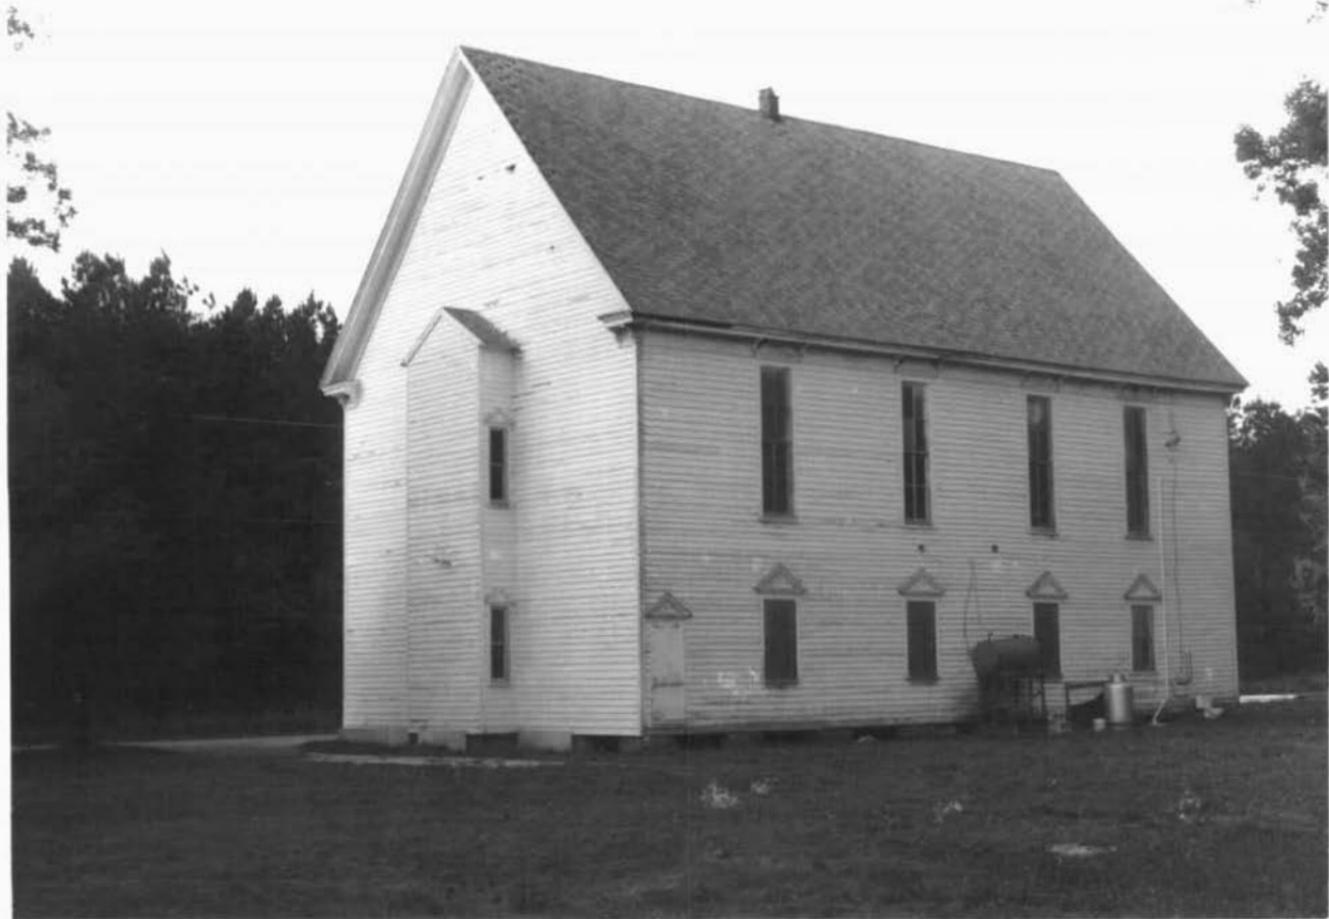
S-153

Centennial M. E. Church
Upper Fairmount, Somerset County
Southeast Elevation
11/83 Paul Touart
Neg./Md. Historical Trust
