Addendum to Maryland Historical Trust Maryland Inventory of Historic Properties Form

Inventory No. S-173

Name of Property: Thomas Sudler Farm (Bill Messick Farm)

Maryland Historical Trust State Historic Sites Inventory Form

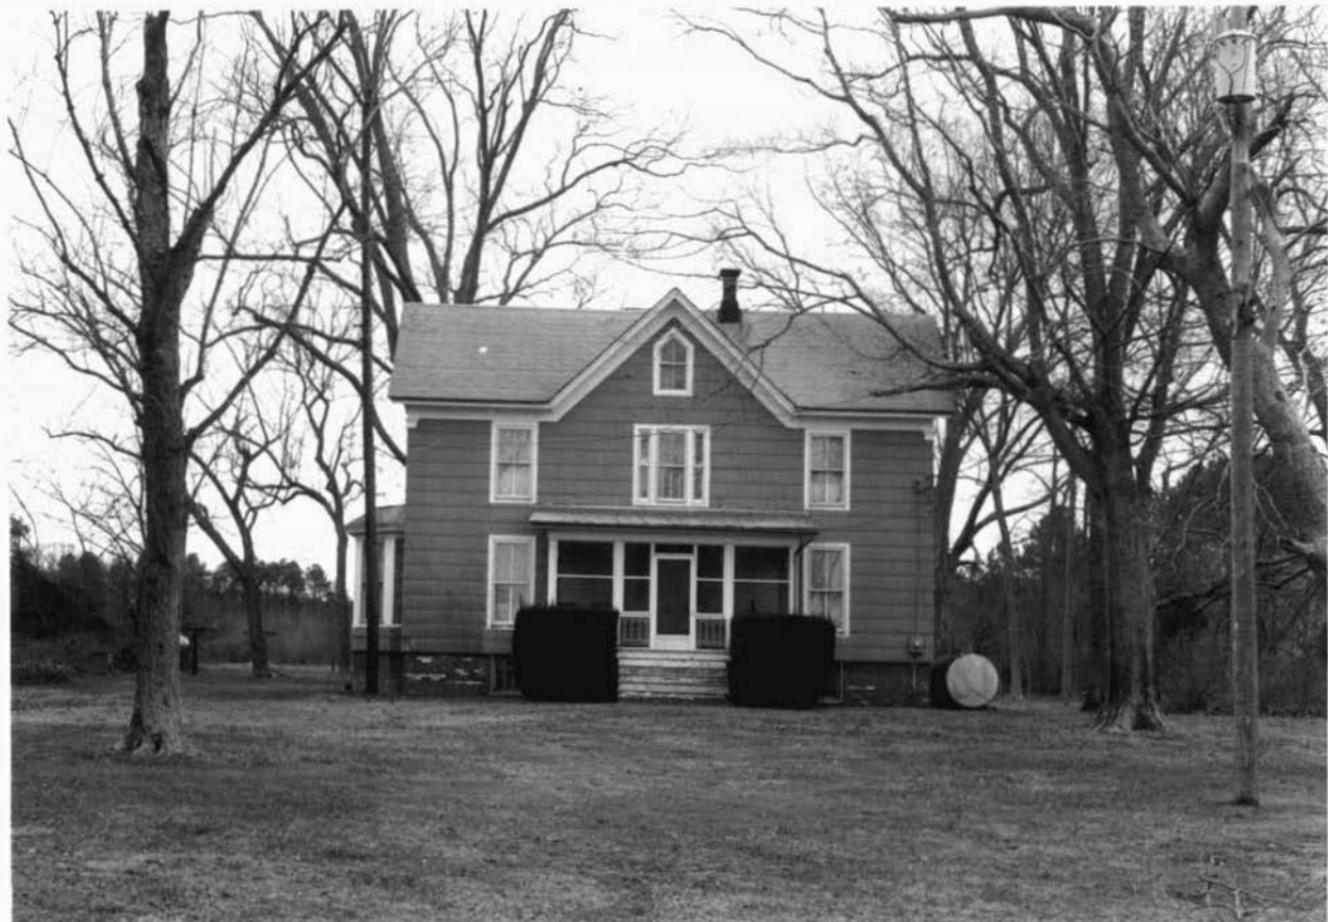
S-173

Thomas Sudler Farm
Near Westover, Somerset County
North Elevation
2/84 Paul Touart
Neg./Md. Historical Trust

Centered in the mowed yard is a c. 1860-1880 two-story three-bay cross-gabled farmhouse which rests on a raised common bond brick foundation and is covered by a steeply pitched asphalt tile roof. The exterior of the T-shaped farmhouse is uniformly sheathed with asbestos siding.

The north (main) facade is symmetrically arranged with a center entrance and flanking 2/2 sash windows. A transom and side-lights surround a molded four-panel door. A shed porch covers the entrance bay with the roof supported by chamfered posts. Sawn balusters remain between the posts. Two over two sash flank the entrance bay. The second floor is pierced by a sidelighted 2/2 sash window in the center and flanking 2/2 sash. Featured in cross-gable is a pointed 2/2 sash window. The dentiled capitals of the covered corner pilasters remain on each upper corner. One center brick chimney with corbelled cap rises above the roofline. The east stack has been taken down.

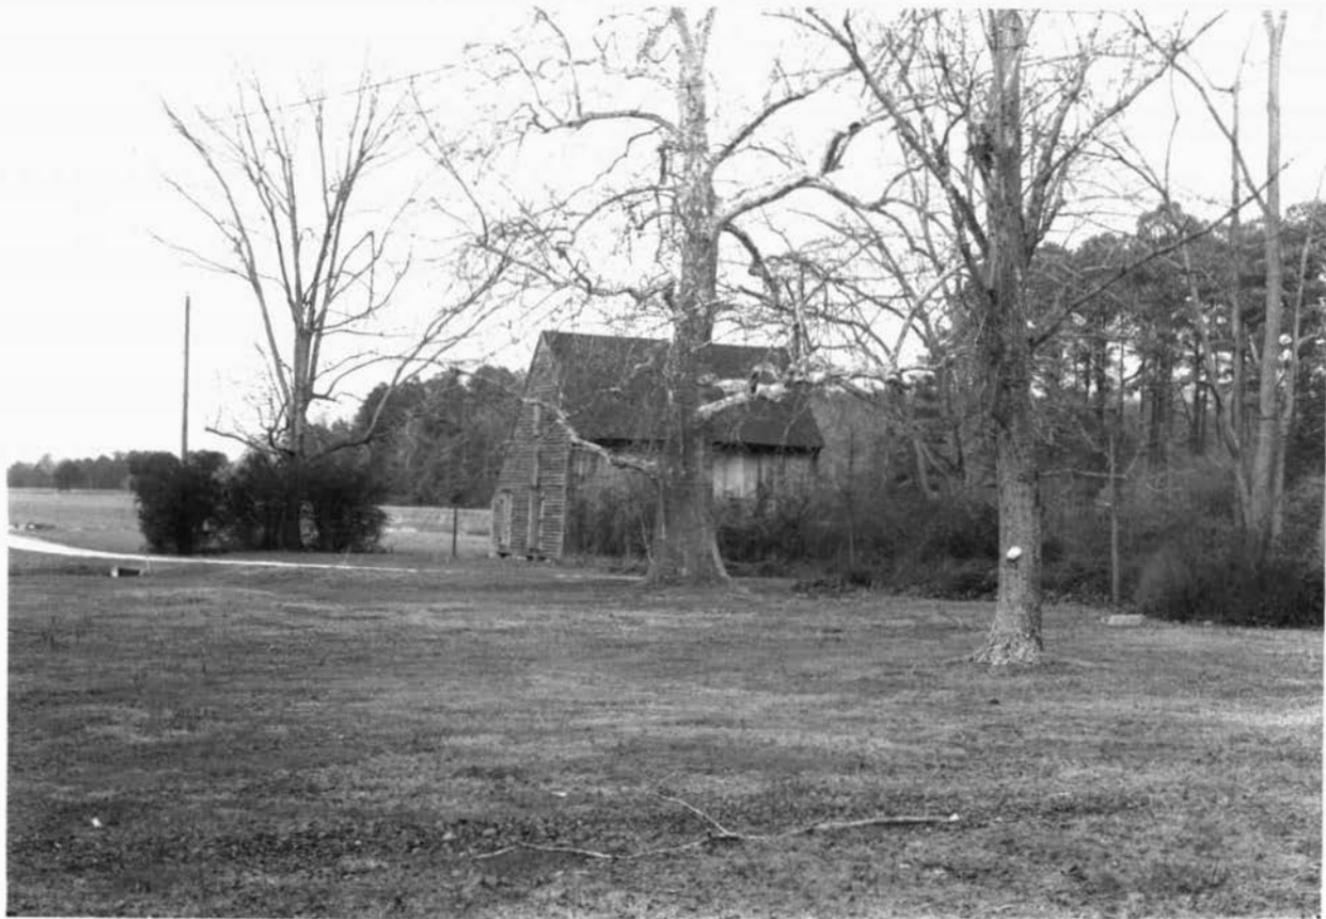
S-173

Thomas Sudler Farm
Near Westover, Somerset County
South Elevation of Tobacco House
2/84 Paul Touart
Neg./Md. Historical Trust

Standing northeast of the house is a bi-level wrought-nail frame barn with one surviving shed on the north side. The south shed, according to the owner, was of later date. From a series of sheared nails on the outside face of the interior stud wall, it appears the north shed was a later addition with the original gable front barn consisting of the center rectangular core. Around the mid-19th century, a new floor was added to allow for grain storage. According to the owner, the barn was

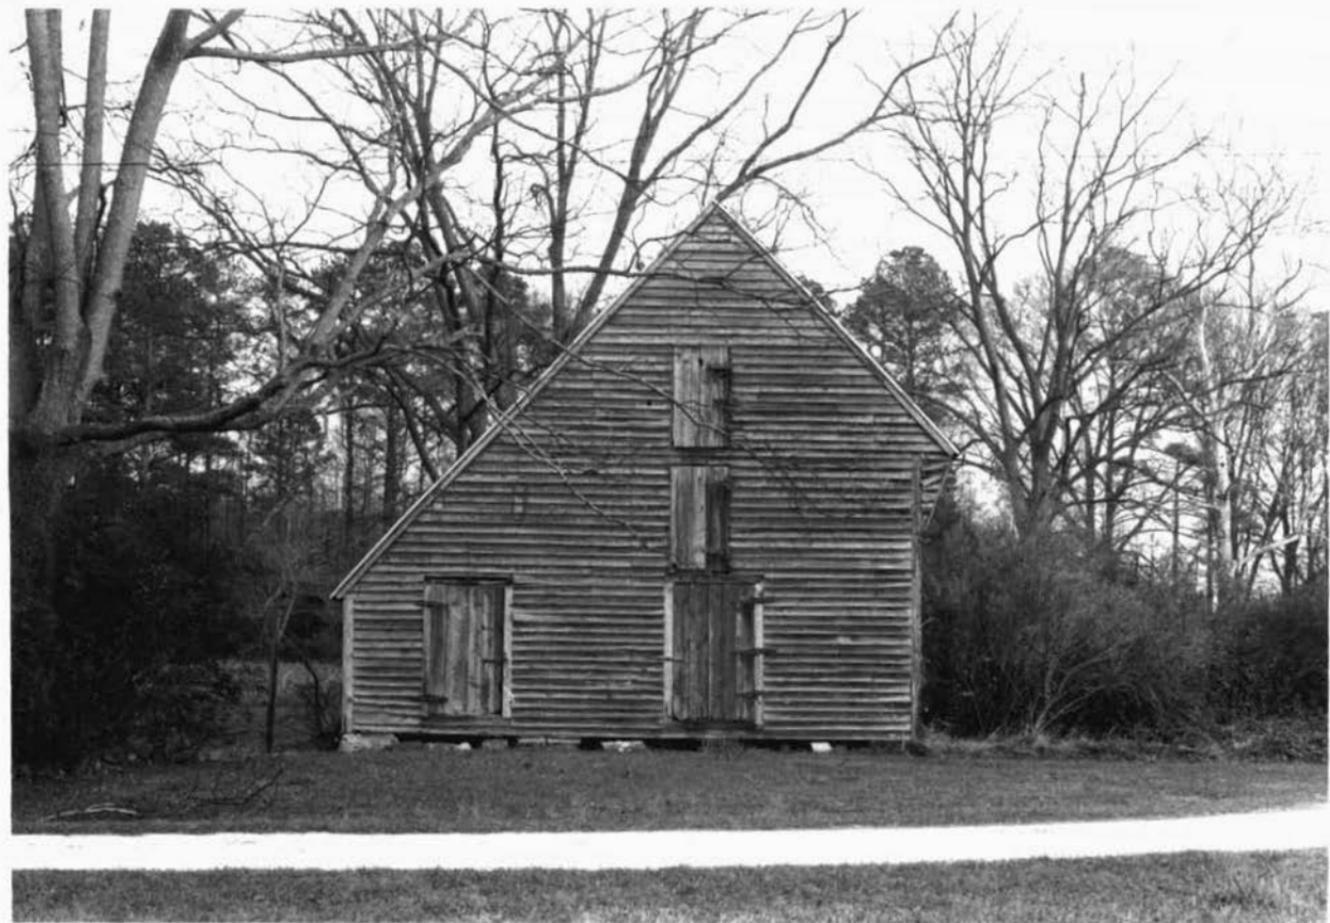
S-173

Thomas Sudler Farm
Near Westover, Somerset County
Barn - West Elevation
2/84 Paul Touart
Neg./Md. Historical Trust

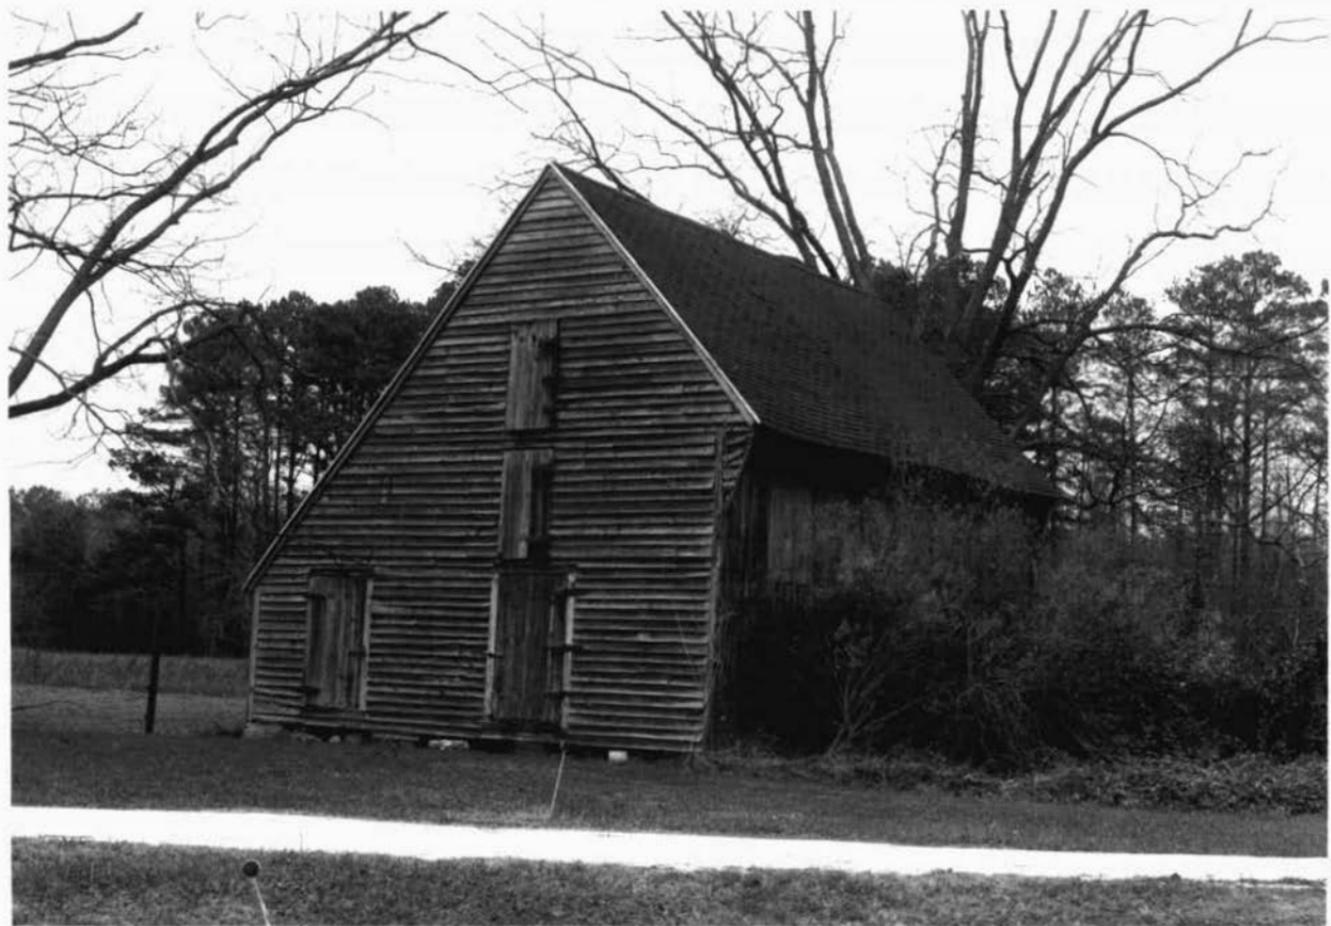
S-173

Thomas Sudler Farm
Near Westover, Somerset County
Southwest Elevation
2/84 Paul Touart
Neg./Md. Historical Trust

Extending to the rear is a shorter two-story service wing with two-story enclosed shed to the east side. This portion of the house also rests on a raised common bond brick cellar and is covered with asbestos shingles.

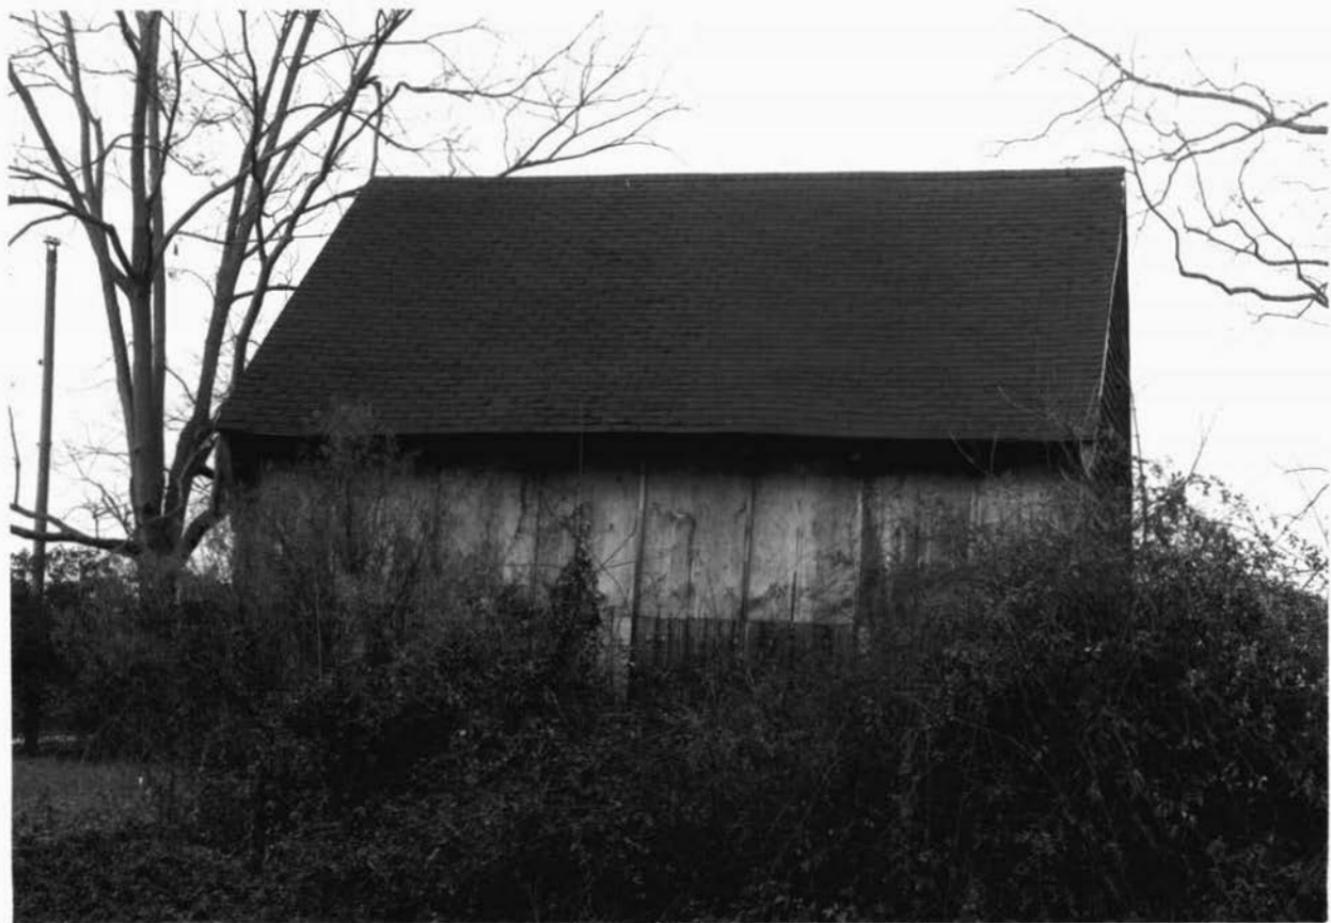
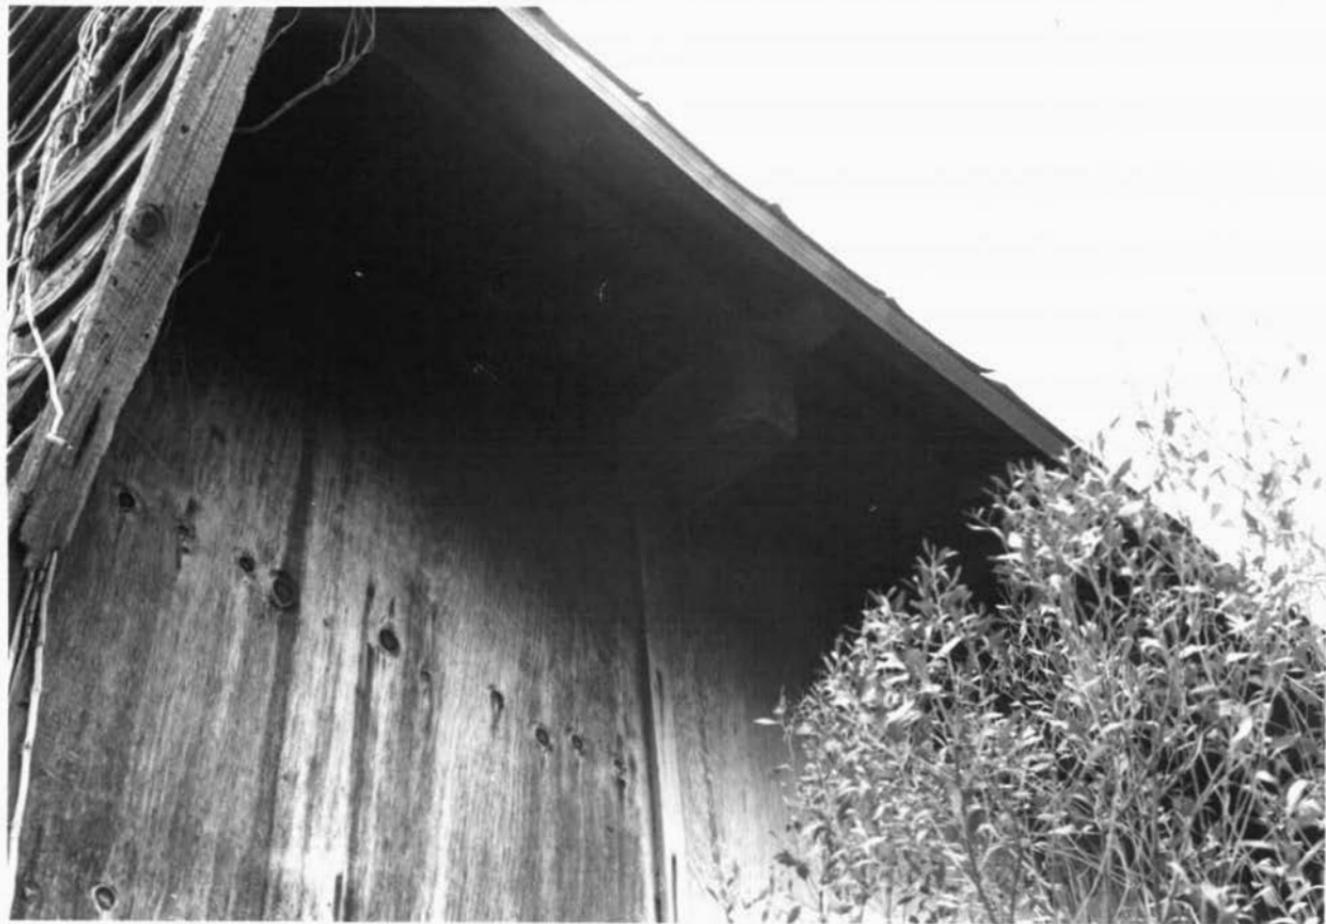
S-173

Thomas Sudler Farm
Near Westover, Somerset County
Barn - South Wall
2/84 Paul Touart
Neg./Md. Historical Trust

Thomas Sudler Farm
Near Westover, Somerset County
Barn Detail - South Wall
2/84 Paul Touart
Neg./Md. Historical Trust

refitted to store hay instead of tobacco. When the middle floor was added, the original floor joists were sawn out to allow for more head room on the second floor. This action sacrificed the original stability of the common rafter roof system. Two tiers of collar beams are let into the rafter pairs with half-dovetailed lap joints. The eave construction for the barn is similar to that of the smoke house with a flat false-plate and pins dropping through the plate as well as the ends of the floor joists.

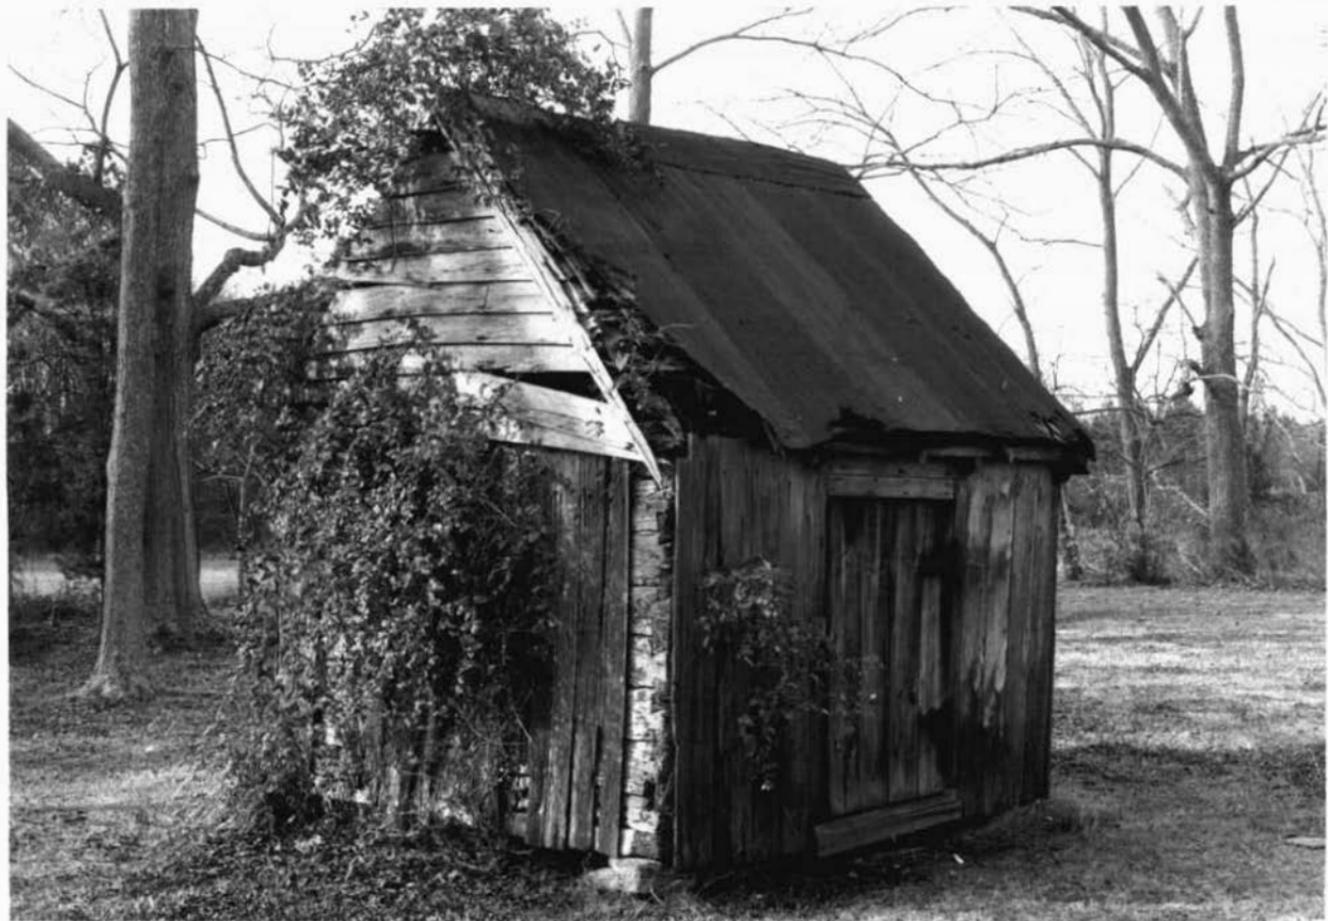
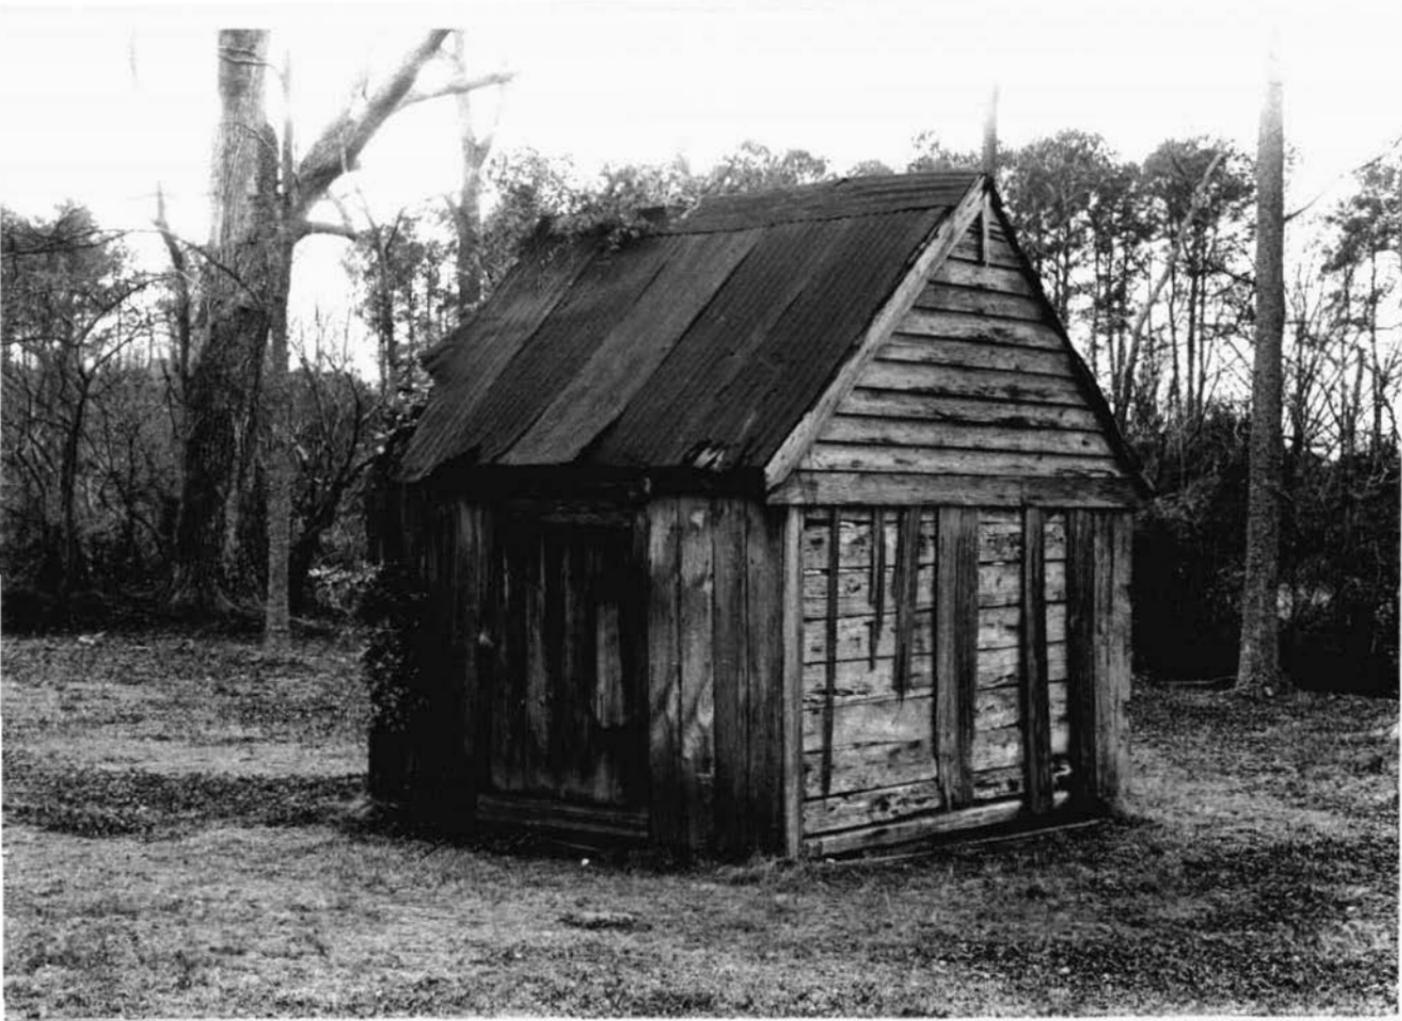
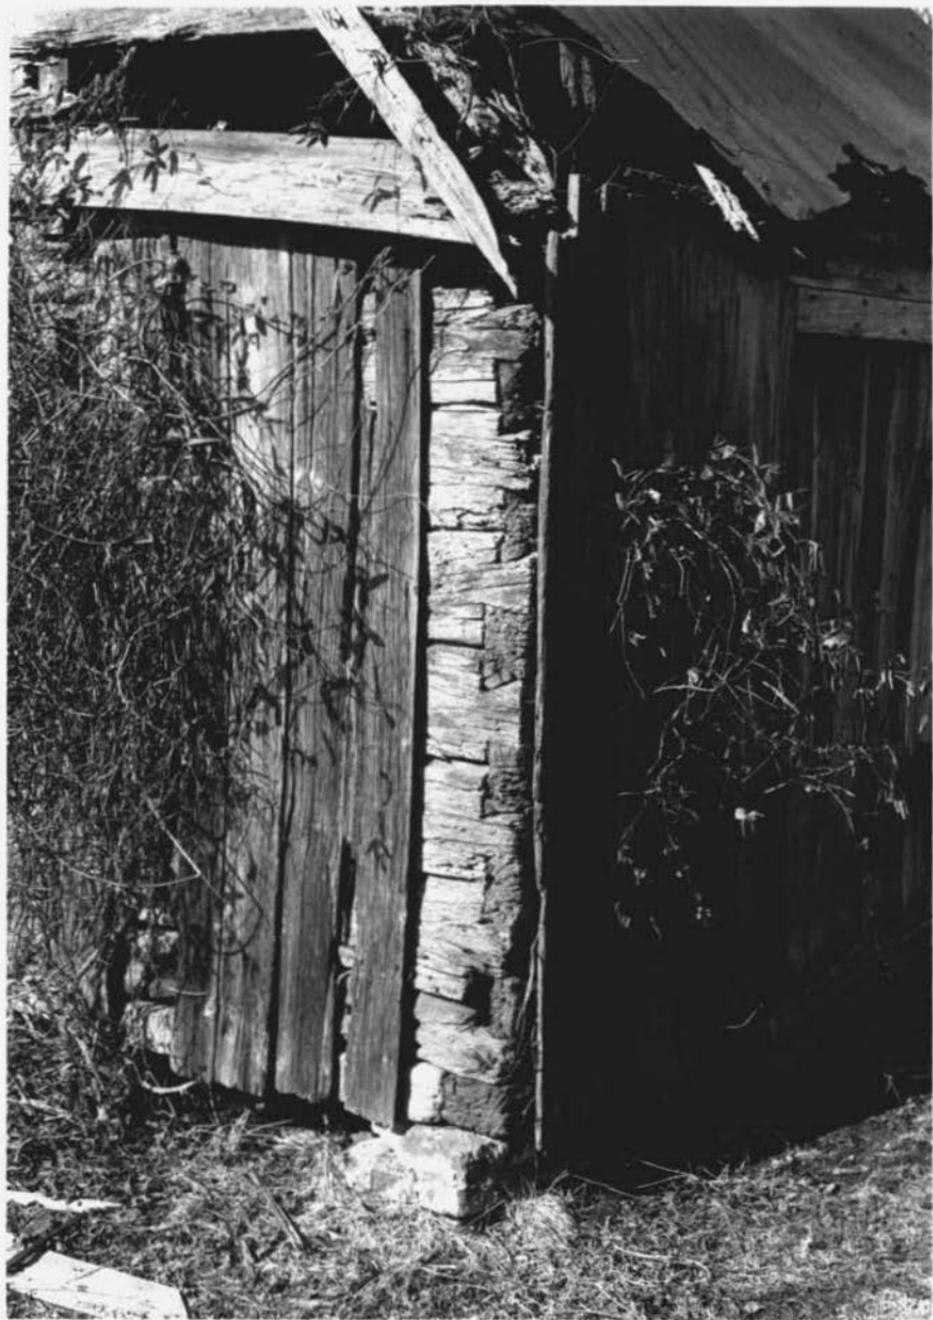
Thomas Sudler Farm
Near Westover, Somerset County
Smokehouse - Southeast Elevation
2/84 Paul Touart
Neg./Md. Historical Trust

Thomas Sudler Farm S-173
Westover vicinity, Somerset Co., MD.
Smokehouse - Northeast elevation
11/83, Paul Touart, Photographer
Neg./ Md. Hist. Trust

Thomas Sudler Farm
Near Westover, Somerset County
Smokehouse - Southeast Corner
2/84 Paul Touart
Neg./Md. Historical Trust

Located behind the house is a full-dovetailed log smokehouse with portions of vertical ship-lap siding fastened with wrought nails surviving on all four walls. Three corners of the ten by ten structure are supported by brick piers but a fourth corner (northeast) is still supported by a log slab.

The east side contains the only opening which is a board and batten door of circular sawn lumber and 20th-century strap hinges. Under the tin is a sheathing of wood shingles. The common rafter roof system is supported by a flat false-plate. In turn, the false-plate is supported by the floor joists. Wooden pins drop through the plate and butt-end of joists to stabilize the false-plate. The rafters' feet are fastened with wrought spikes. One tier of collar beams are let into each rafter pair with half-dovetail lap joints and fastened with wrought nails. The rafters are lapped and pinned. Each gable end is framed with a grid of studs and covered outside with weatherboards. All interior elements are smoke-blackened.

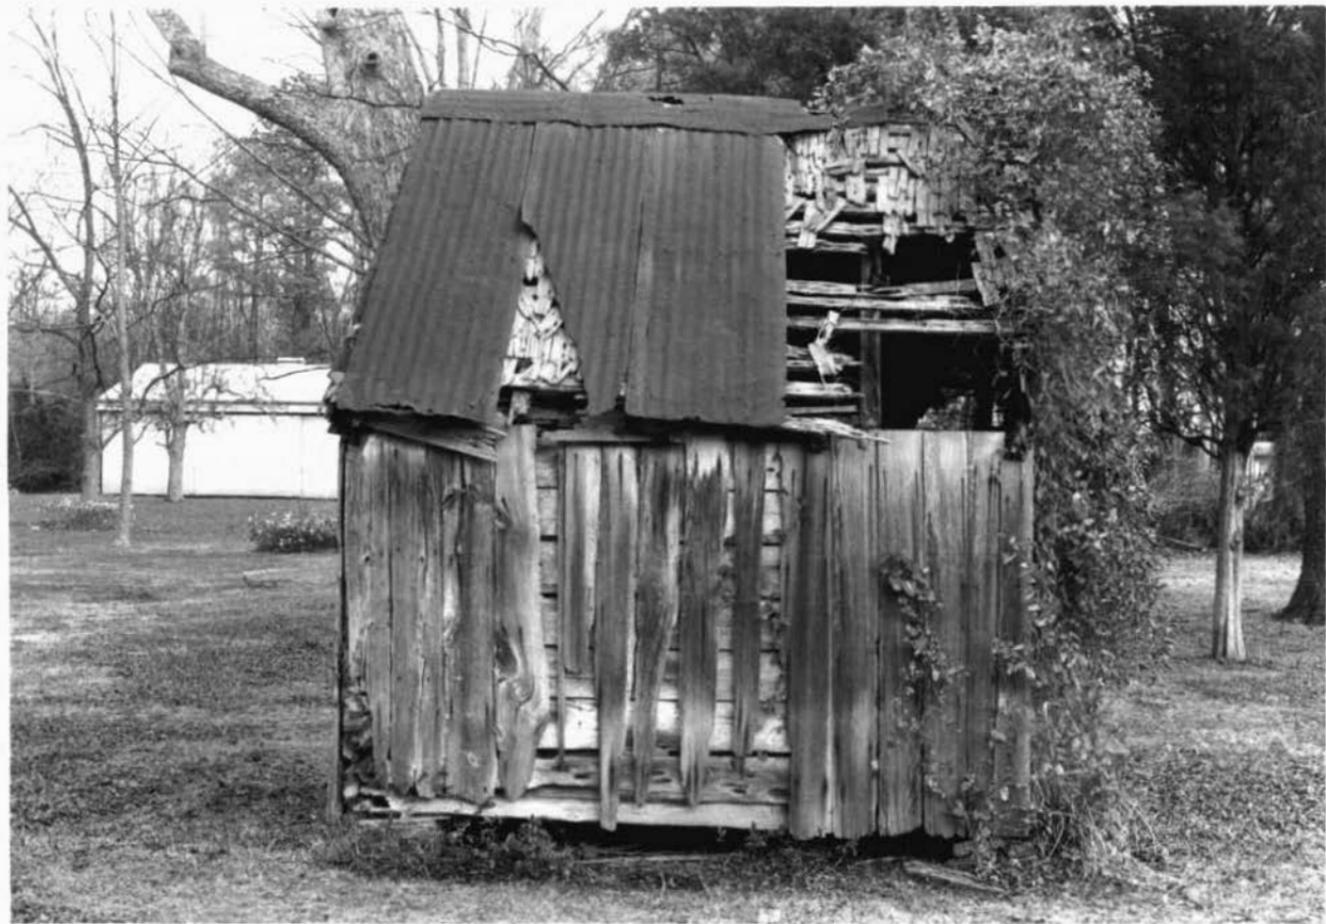
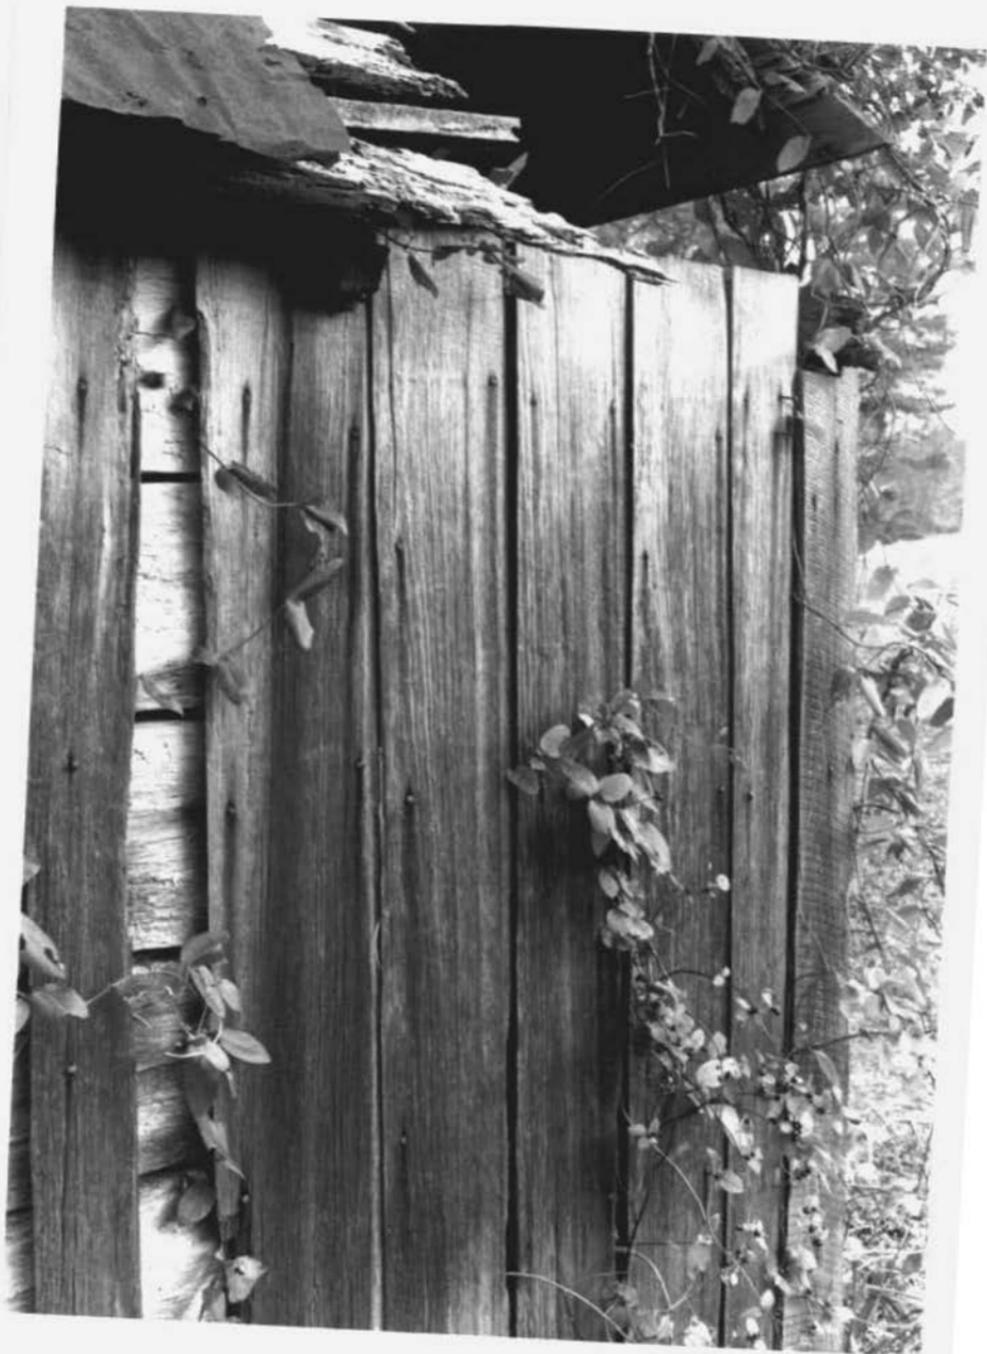
S-173

Thomas Sudler Farm
Near Westover, Somerset County
Smokehouse - West Wall
2/84 Paul Touart
Neg./Md. Historical Trust

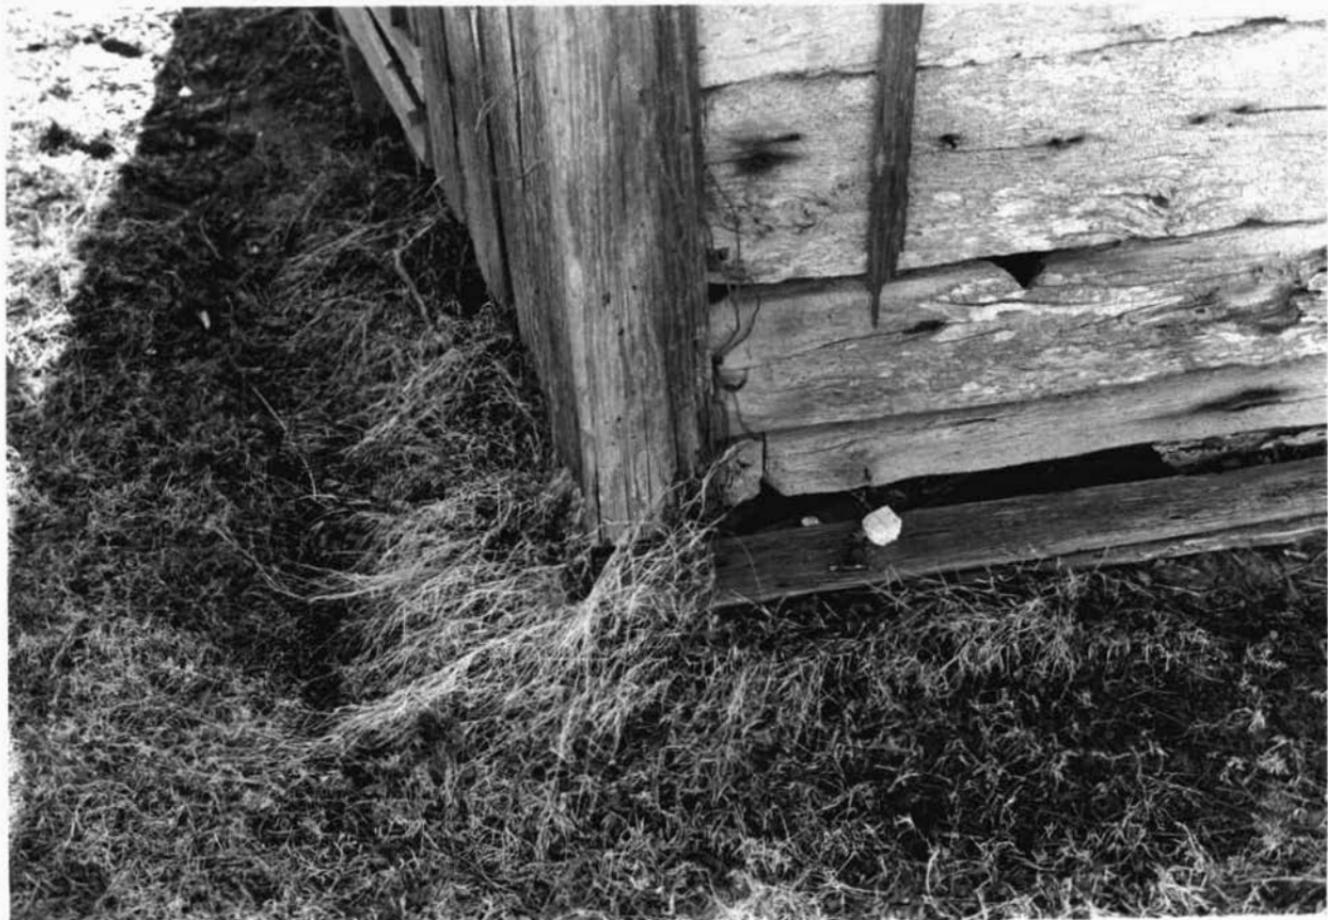
S-173

Thomas Sudler Farm
Near Westover, Somerset County
Smokehouse - Northeast Corner
2/84 Paul Touart
Neg./Md. Historical Trust

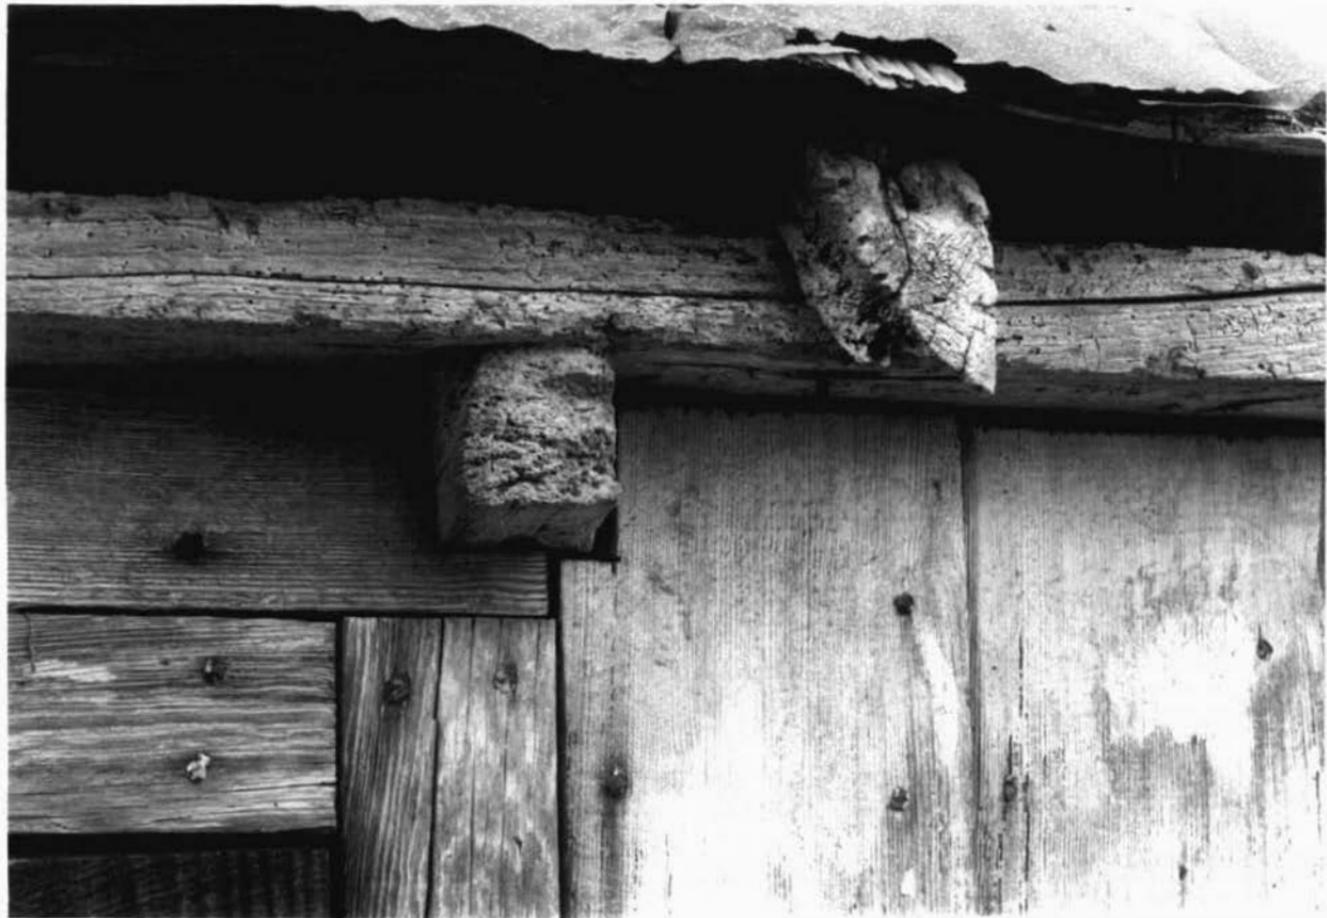
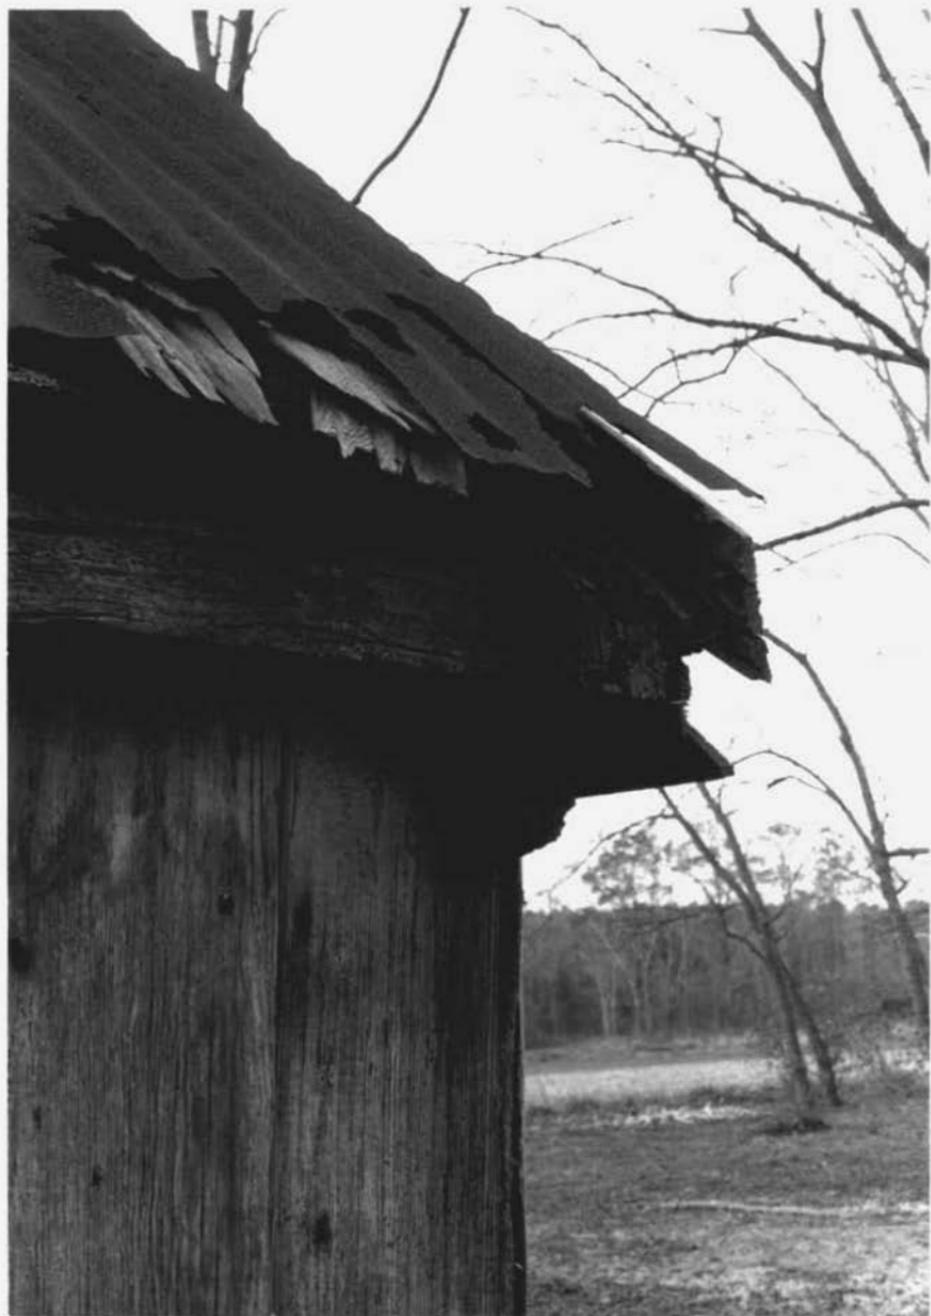
S-173

Smokehouse - Eave Detail

Thomas Sudler Farm
Near Westover, Somerset County
Smokehouse - Eave Detail
2/84 Paul Touart
Neg./Md. Historical Trust
