**Addendum to
Maryland Historical Trust
Maryland Inventory of
Historic Properties Form**

Inventory No. S-208

Name of Property: Paul Eby Farm

Great Bay Wind Energy Center
 Somerset County - Maryland
Historic Resources Assessment
 February 2014

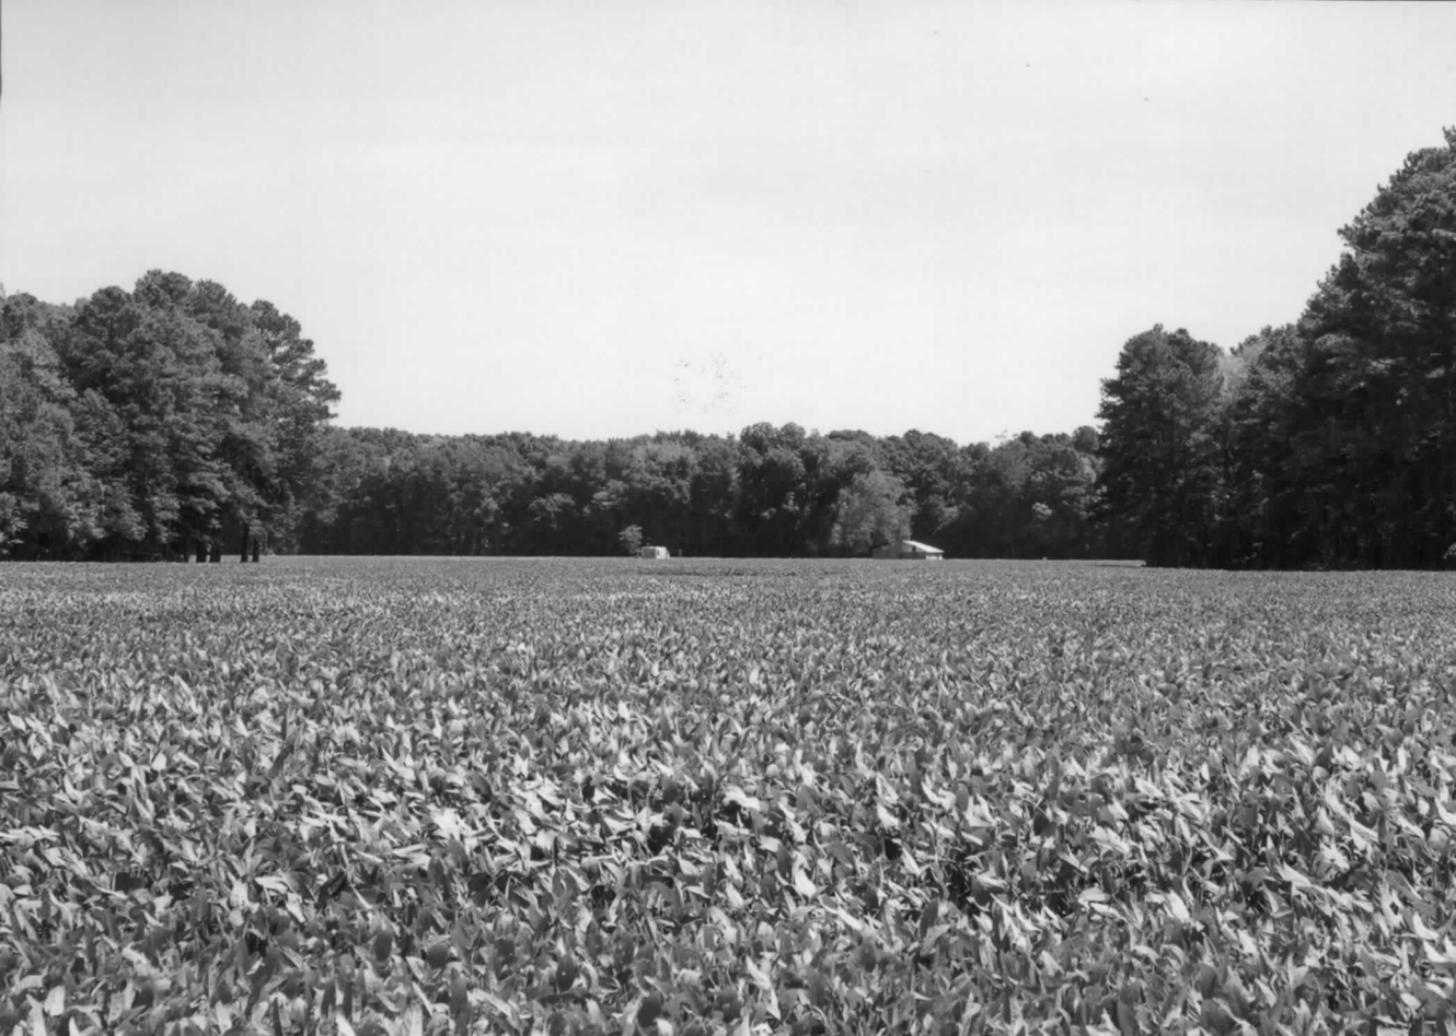
VIEW SE TOWARD FORMER HOUSE SITE
PHOTO #1

The Paul Eby Farm was comprised of a two-story L-plan farmhouse built circa 1890-1900 on the east side of Mennonite Church Road. A previous survey (1984) noted the structure was deteriorated, with much of the period woodwork already removed. It is no longer standing. An aluminum sided storage garage and small residential trailer are currently located on the site.

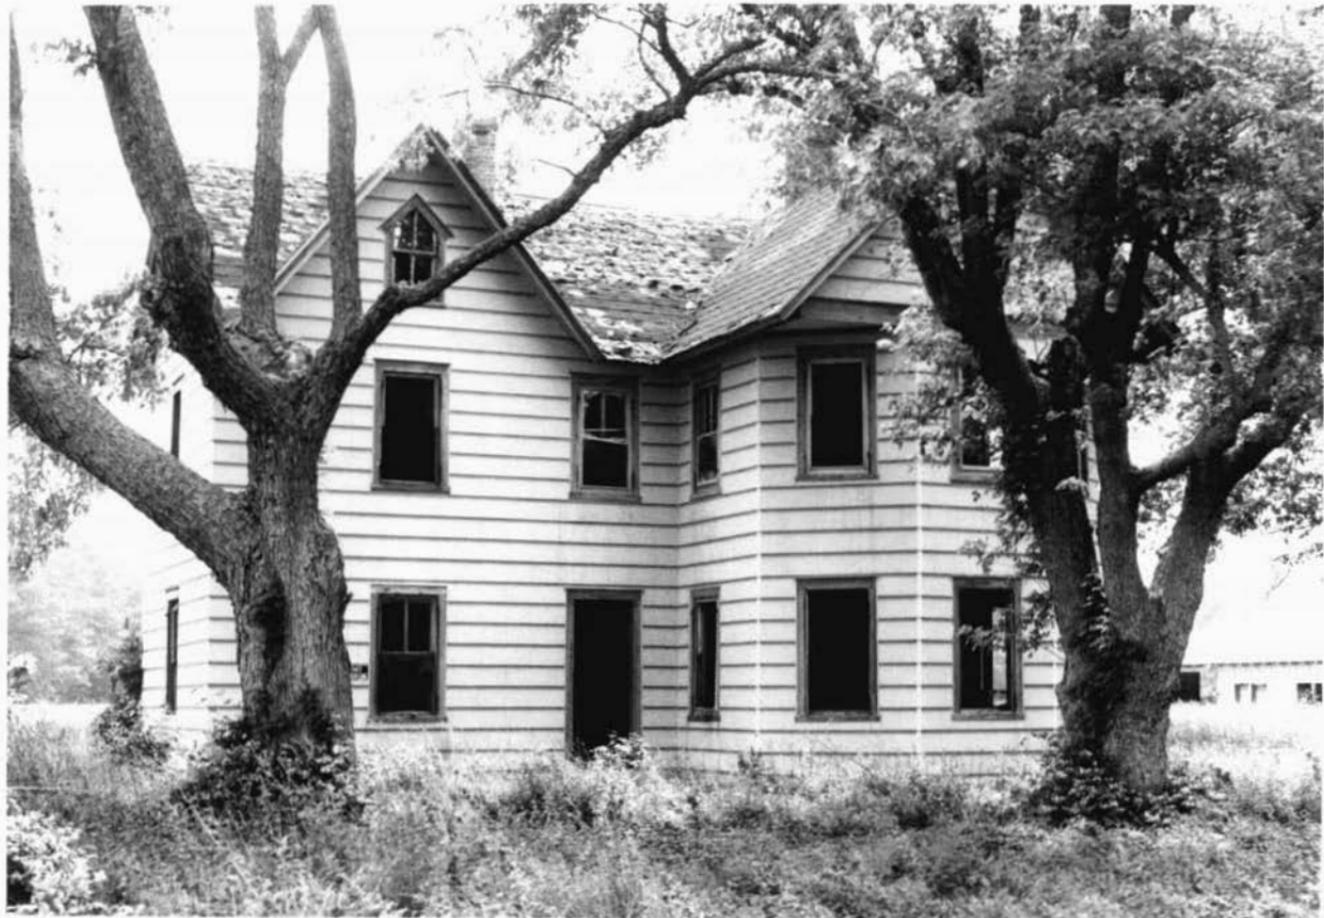
Paul Eby Farm
Near Green Hill, Somerset County
Northwest Elevation
5/84 Paul Touart
Neg./ Maryland Historic Trust

The only significant remnant of the Paul Eby Farm is a c. 1890-1900 two-story ell-plan farmhouse that stands at the end of a dirt road off Mennonite Church Road, .25 of a mile south of the intersection with Turkey Branch Road. The farmhouse faces west with the main gable running north/south.

The abestos sided frame house rests on a brick pier foundation and is supported by a steeply pitched wood shingle roof with extended eaves and exposed rafter feet.

The west (main) elevation is an asymmetrical design with a projecting two-story bay to the south. The main entrance occupies the center bay and is flanked by broken out 2/2 sash windows. A cross-gable interrupts the roofline and is pierced by a small 2/2 arched window.

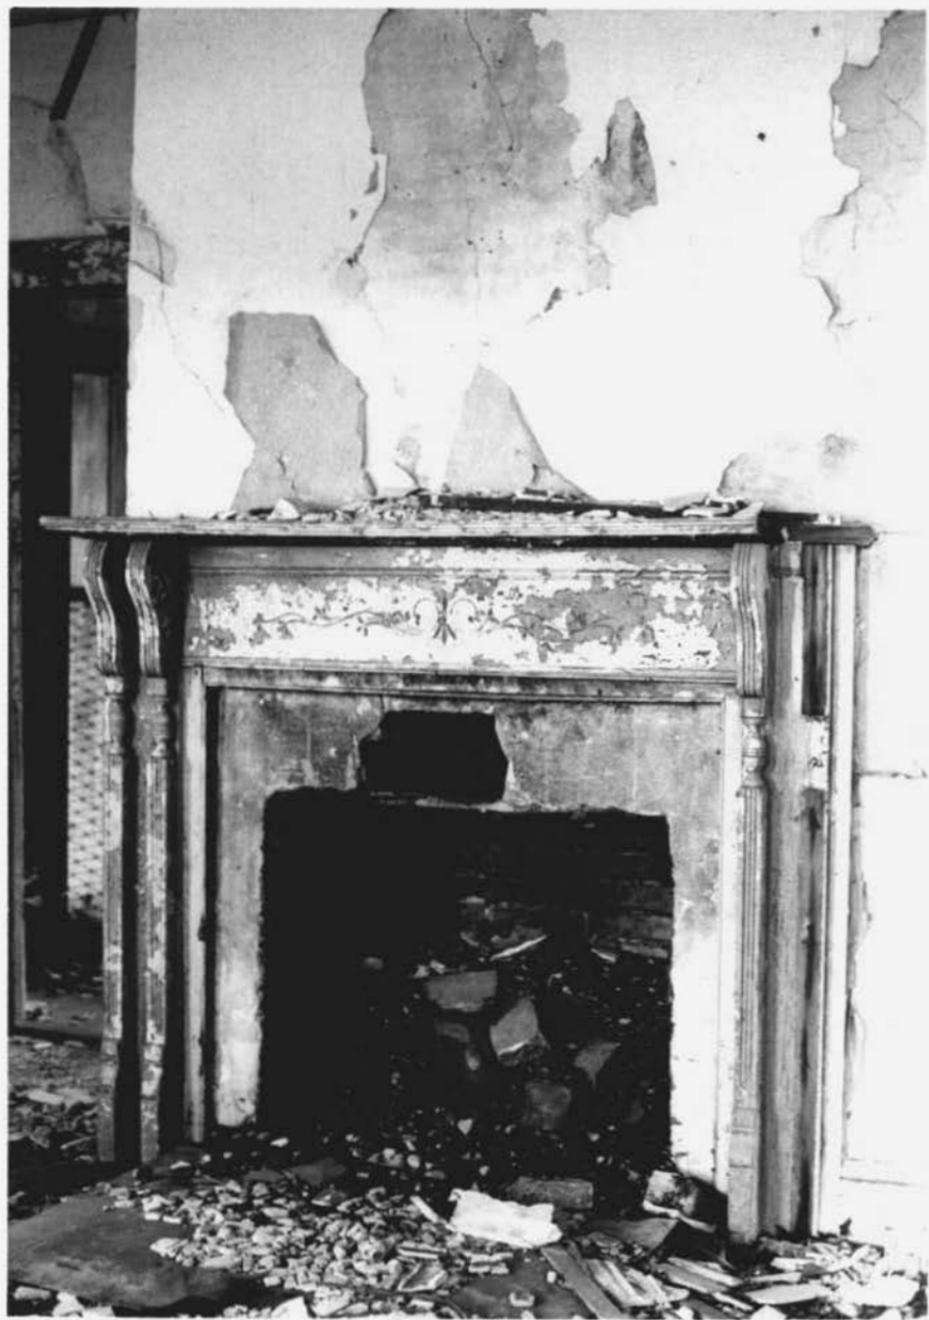
Paul Eby Farm S-208
Near Green Hill, Somerset County
Mantel in Parlor
5/84 Paul Touart
Neg./MD Historical Trust

Inside, a center hall separates three rooms; one to the north and two rooms to the south. The woodwork has been partially removed, but a Victorian period mantel survives in the front room on the south side of the house. Four-panel doors with molded surrounds and bulls-eye corner blocks characterize most door openings. The newel post as well as most of the turned balusters have been removed.
