S-262
 Old Bank of Marion
 Marion
 public

Maryland Historical Trust State Historic Sites Inventory Form

historic Bank of Marion

and/or common Marion Pharmacy

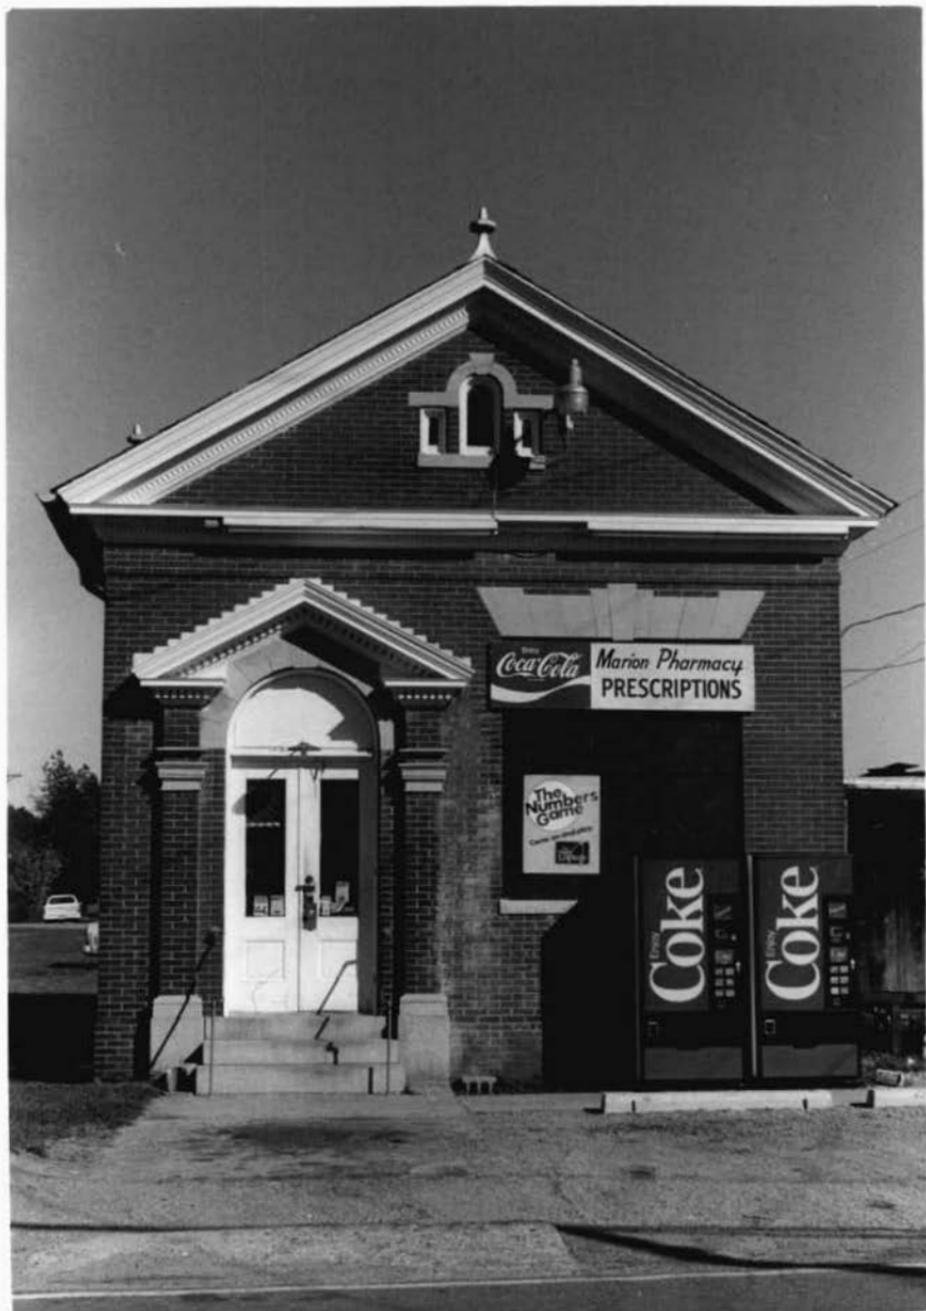
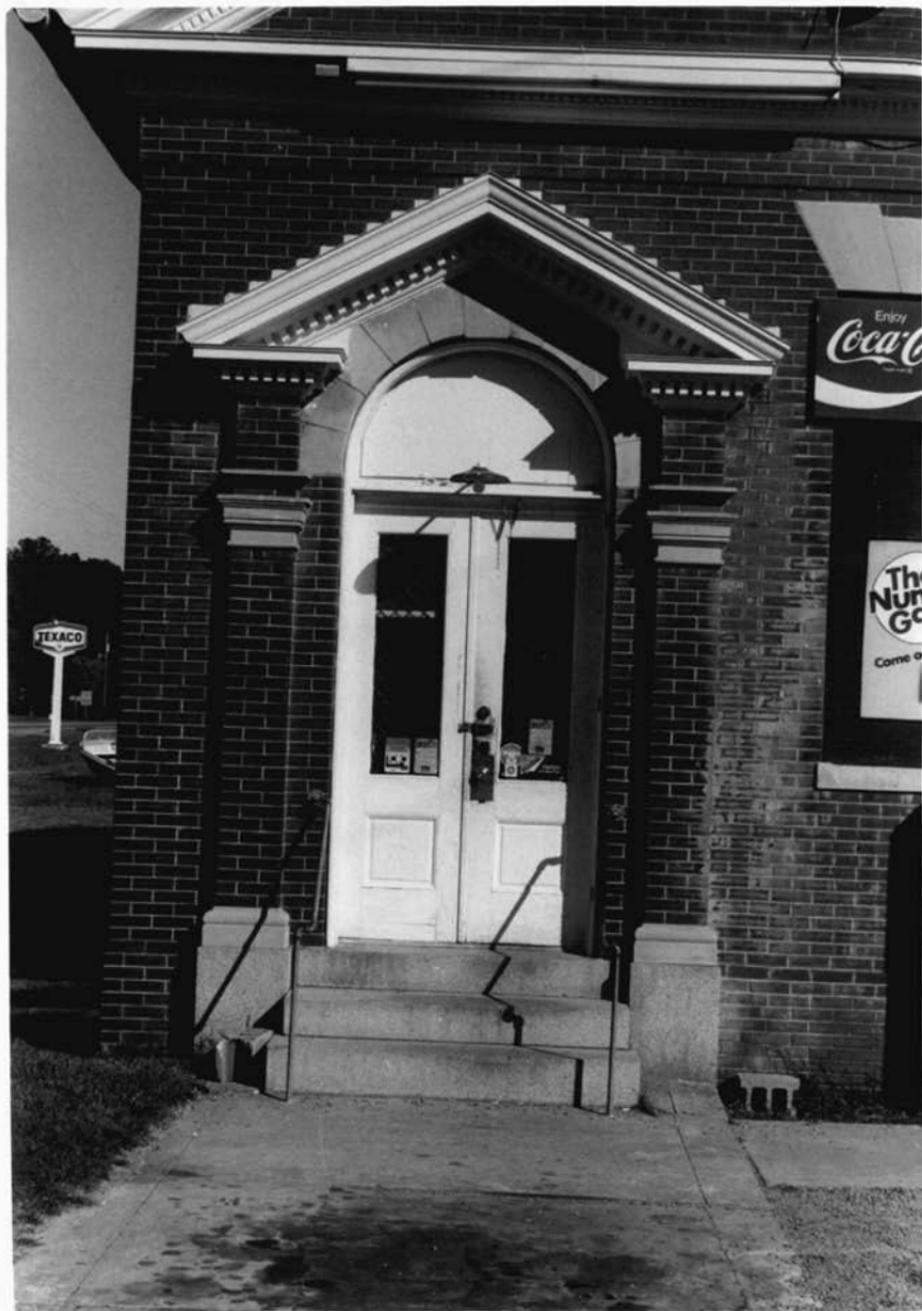
S-262

Old Marion Bank
Southwest Entrance
Marion, Somerset County
10/84, Paul Touart, Photographer
Neg./MD Historical Trust

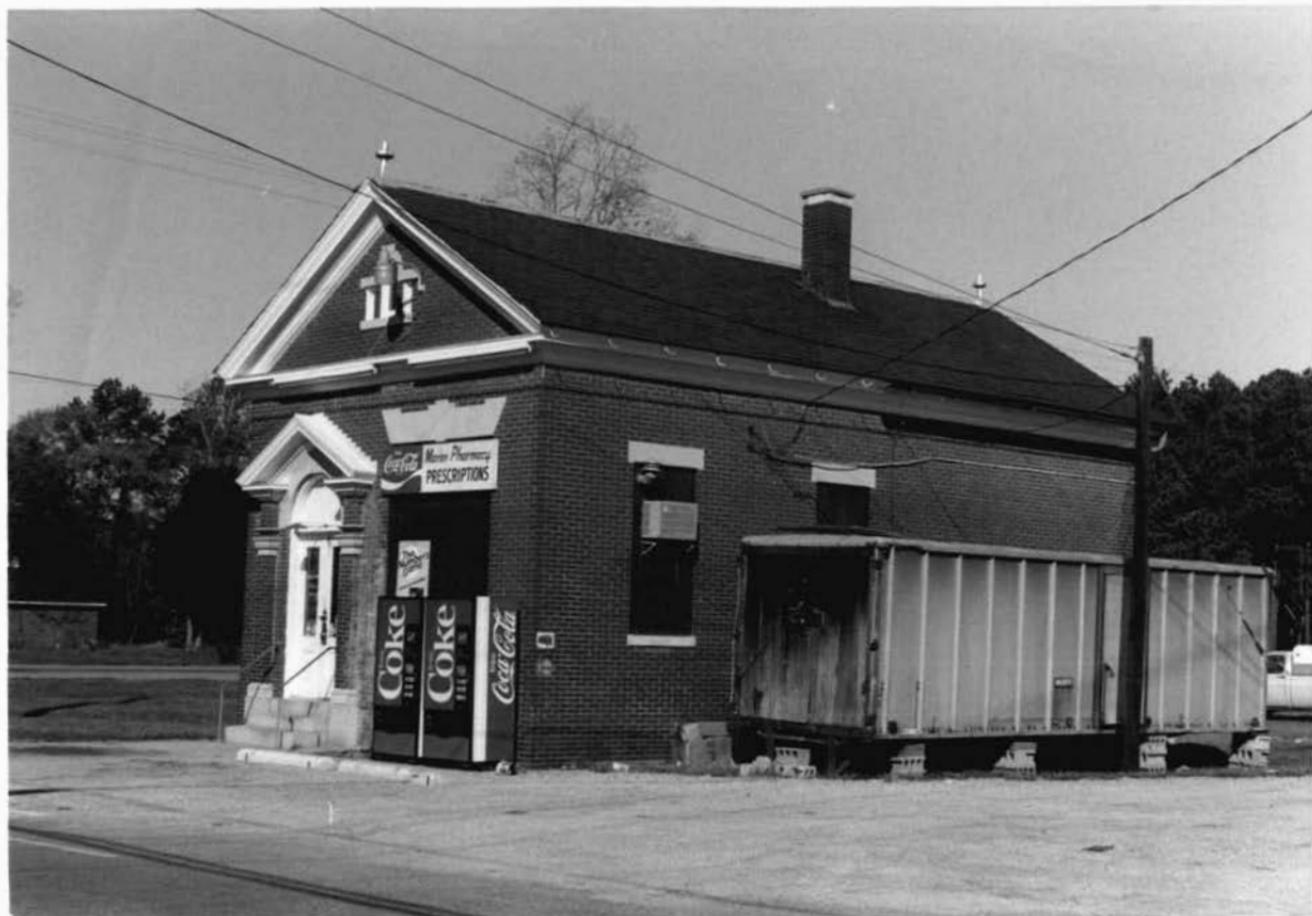
S-262

Old Bank of Marion
South Elevation
Near Marion, Somerset County
11/84, Paul Touart
Neg./MD Historical Trust
