S-265  
Eastern Shore National Bank  
Marion  
public

c. 1900

# Maryland Historical Trust State Historic Sites Inventory Form

historic Eastern Shore National Bank

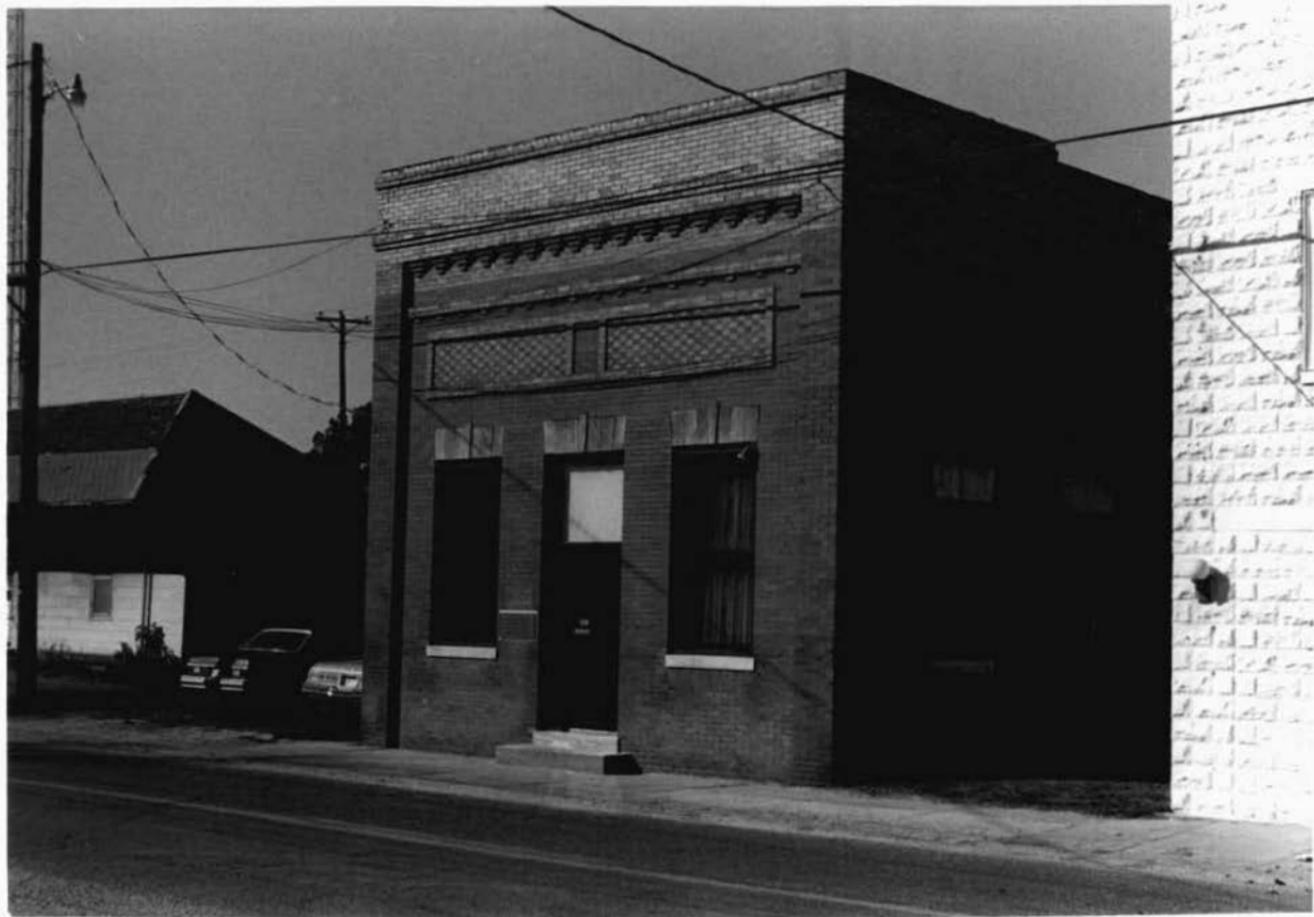
Eastern Shore National Bank      S-265  
Northeast Elevation  
Marion, Somerset County  
10/84, Paul Touart, Photographer  
Neg./MD Historical Trust

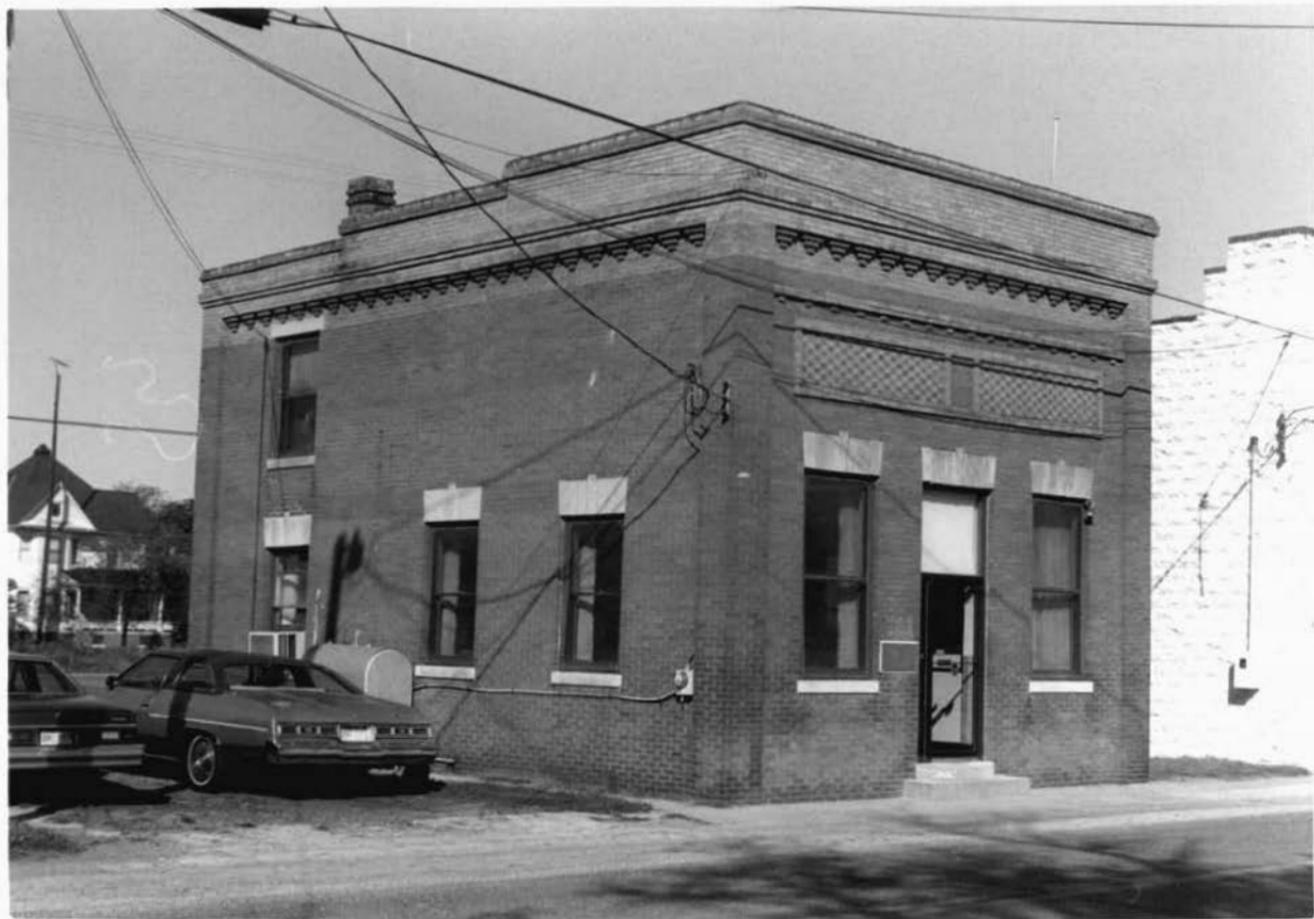
Eastern Shore National Bank      S-265

The main (southeast) facade is a symmetrical three-bay elevation with a center door and flanking single-pane sash windows. All three openings are topped by keystone masonry arches. The windows have limestone sills. Located between the first floor window arches and the cornice is a checkerboard brick pattern of light and dark brown bricks. A rectangular light colored brick border frames the decorative area.

Southeast Elevation
