S-298

1905

# Maryland Historical Trust State Historic Sites Inventory Form

historic Marine Bank of Crisfield

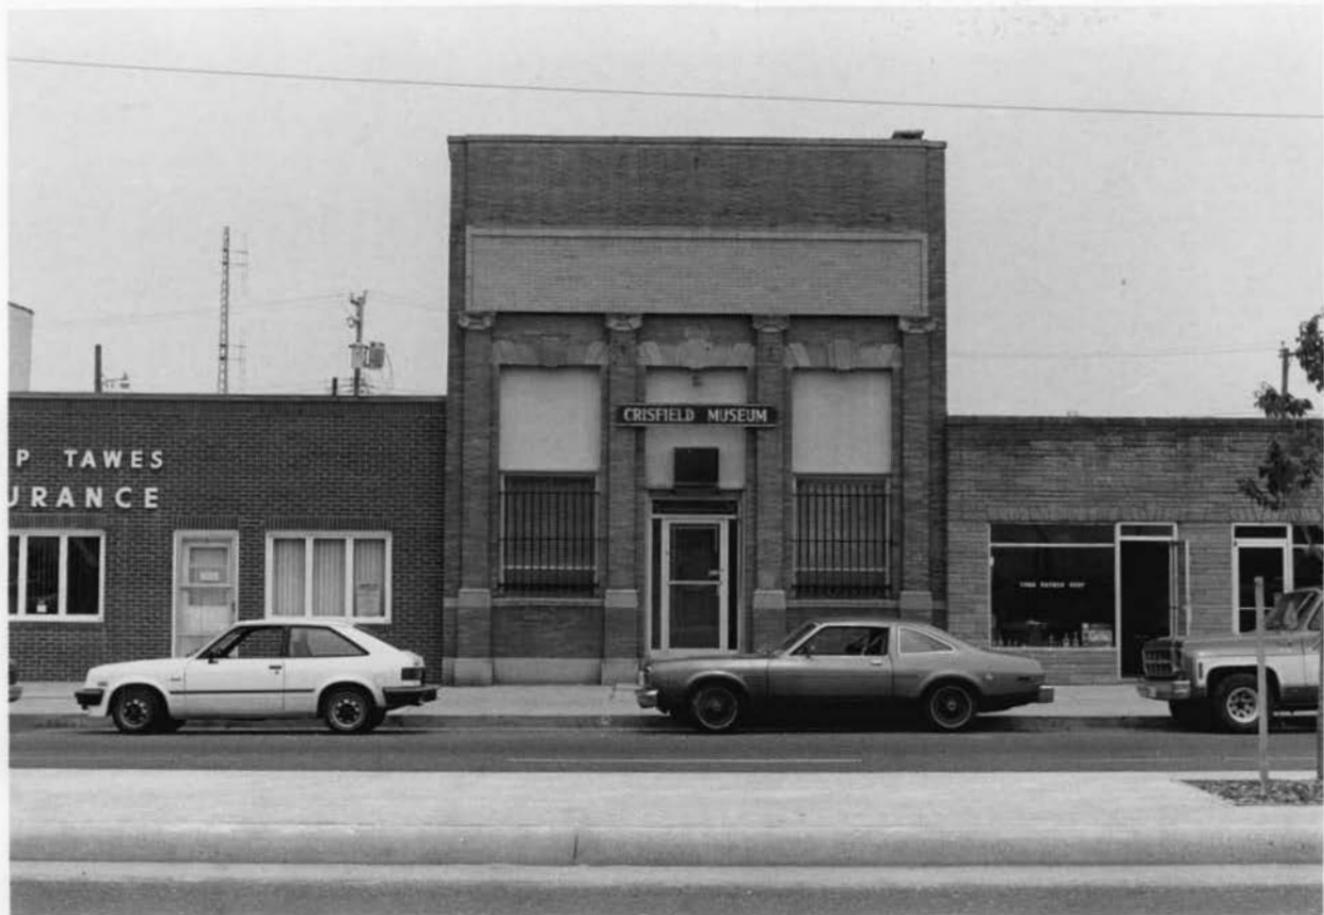
S-298

Marine Bank of Crisfield  
Crisfield, Somerset County  
Southeast Elevation  
7/85 Photographer - Paul Touart  
Neg/Maryland Historical Trust

The southeast (main) elevation is divided into three bays by four Ionic pilasters that rise from simply molded granite bases. The pilaster shafts are of brown brick while the capitals are of carved limestone. The pilasters support a rectangular beige-colored brick panel that stretches across the upper portion of the building. The parapet roof is capped by a course of limestone blocks. Located between each pair of pilasters is a large door or window opening with a finely tooled keystone arch. The center door and the flanking windows have been reduced in size. Curved iron grills protect the two window openings.

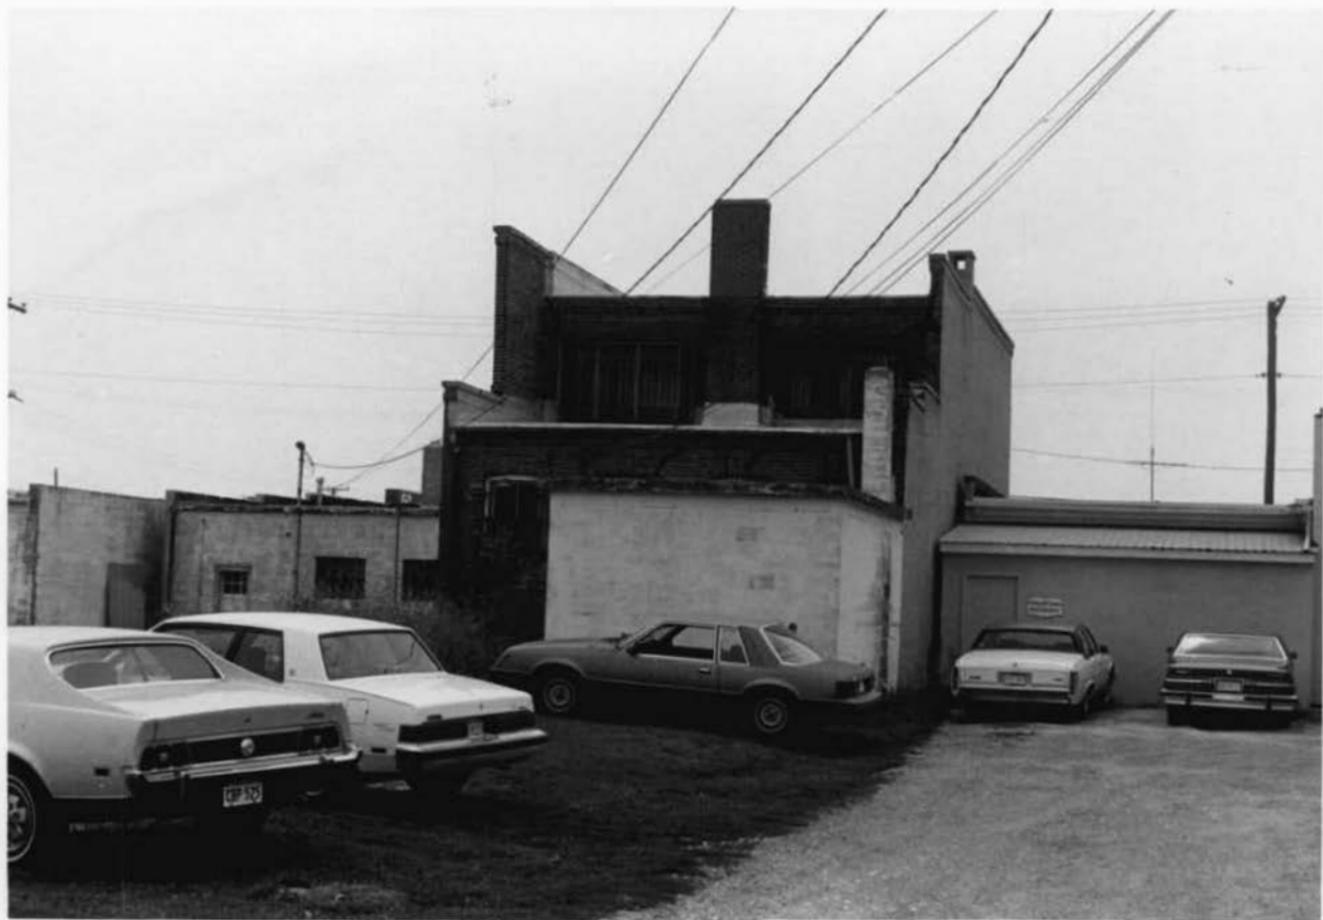
S-298

Northwest Elevation

The northwest (rear) elevation of the old bank consists of a shorter single-story section that extends from the taller main block. Extending farther from the main block is a one-room concrete block addition. Large windows have been cut through the upper wall of the main block on either side of a brick chimney stack. The rear wall of the shorter section is marked by four segmental arched window openings, three of which are now covered by the concrete block addition. Iron bars remain on the northern-most window opening.
