S-310
Peyton Pharmacy Building
Crisfield
public

Maryland Historical Trust State Historic Sites Inventory Form

Peyton Pharmacy building description

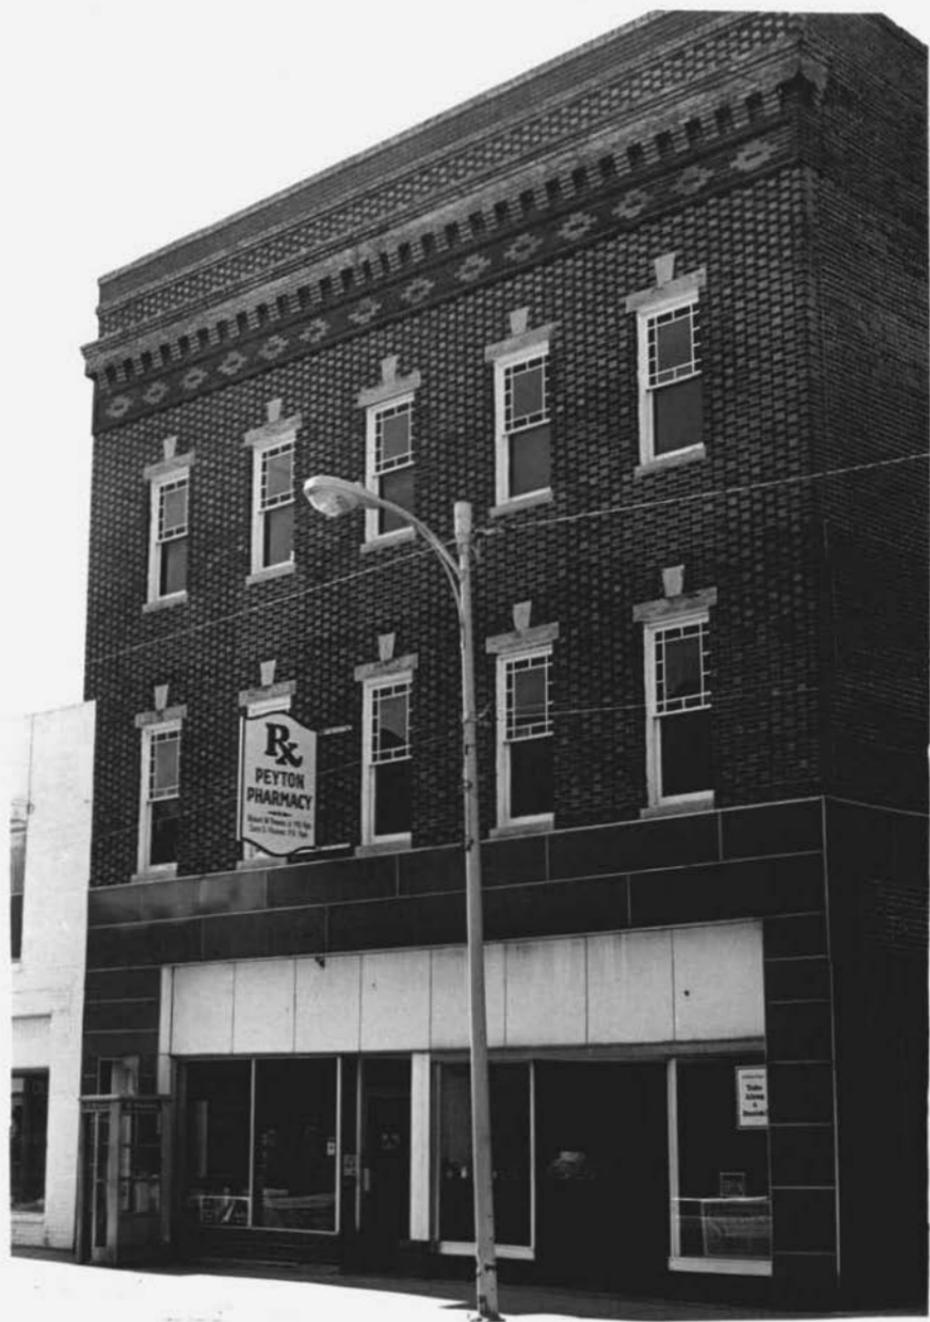
S-310

Peyton Pharmacy
Crisfield, Somerset County
North Elevation
7/85, Photographer, Paul Touart
Neg/Md. Historical Trust

The (main) facade is a symmetrical five-bay elevation with an altered 1950s blue-glass storefront that frames two recessed entrances with glass display windows. The second and third floors are pierced by five evenly spaced multi-pane windows accented with rusticated stone lintels and door sills. Atop each window lintel is an oddly placed masonry keystone. The two floors of windows are set in a field of glazed header checkerboard bricks. Above the second floor windows a corbelled brick cornice is further embellished with a decorative brick frieze with light colored brick lozenges. The glazed header checkerboard pattern resumes above the brick cornice, and the brick parapet is topped by a lighter colored brick capping.
