S-408
Catalpa Farm
Princess Anne vicinity
private

National Register of Historic Places Registration Form

historic name Catalpa Farm
other names/site number S-408

**United States Department of the Interior
National Park Service****National Register of Historic Places
Continuation Sheet**Section number 7 Page 1Catalpa Farm
Somerset County, Maryland

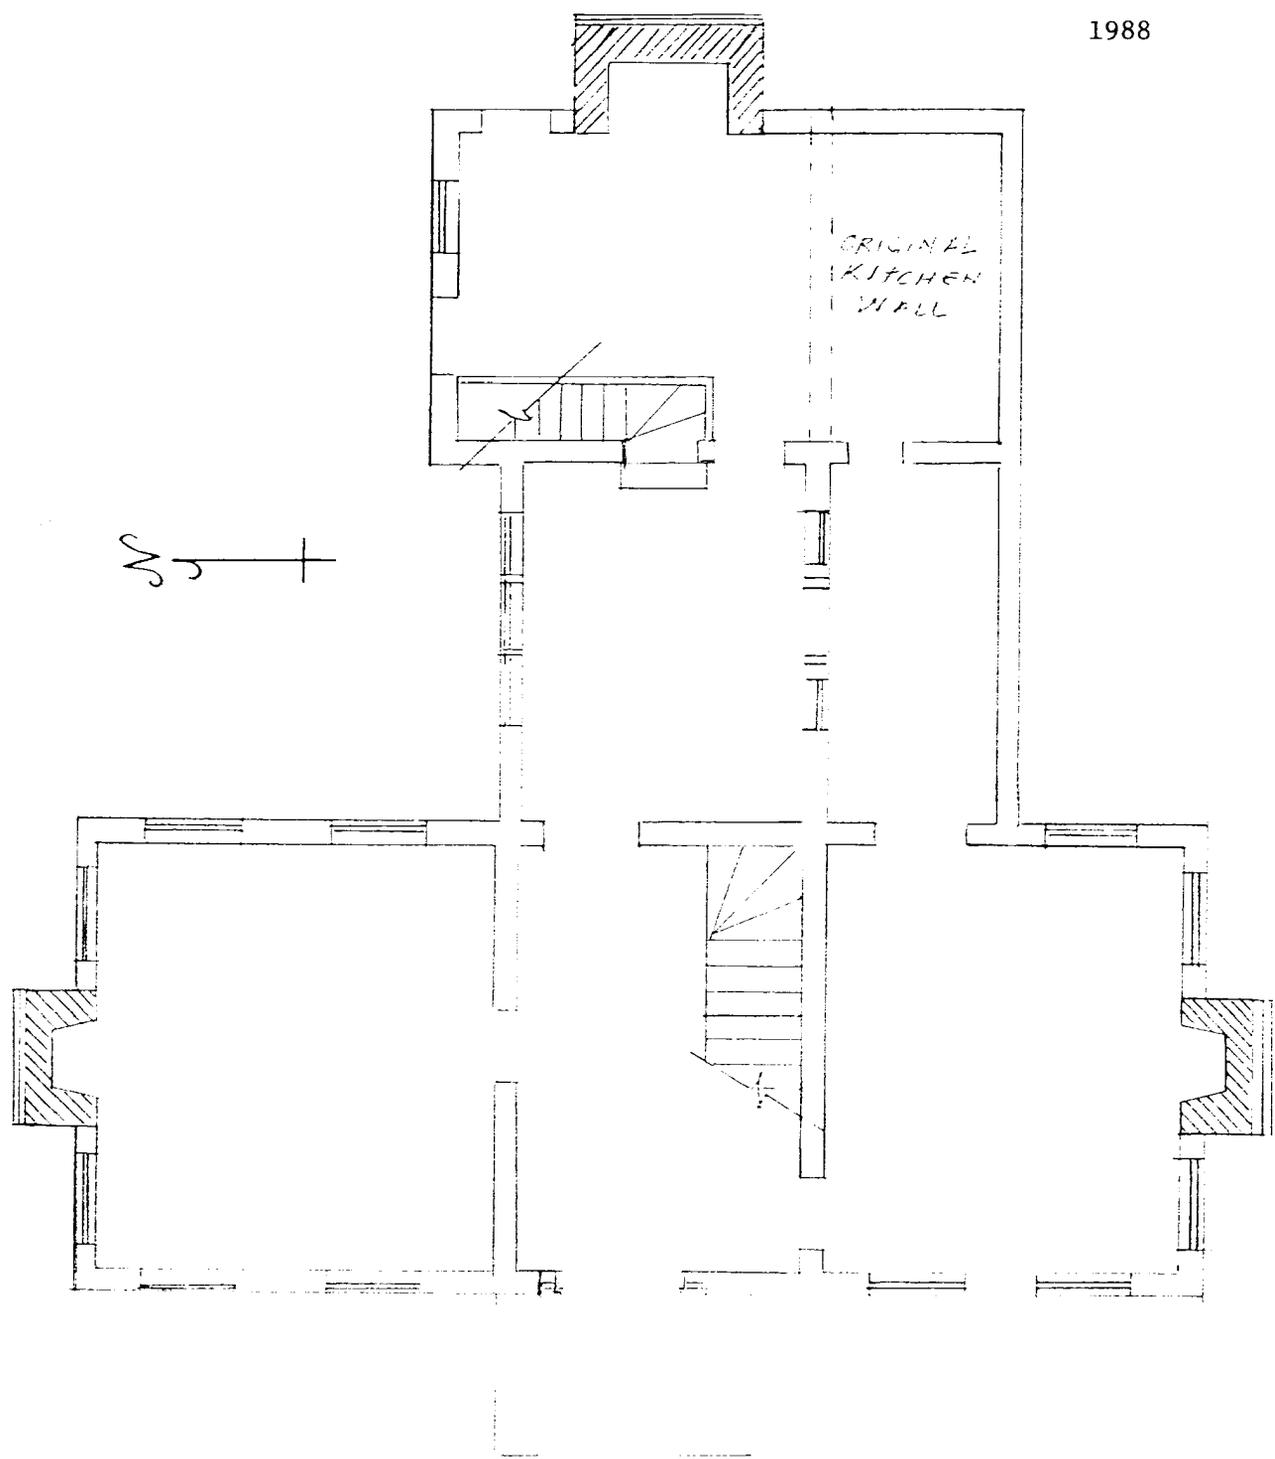
first floor plan

The house is a two-story, five-bay center passage structure built in two principal stages, beginning with a two-story, three-bay side-hall parlor house with service wing erected around 1825-1840. A two-story one-room plan frame addition was attached shortly thereafter to the north gable end of the front block. A two-story one-room plan kitchen was originally joined to the main block by a single-story hyphen, the present dining room, which was later raised to a two-story height. More recent shed roofed additions have been attached to the south and east sides of the service wing. Supported by a minimal brick foundation, the two-story house is largely covered by beaded weatherboards. The second floor level of the hyphen, added later, is the most conspicuous section not sheathed with the beaded siding. A layer of asphalt shingles covers the medium sloped gable roof.

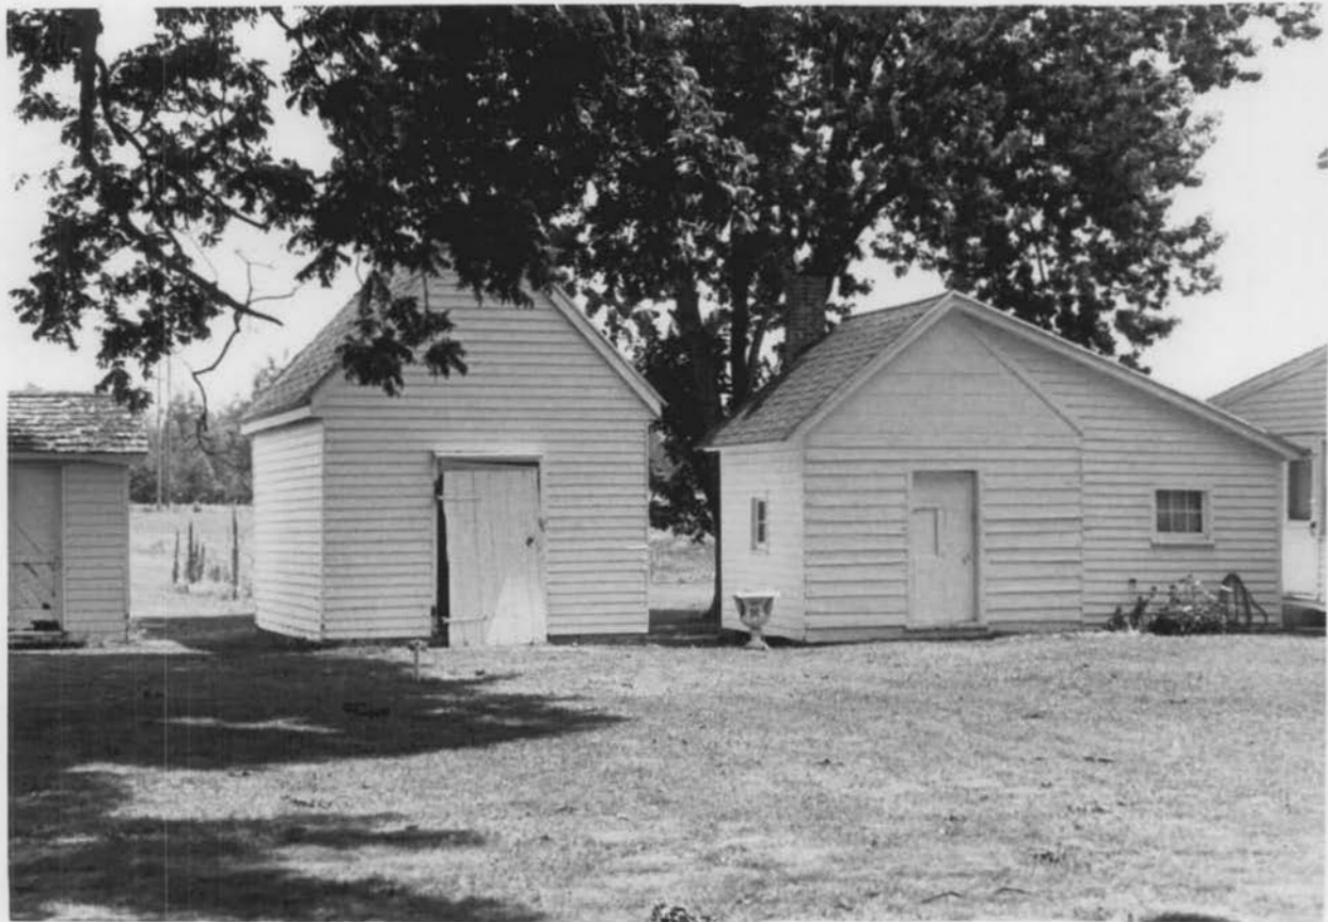
West elevation - *outbuildings*
6/85 Paul Touart - Photographer
Neg/Md. Historical Trust

The outbuildings that accompany the house include an early nineteenth-century dairy and smoke house of the same period, a late nineteenth-century privy, a modern garage, a mid nineteenth-century corn crib, an early twentieth-century gambrel roofed barn, and an early nineteenth-century tobacco house. Standing nearest the house on the north side is the single-story frame dairy that dates to the same period as the house, c. 1835-1840. The one-room, weatherboarded frame structure was enlarged on the south side with a shed addition that houses the pump. The structure is supported by a minimal brick pier foundation, and is covered with a mixture of plain lapped weatherboards, flush weatherboarding, and German siding. The steeply pitched roof is covered with asphalt shingles. The front (west) elevation is marked by a centered six-panel door. A six-pane window lights the adjacent pump house shed. The north side of the dairy is pierced by a simple four-pane window, while the east (rear) elevation has two four-pane windows, one lighting each floor. A narrow brick stove stack has been added to the east end. The south side of the dairy is fully covered by the shed addition. The dairy interior has remained largely intact with plastered wall surfaces and bracketed shelving. Riven lath held with cut-nails is exposed in a few sections. A layer of old blue paint remains on sections of the shelving. The loft space is entered through a small access hole in the northwest corner, where a common rafter roof is clearly visible.

Located directly north of the dairy is the contemporary frame smoke house which rests on a minimal brick foundation and has been resheathed with new weatherboards. The steeply pitched roof is covered with asphalt tile shingles. The west (main) facade is marked by a single board door with round-tipped iron strap hinges. The interior has a brick paved floor and fully blackened walls and ceiling. The studs are set on one-foot centers.

Standing behind the smoke house is a frame privy sheathed with German siding and covered by a medium sloped wood shingle roof. The front (west) wall has a diagonal board door, and the north side has a louvered opening. The clean-out is located at the bottom of the east side. Inside, the privy has three seats, and exposed framing members have been whitewashed.

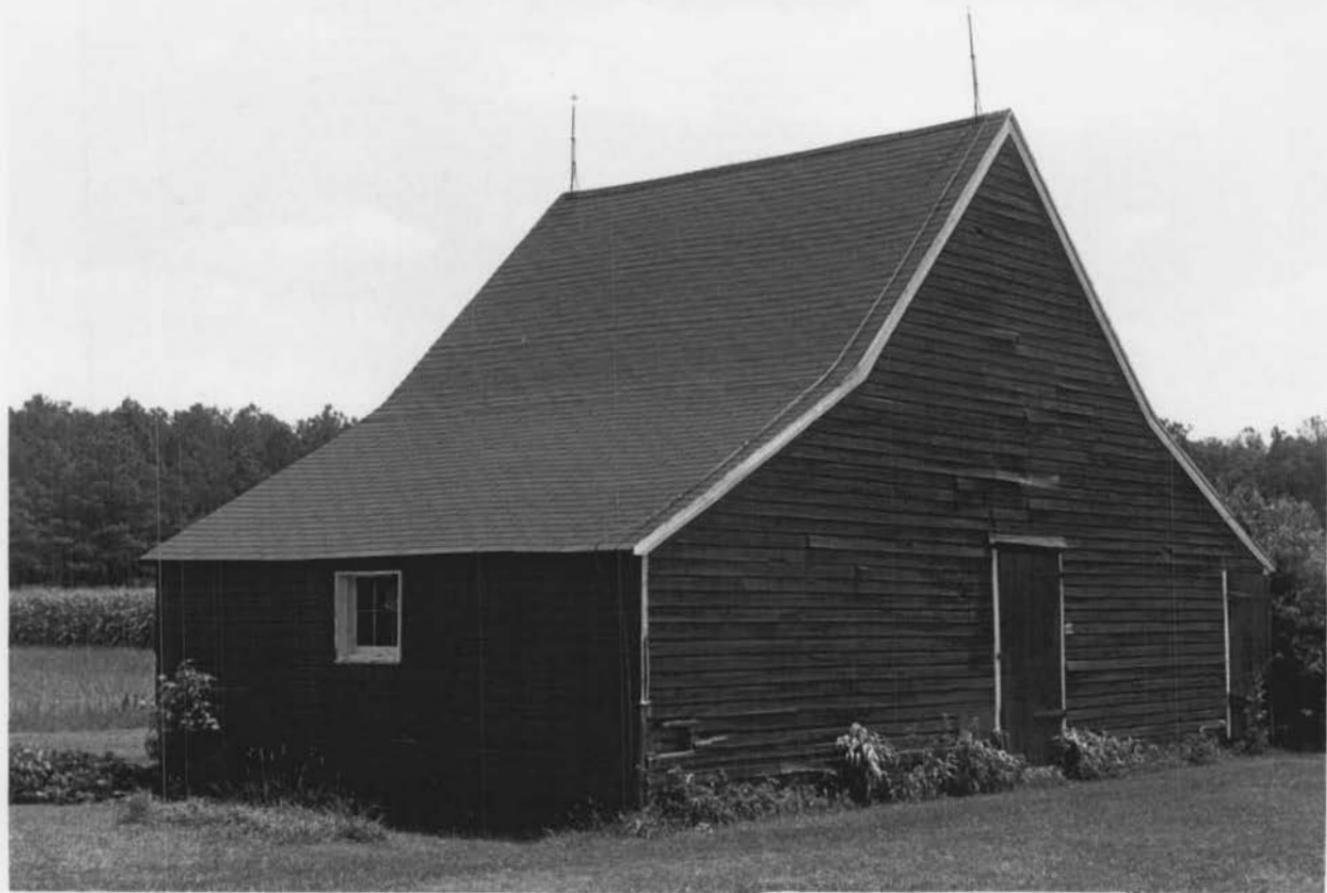
Tobacco House - Northwest elevation
6/85 Paul Touart - Photographer
Neg/Md. Historical Trust

Finally, the tobacco house is located at the south end of the farmyard. The single-story gable front frame structure is supported by a minimal brick foundation, and it is sheathed with a combination of weatherboards and German siding. The squarish frame center structure is covered by a steeply pitched gable roof, while the side sheds are covered by a less steep shed roof; all of which is covered with asphalt shingles. The west (main) elevation is marked by a central board door and another door that opens into the south shed. The interior is divided into three sections with a center room and flanking sheds. The pit-sawn lumber is held together by a combination of mortise-and-tenon joints for the principal posts and mature cut-nails for the studs. Two tiers of collars rise above the tie beams. Corresponding rails are nailed into the interior face of the front and rear gables where tobacco sticks were supported. The rafter peaks have pinned mortise-and-tenon joints. An odd feature of the roof frame is a pair of lateral, diagonally placed beams that stretch downward from the center of the roof to the front and rear girts.

Finally, the tobacco house is located at the south end of the farmyard. The single-story gable front frame structure is supported by a mainimal brick foundation, and it is sheathed with a combination of plain weatherboards and German siding. The squarish frame center structure is covered by a steeply pitched gable roof, while the side sheds are covered by a less steep shed roof; all of which is covered with asphalt shingles. The west (main) elevation is marked by a central board and batten door and another door that opens into the south shed. The interior is divided into three sections with a center room and flanking sheds. The pit-sawn lumber is held together by a combination of mortise and tenon joints for the principal posts and mature cut nails for the studs. Two tiers of collars rise above the tie beams. Corresponding rails are nailed into the interior face of the front and rear gables. The rafter peaks have pinned mortise and tenon joints. An odd feature is the pair of lateral diagonally placed beams that stretch downward from the center of the roof to the front and rear girts.

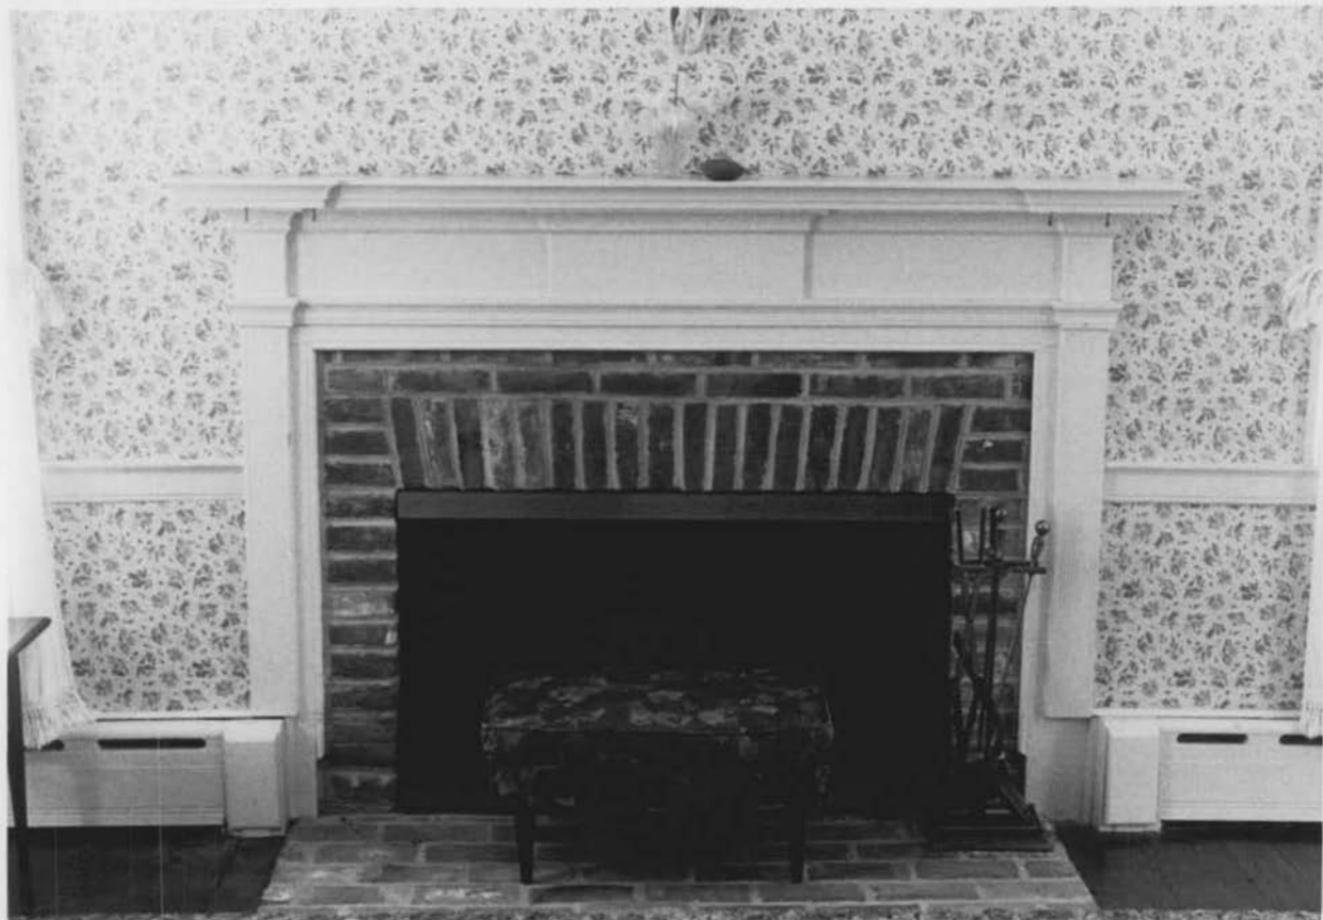
Living Room Mantel
6/85 Paul Touart - Photographer
Neg/Md. Historical Trust

than the other rooms with a Federal period mantel, molded chair rail, and a decorative plaster cornice. The mantel has fluted pilasters which support a five-part frieze. The end blocks are fluted while the center tablet was left plain. The mantel shelf is decorated with a reeded bed molding. The shelf is stepped and broken at each end. Carpenter box locks still remain on many of the doors.
