S-59
Robert H. Jones House
Upper Fairmount
Private

Maryland Historical Trust State Historic Sites Inventory Form

historic Robert H. Jones House

Survey No. S-59

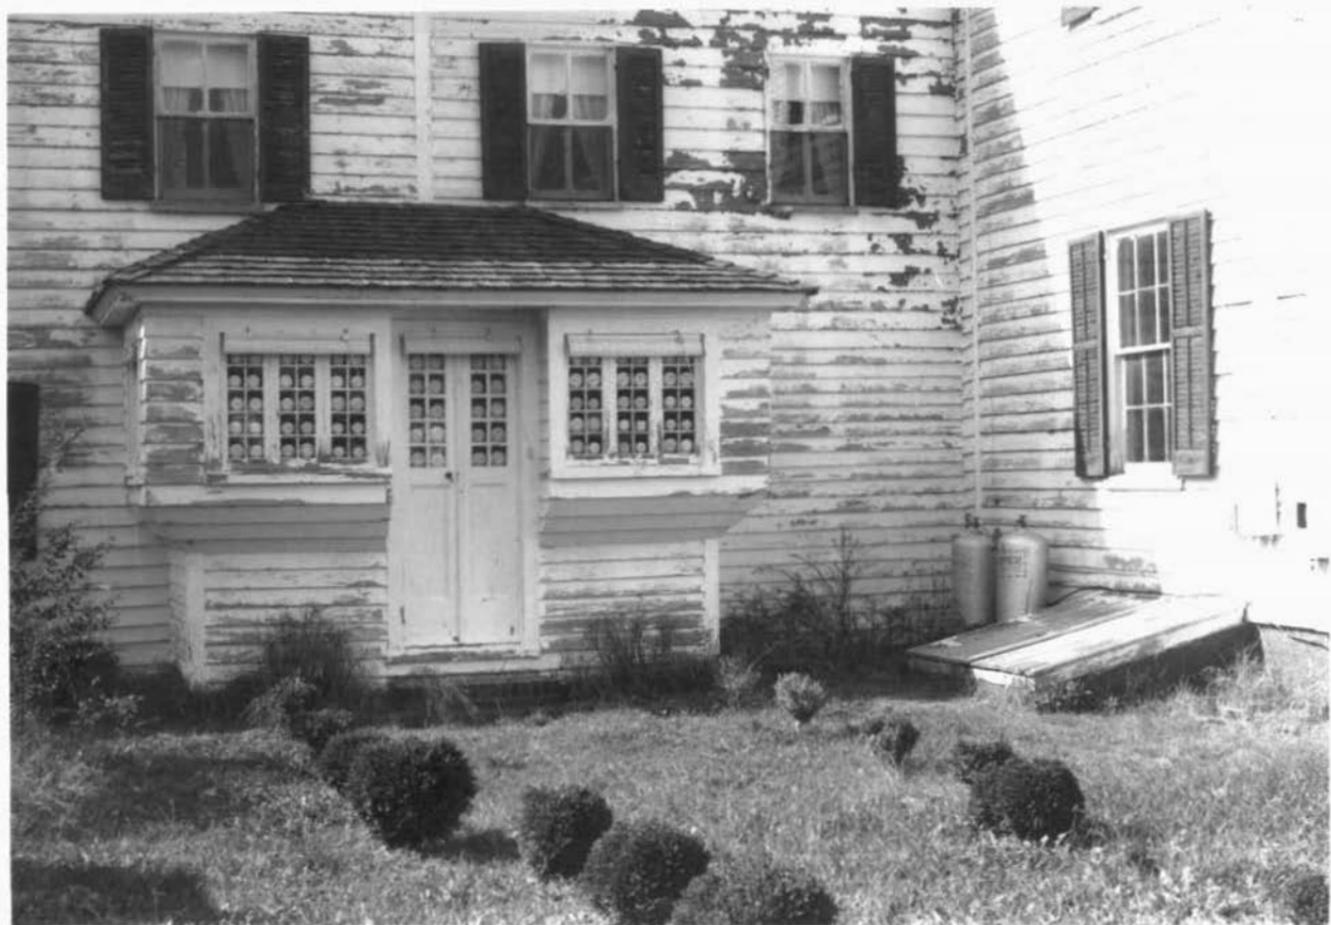
Robert H. Jones House
Upper Fairmount, Md. Somerset County
Butler's Pantry
East Elevation
Photographer - Paul Touart - 10/83
Neg./Md. Historical Trust

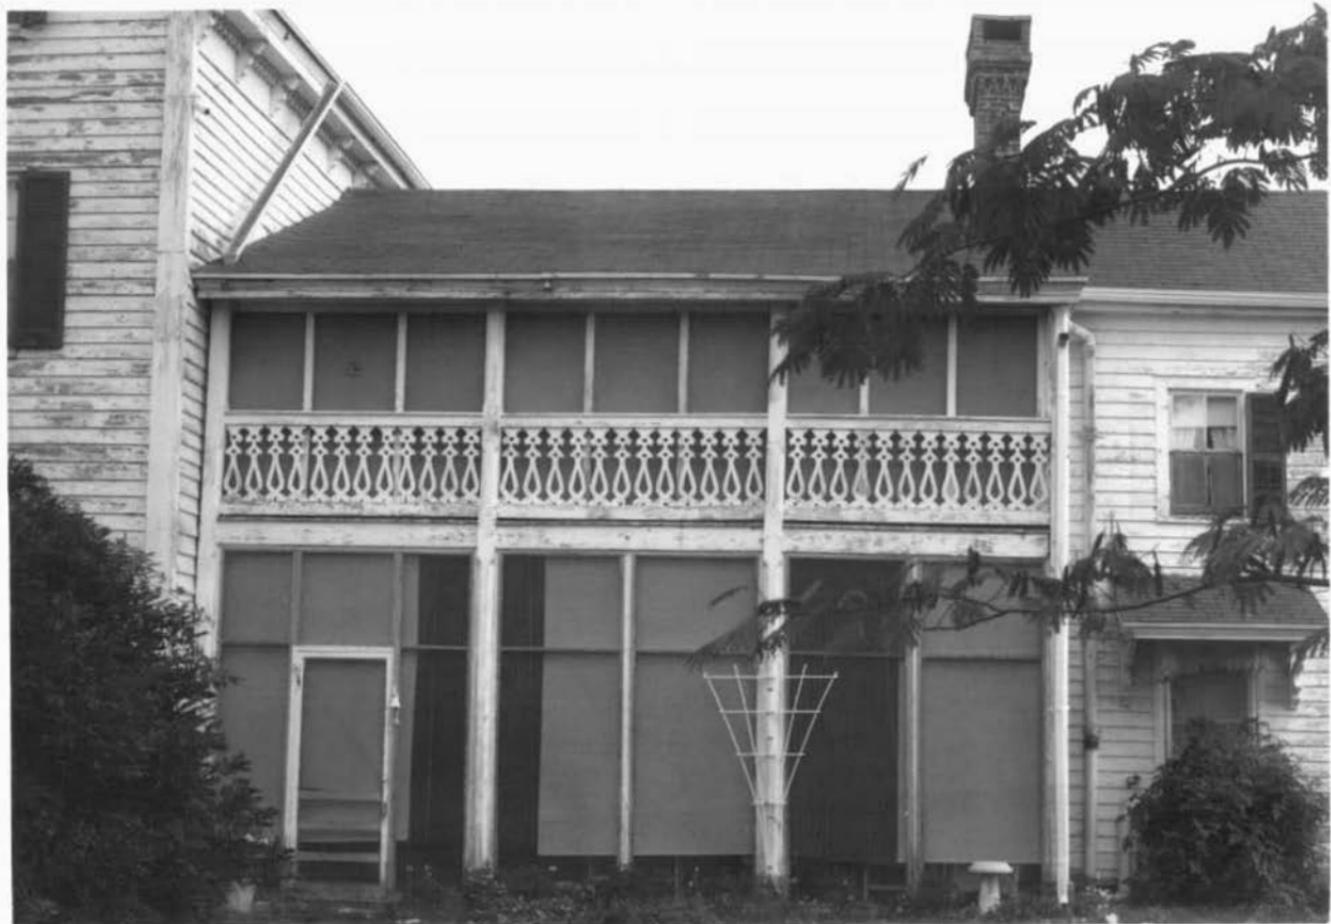
The two-story service wing was built in at least three stages; evidenced by several seams in the weatherboards. A brick chimney rises from the center of the wing, and a brick stove stack protrudes from the gable end. A two-story porch covers part of the west side of the service wing and is distinguished by sawn balusters. Located on the east side is a small c. 1900 hip roofed butler's pantry with access outside through a center double door. Multipane windows fill the top half of the walls to each side.

Robert H. Jones House
Upper Fairmount, Md. Somerset County
West Porch
Photographer - Paul Touart - 10/83
Neg./Md. Historical Trust

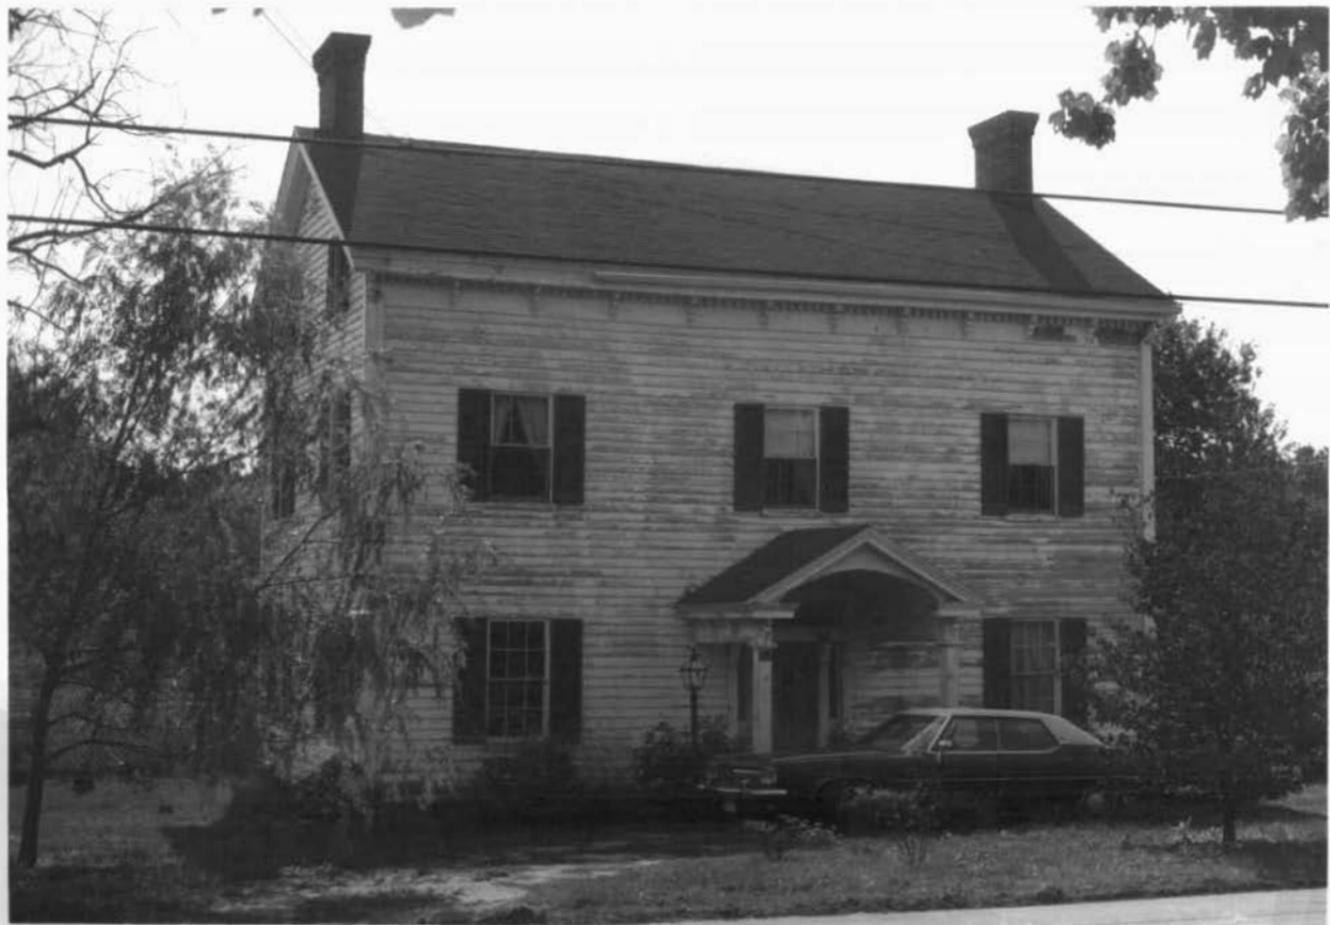
The north facade is three bays across with a center entrance and one-bay porch, which is flanked by 6/6 sash windows. A heavily molded four-panel front door is framed by an exuberant surround and bordered by etched-glass sidelights and transom. Covering the entrance bay is a single bay gabled porch which was built with materials taken from the previous stretched across the facade. A missing two-story porch is the reason for the abnormally large wall space between the second floor windows and bracketed eaves. In fact, the center second floor window once was a door that opened onto the porch. All the windows on the main facade as well as the rest of the house are flanked by louvered shutters.

Robert H. Jones House
Upper Fairmount, Md. Somerset County
North Elevation
Photographer - Paul Touart - 10/83
Neg./Md. Historical Trust

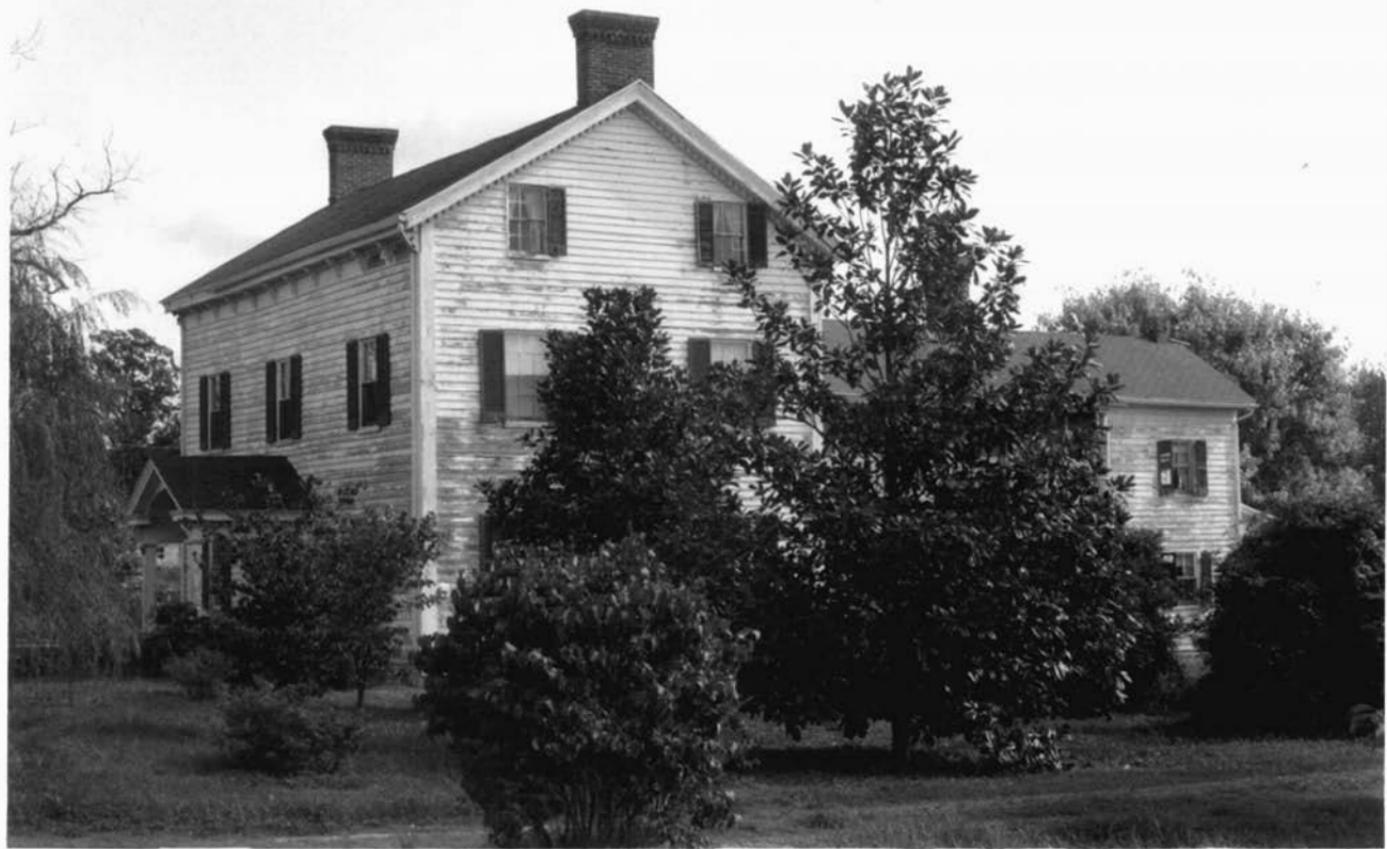
Robert H. Jones House
Upper Fairmount, Somerset Co. Md.
Northwest Elevation
10/83 Paul Touart, Photographer
Neg/Md. Historical Trust

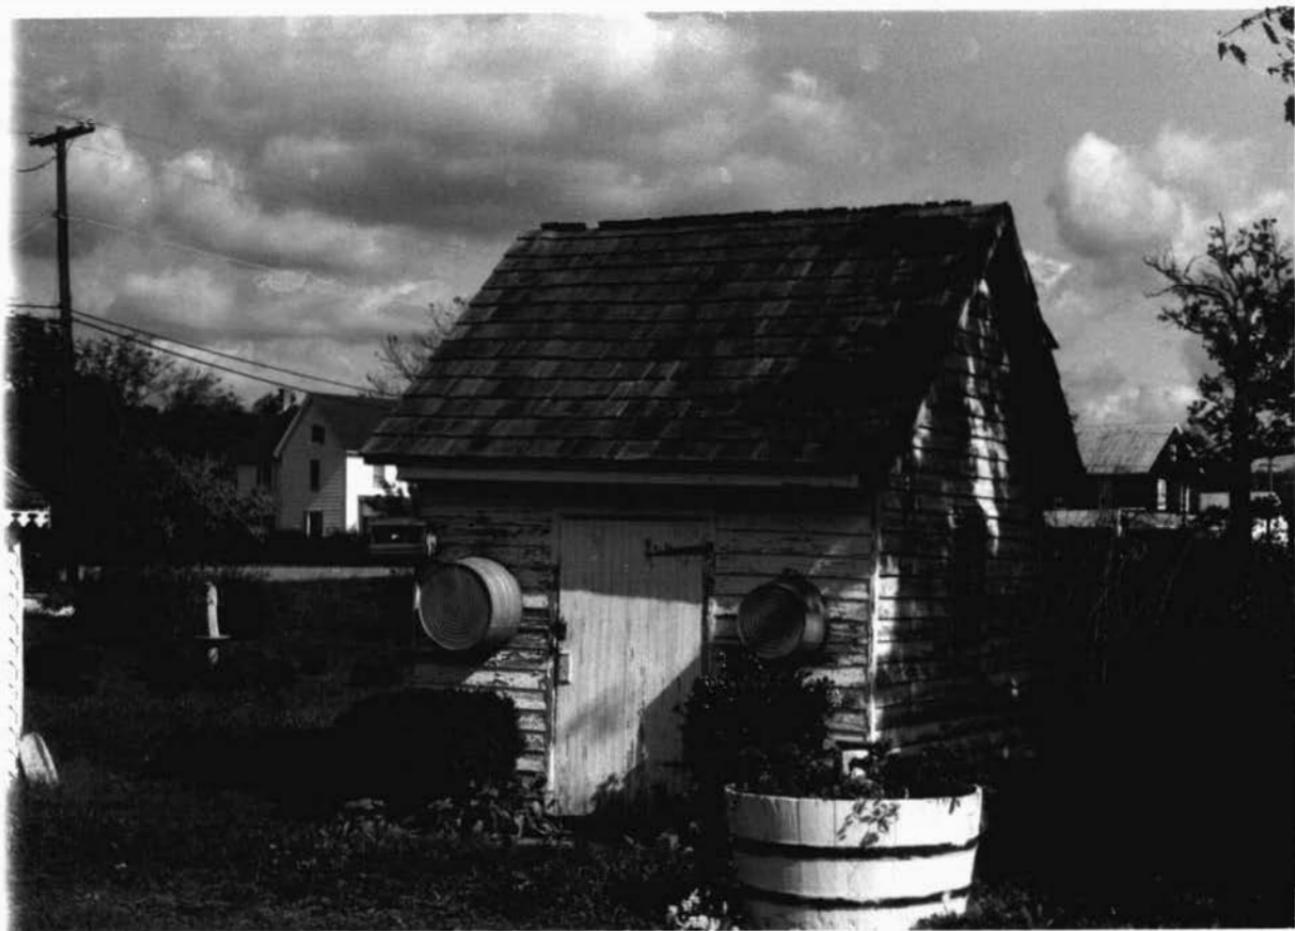
Standing behind the house are two 19th-century outbuildings; a weatherboard frame smoke house and an octagonal gazebo. The smoke house rests on a brick foundation and is covered with a medium sloped wood shingle roof. The front wall is pierced by a board and batten door with strap hinges. A louvered vent is located on each side wall. The interior is completely blackened.

Elevation of Smoke House

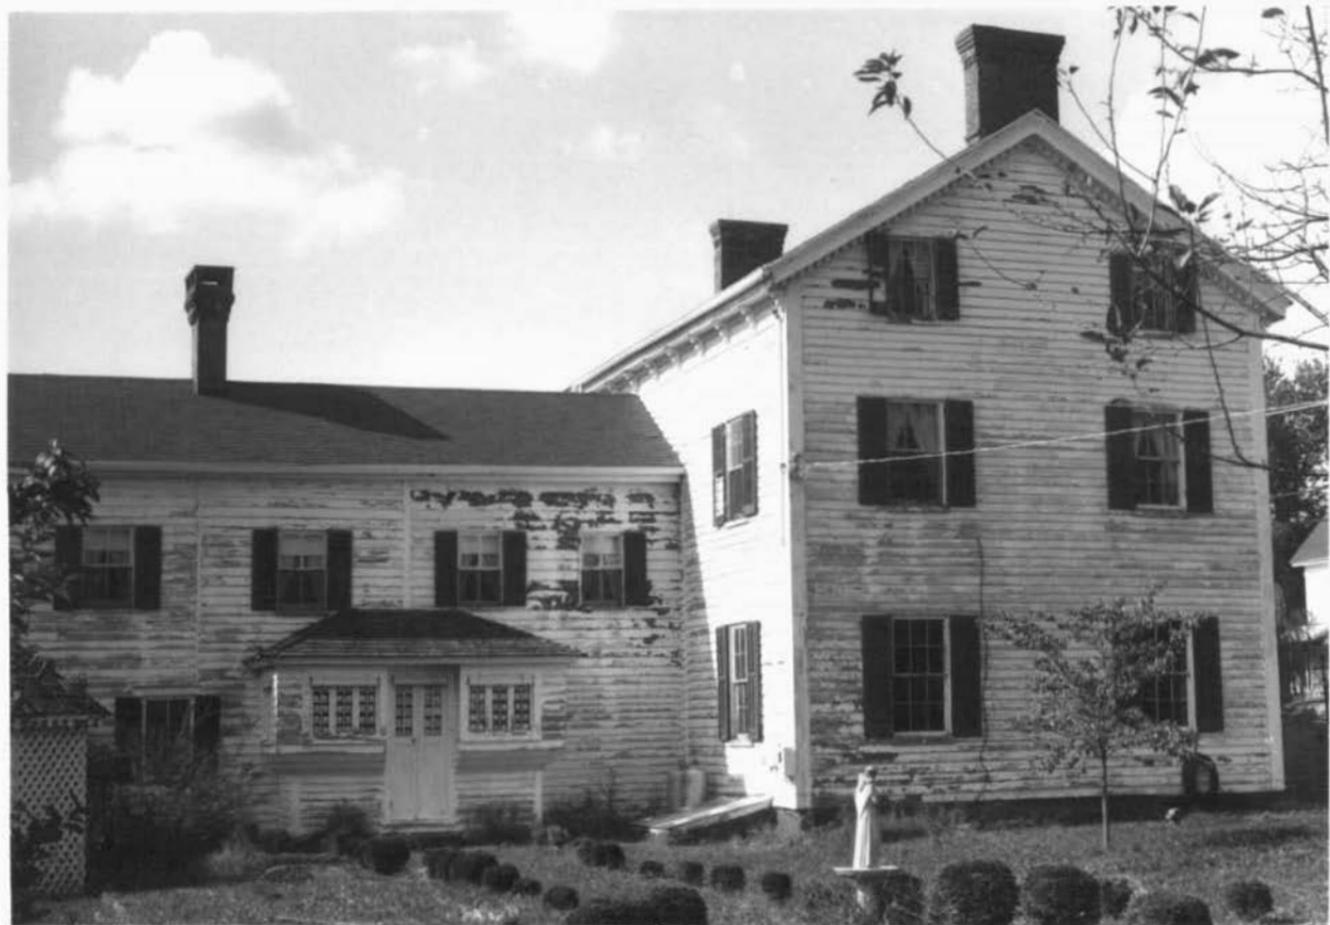
Robert H. Jones House
Upper Fairmount, Md. Somerset County
East Elevation
Photographer - Paul Touart - 10/83
Neg./Md. Historical Trust

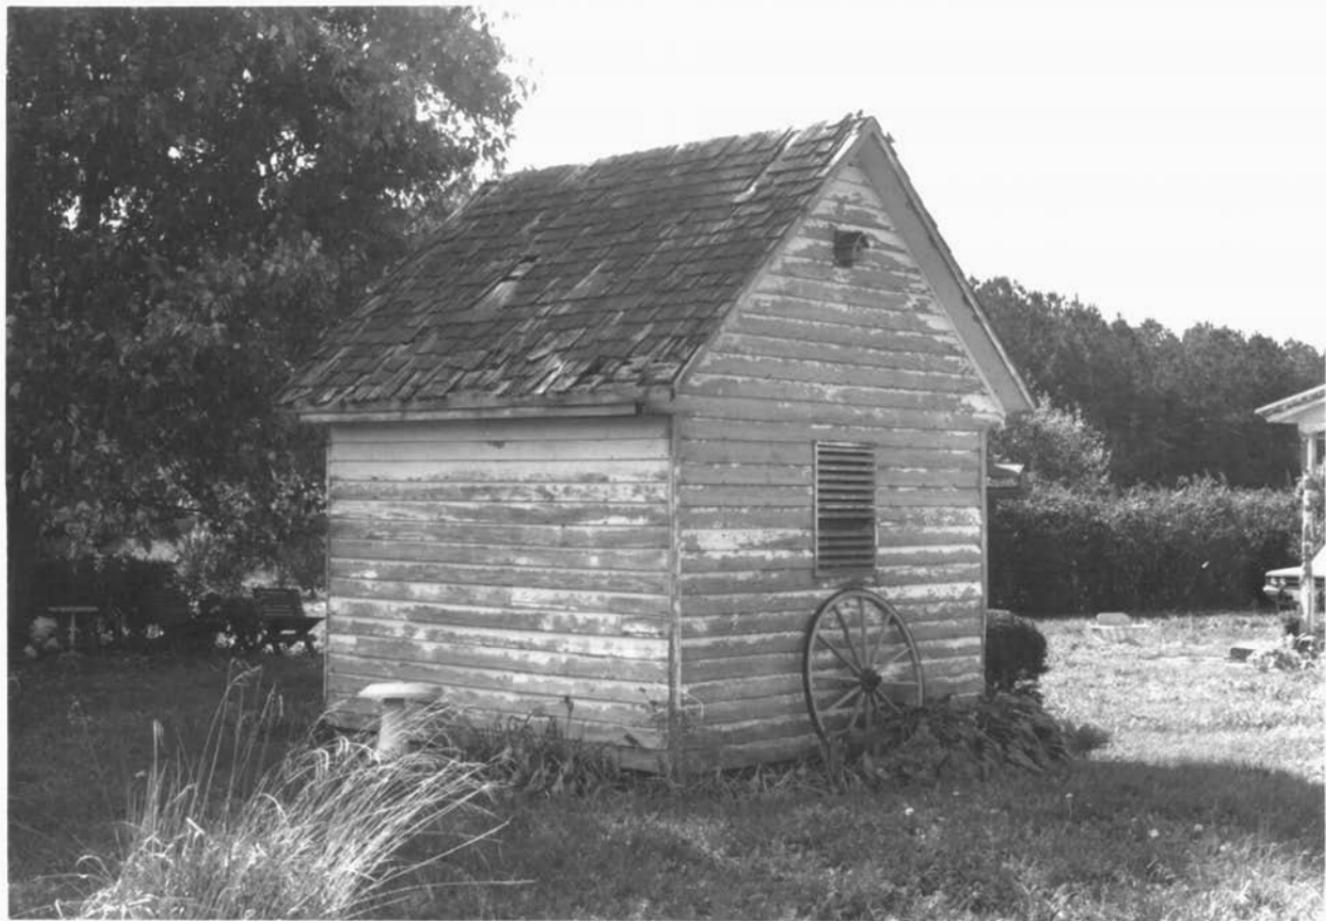
Robert H. Jones House
Upper Fairmount, Md. Somerset County
Smoke House

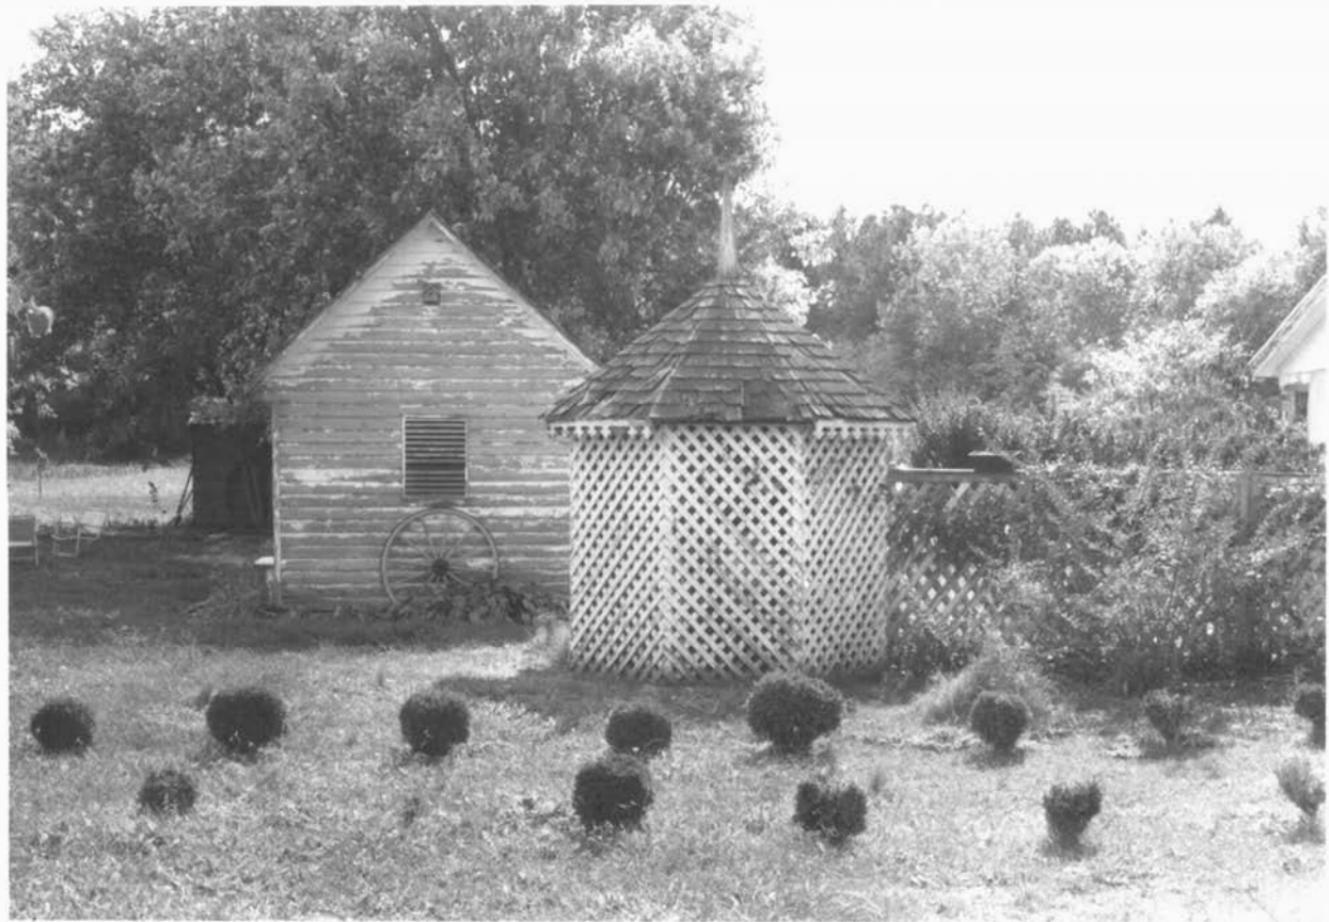
The diagonal lattice gazebo stands next to the smoke house. The roof is covered with wood shingles and topped by a wooden spire. The base of the roof is trimmed with decorative sawn work.

Robert H. Jones House S-59
Upper Fairmount, Md. Somerset County
Gazebo and Smoke House - North Elevation
Photographer - Paul Touart - 10/83
Neg./Md. Historical Trust

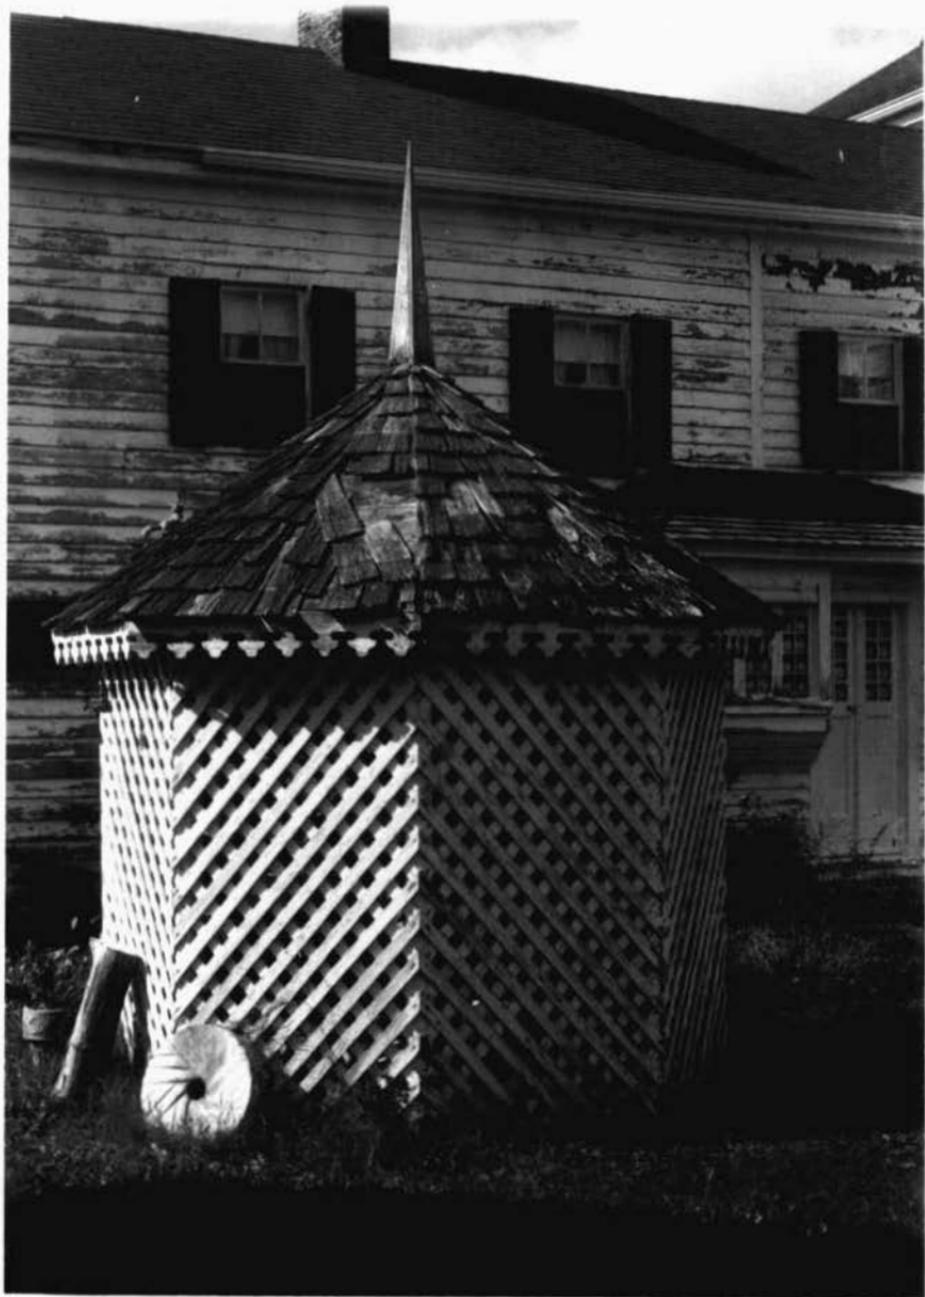
Robert H. Jones House
Upper Fairmount, Somerset County
Entrance - North Elevation
Photographer - Paul Touart - 10/83
Neg./Md. Historical Trust
