National Register of Historic Places  
Inventory—Nomination Form

historic Costen, William, House (preferred)

and/or common Old Costen Homestead

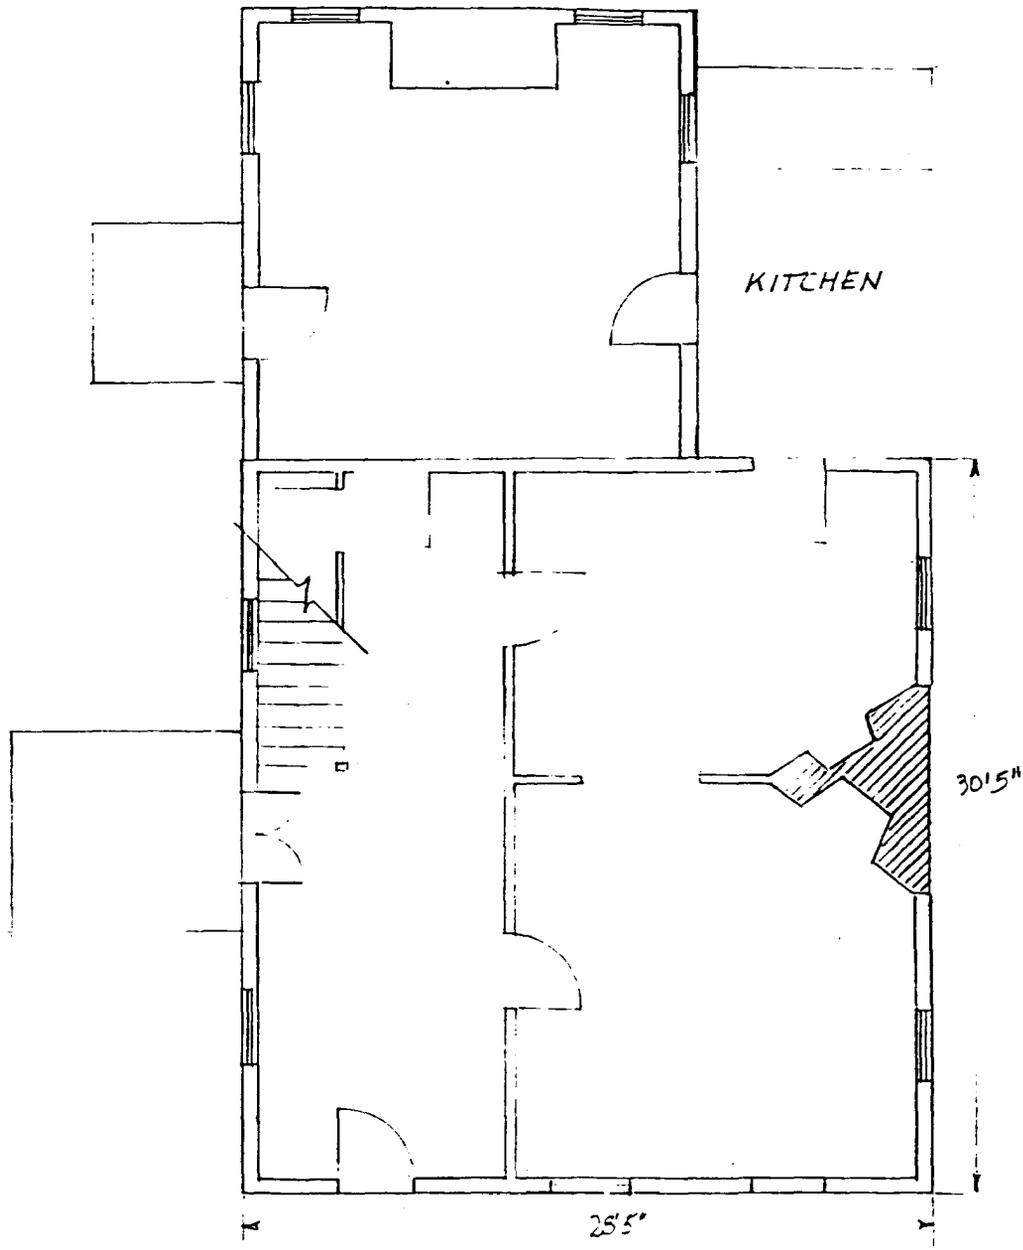
WILLIAM COSTEN HOUSE  
NEAR WELLINGTON

1/8" = 1'0"

Inside the main house is divided into three rooms with a side hall on the east and two rooms with corner hearths on the west.

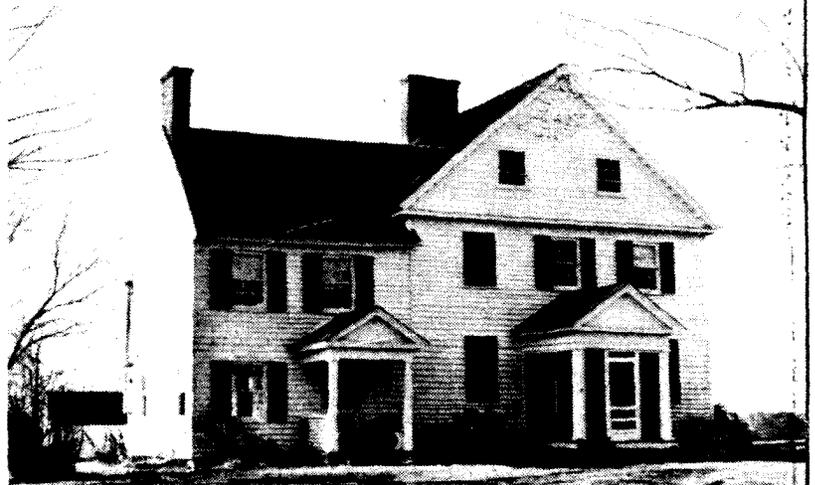
tion of Costen's to occupy the property. In the upper section of the chimney is a brick with his initials and 1829 etched on it. The addition is of a later date. The burning served as a training exercise for volunteer firefighters from Princess Anne, Mt. Vernon, Deal Island-Chance and Marion. The house had lost its structural integrity and woodwork and mantels had already been stripped from the interior. Before it was burned, only a few pieces of old hardware were left to salvage. (Intact house photo from *Somerset: An Architectural History*)

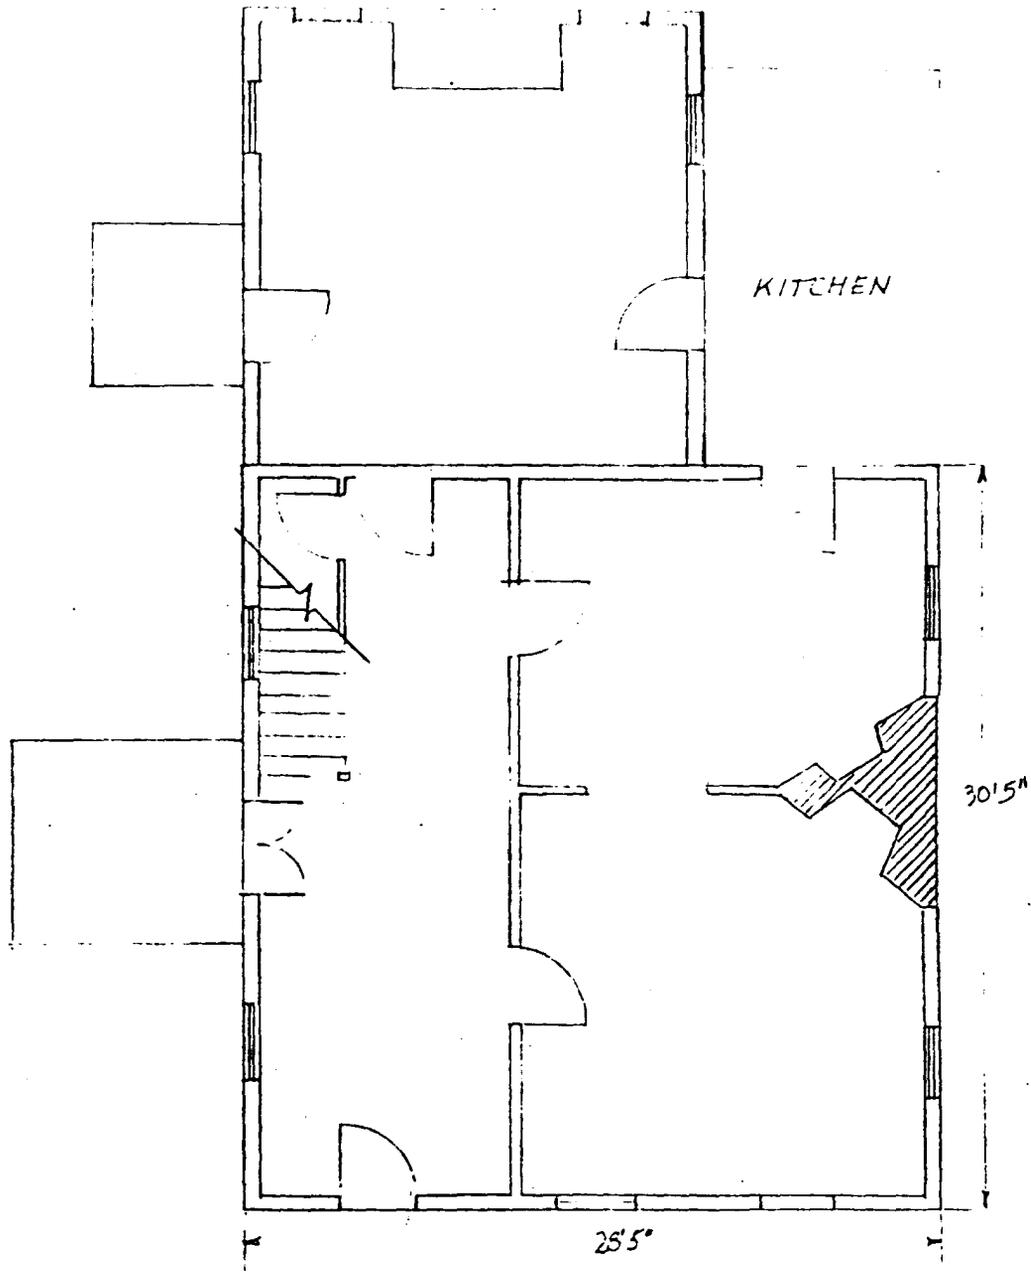
WILLIAM COSTEN HOUSE  
NEAR WELINGTON

1/8" = 1'0"
