S-92  
Mount Pleasant M. P. Church  
Crisfield  
public worship

# Maryland Historical Trust State Historic Sites Inventory Form

historic Mount Pleasant M.P. Church

Survey No. S-~~000~~ 92

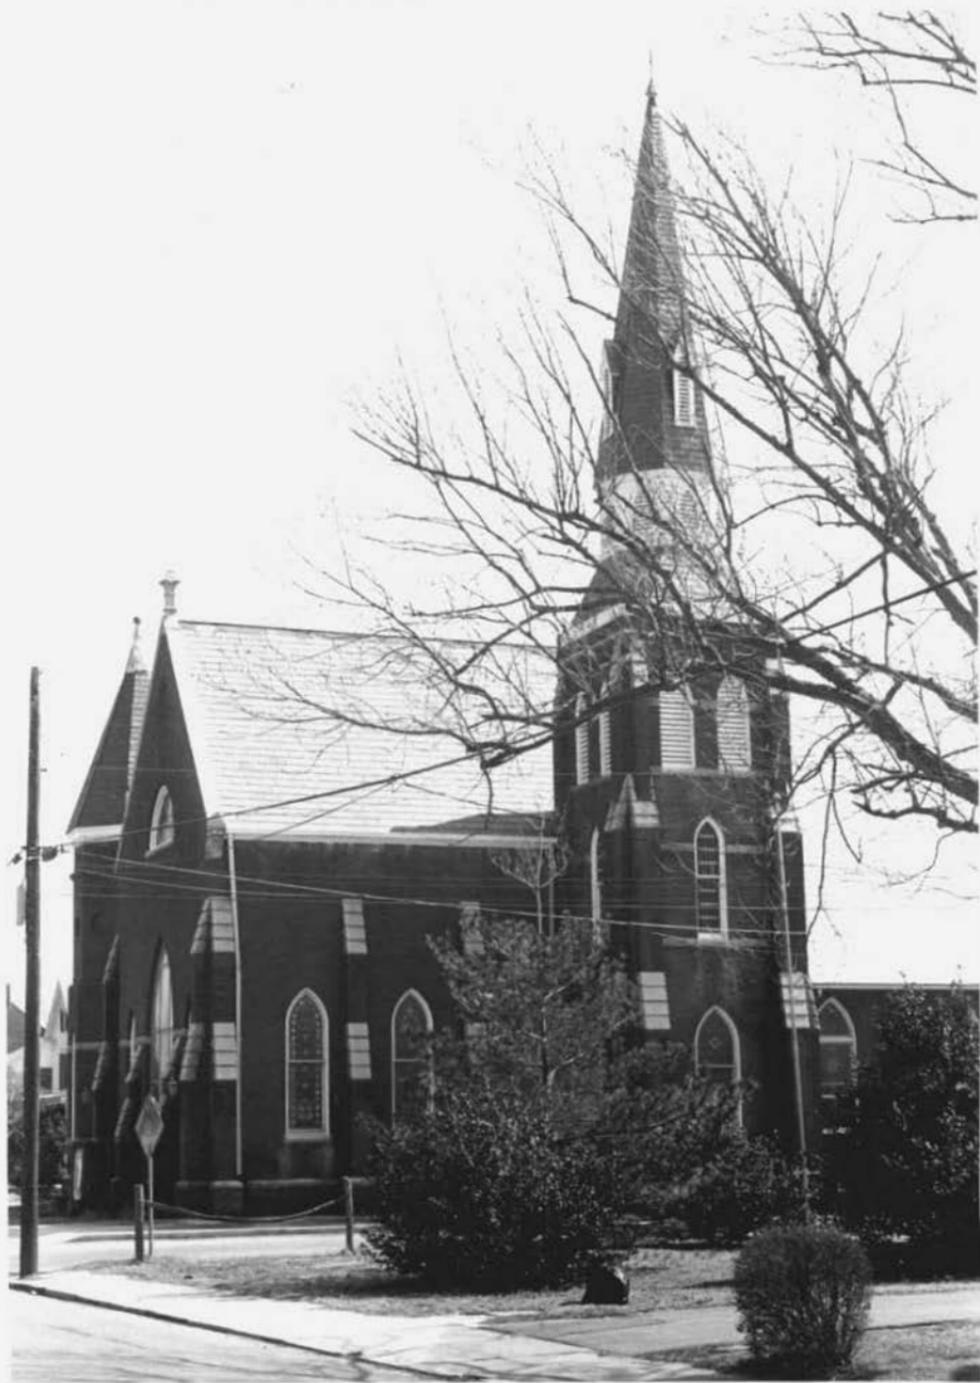
S-92

Mount Pleasant M.E. Church  
Crisfield, Somerset Co. Md.  
Norhtwest - Elevation  
2/86, Paul Touart, Photographer  
Neg/ Md. Historical Trust

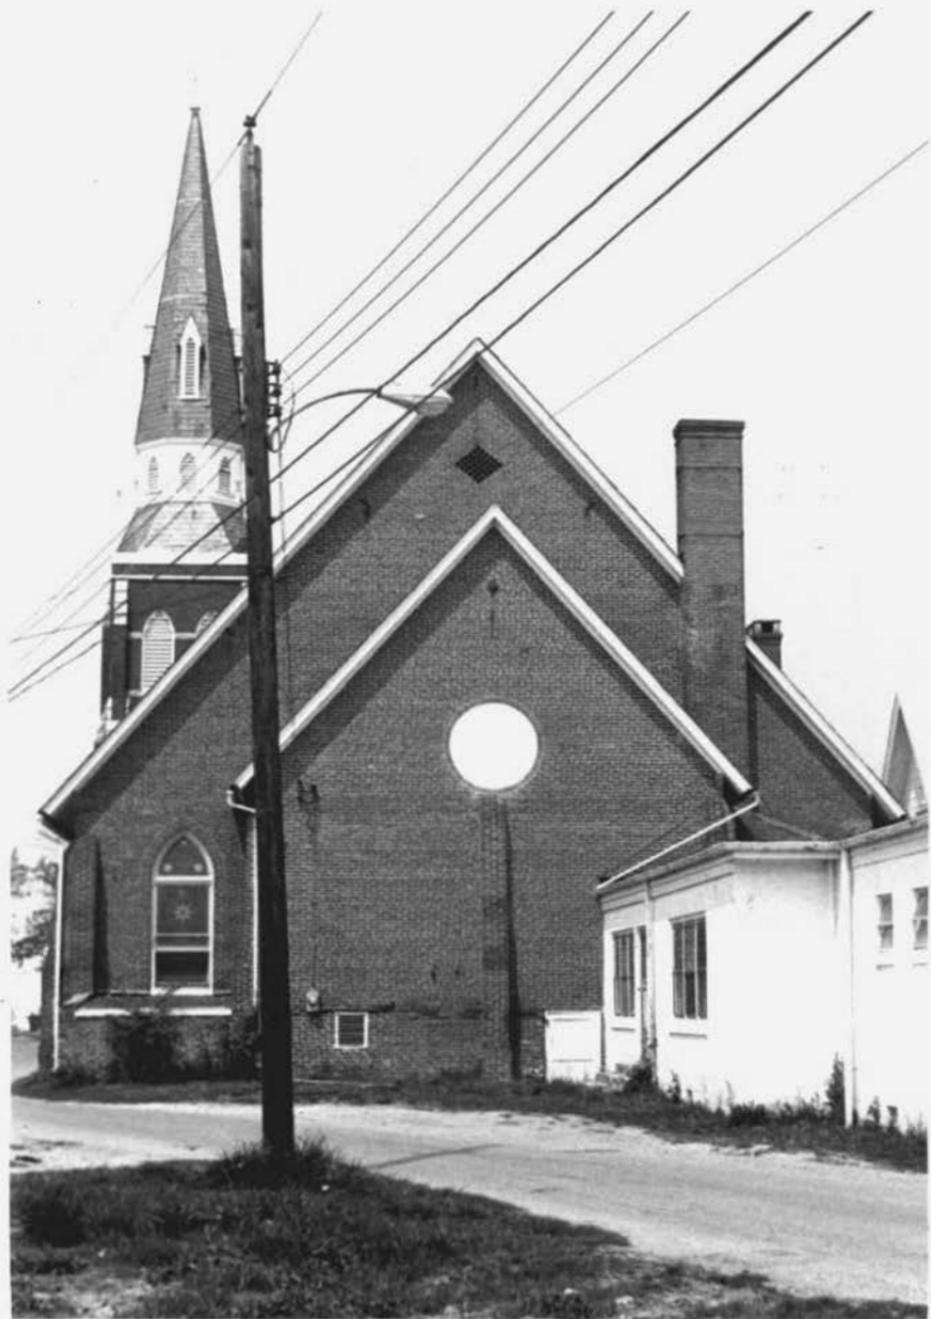
S-92

The south side of the main block is covered by a single-story apse with a blocked up round window centered within the gable. A Gothic arched lancet window pierces the wall surface west of the apse, while a diamond shaped brick vent is located in the uppermost portion of the gable end. A square brick furnace stack rises against the east side of the church body, and the concrete block Sunday school rooms extend from the southeast corner.

Mount Pleasant M.P. Church  
Crisfield, Somerset County  
South Elevation  
7/85, Photographer, Paul Touart  
Neg/Md. Historical Trust

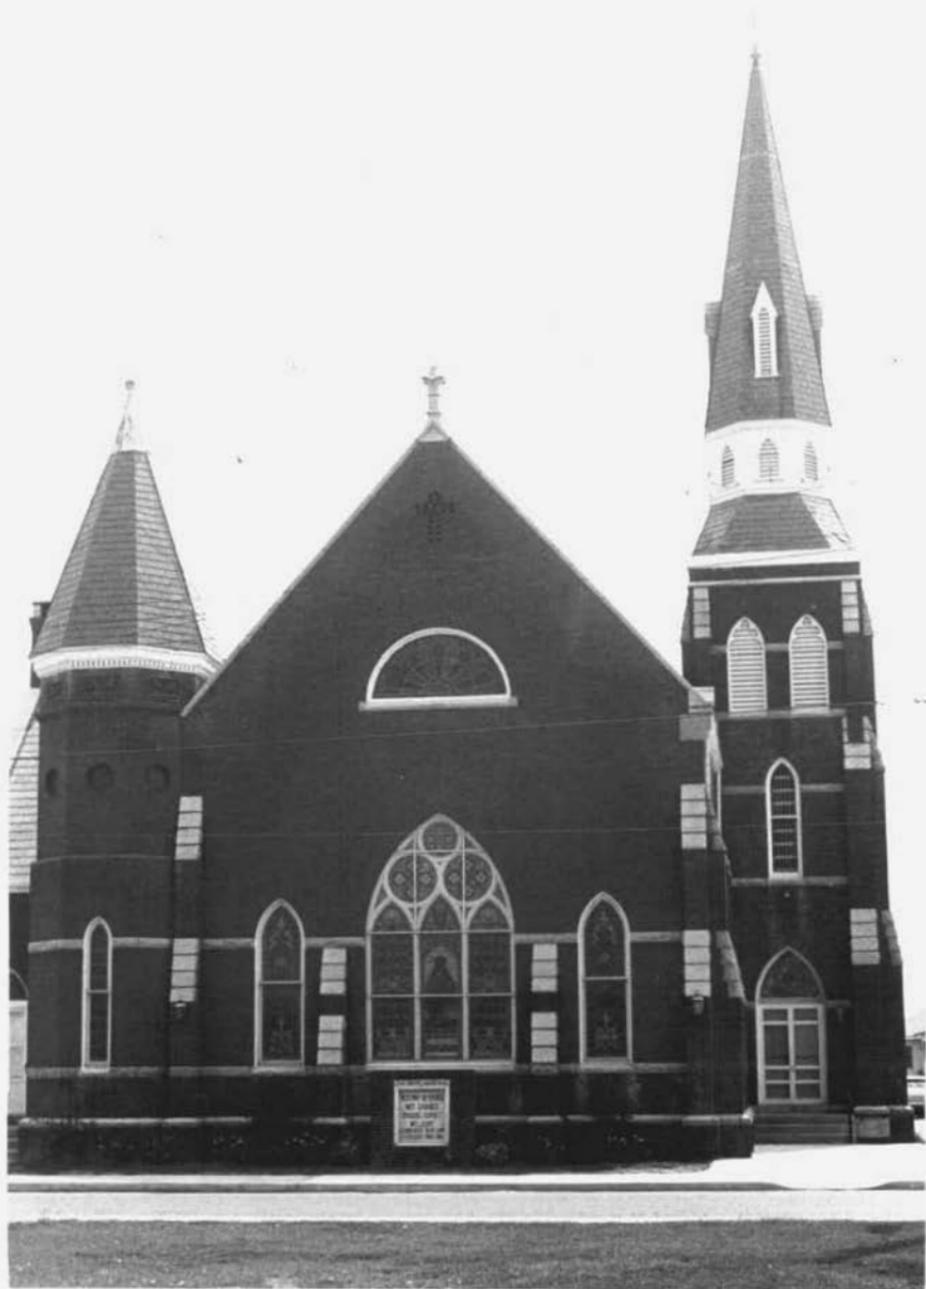
S-92

The north (main) facade is an asymmetrical elevation with the body of the church flanked by a four-story bell tower to the west and a two-story octagonal tower on the northeast corner. The church body itself has a balanced three-bay fenestration divided by brick buttresses capped with granite blocks; the corner buttresses rising two stories. Decorative rusticated granite bands run across the facade at the level of the window sills and at the bottom of the Gothic arched front windows. The center bay is filled with a Gothic arched tri-partite window with the upper portion distinguished by three round windows. Flanking the center window are narrow colored glass lancet windows. The upper portion of the parapet front wall is pierced by a colored glass lunette window with a granite sill, and the peak of the wall is vented in the shape of a cross. The parapet wall is capped with stone and finished with a floral iron finial. Rising on the northeast corner of the sanctuary is a two-story octagonal tower lighted by lancet windows on the <sup>first</sup> floor and finished with round terra cotta panels on the second floor, and rectangular panels are the base of the cornical roof. The tower cornice is embellished with a dentil row, and the peak is capped with a ball finial.

Mount Pleasant M.P. Church  
Crisfield, Somerset County  
North Elevation  
7/85, Photographer, Paul Touart  
Neg/Md. Historical Trust

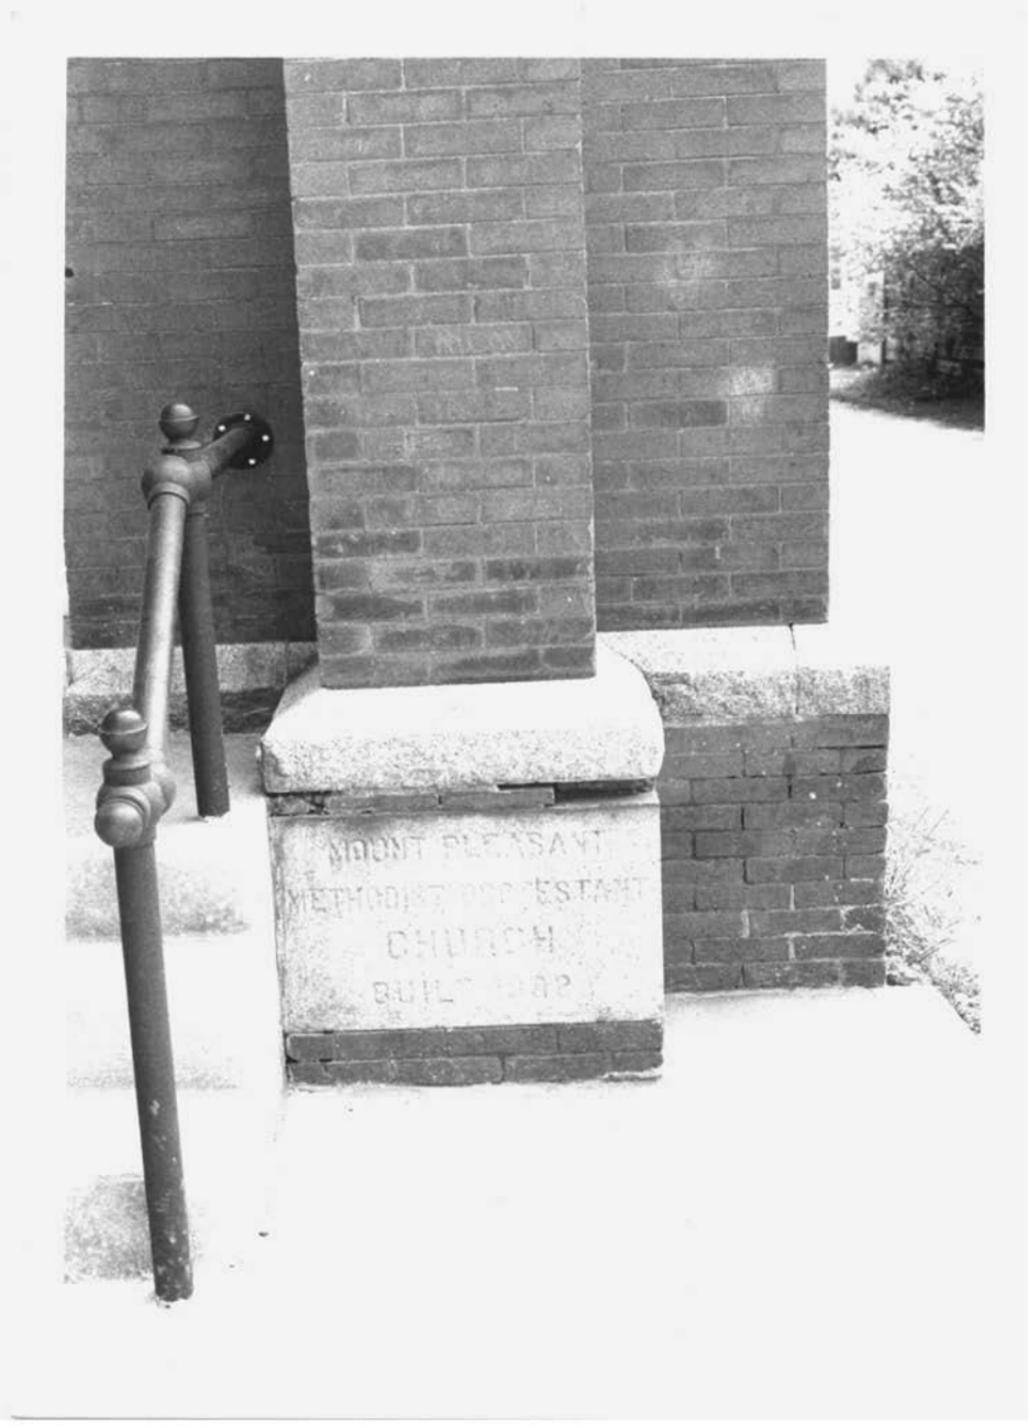
S-92

The west tower contains the principal entrance, a Gothic arched double door with a colored glass transom. A flight of three granite steps front the entrance and three-story buttresses flank the entrance as well as frame the tower. The granite datestone is fixed in the base of the northwest buttress and reads, "Mount Pleasant Methodist Protestant Church, 1892." The second story of the tower is pierced by a narrow lancet window as well as being marked by horizontal granite string courses. Two Gothic arched louvered vents fill the third story, after which the tower tapers to the spire. The base of the spire is pierced by eight Gothic arched louvered openings. The tapering octagonal spire is distinguished on four sides; north, south, east and west by a narrow gable roofed vent pierced by a louvered opening. The spire is finished by a delicate iron lightning rod. An old datestone is found at the base of the tower and reads, "M.P. Church, 1876."

MOUNT PLEASANT  
METHODIST EPISCOPAL  
CHURCH  
BUILT 1882

Mount Pleasant M.P.Church

Datestone-1892

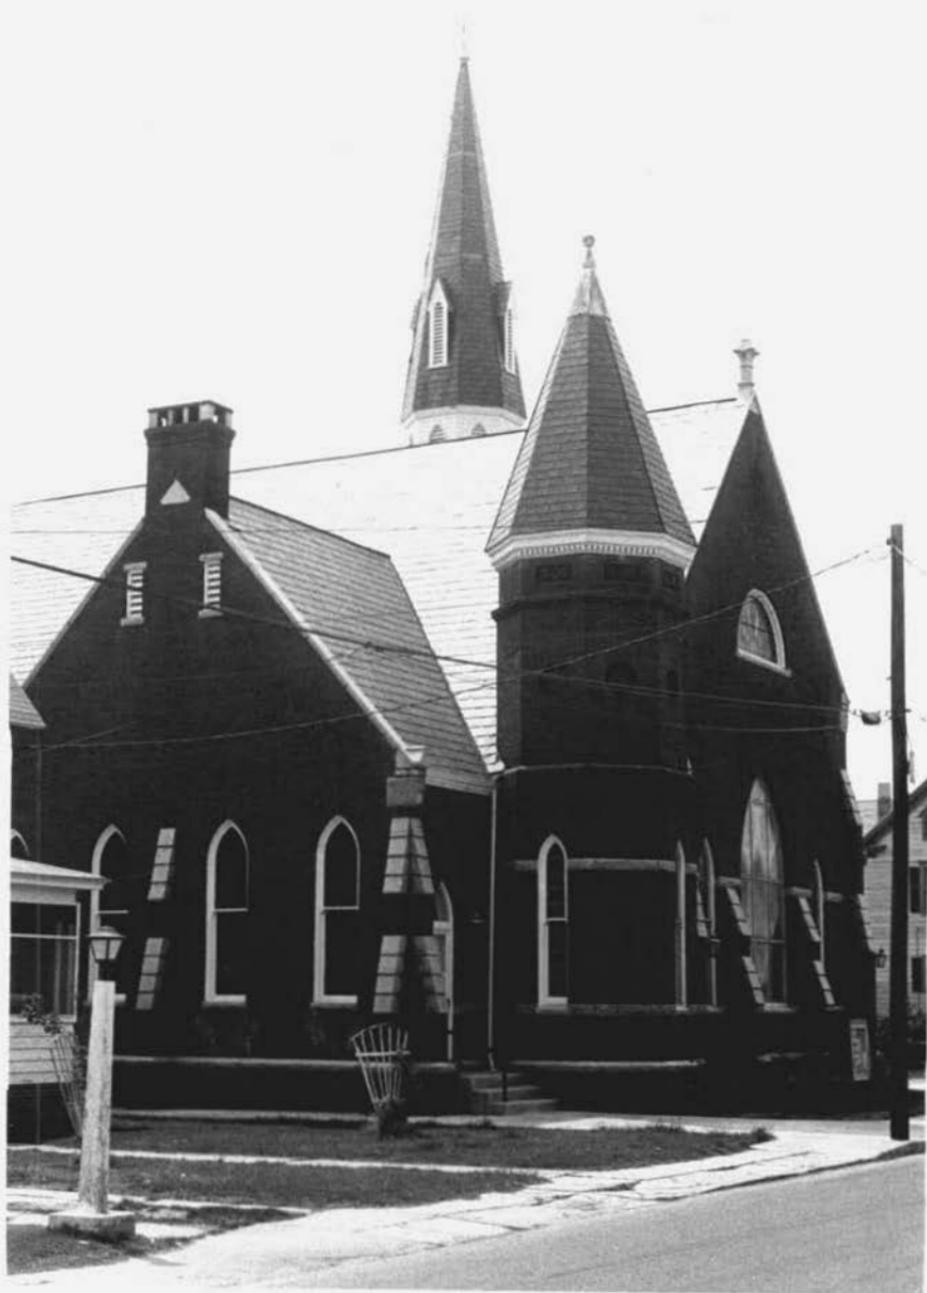
S-92

The east side of the church has a gable-roofed section which extends out from the main building at a right angle. This side chapel is one bay across by four bays deep and is covered by a parapet gable roof pierced by an internal and brick chimney. Brick buttresses with granite capping stones mark the corners and sides as in the main building, and the sides are distinguished by Gothic arched openings. Two louvered attic vents with granite lintels and sills flank the interior and chimney.

Mount Pleasant M.P. Church  
Crisfield, Somerset County  
Northeast Elevation  
7/85, Photographer, Paul Touart  
Neg/Md. Historical Trust
