S M -111
OCEAN HALL
Bushwood
Private

NATIONAL REGISTER OF HISTORIC PLACES INVENTORY - NOMINATION FORM

COMMON:
Ocean Hall

HISTORIC AMERICAN
 BUILDINGS SURVEY
 SHEET 1 OF 9 SHEETS

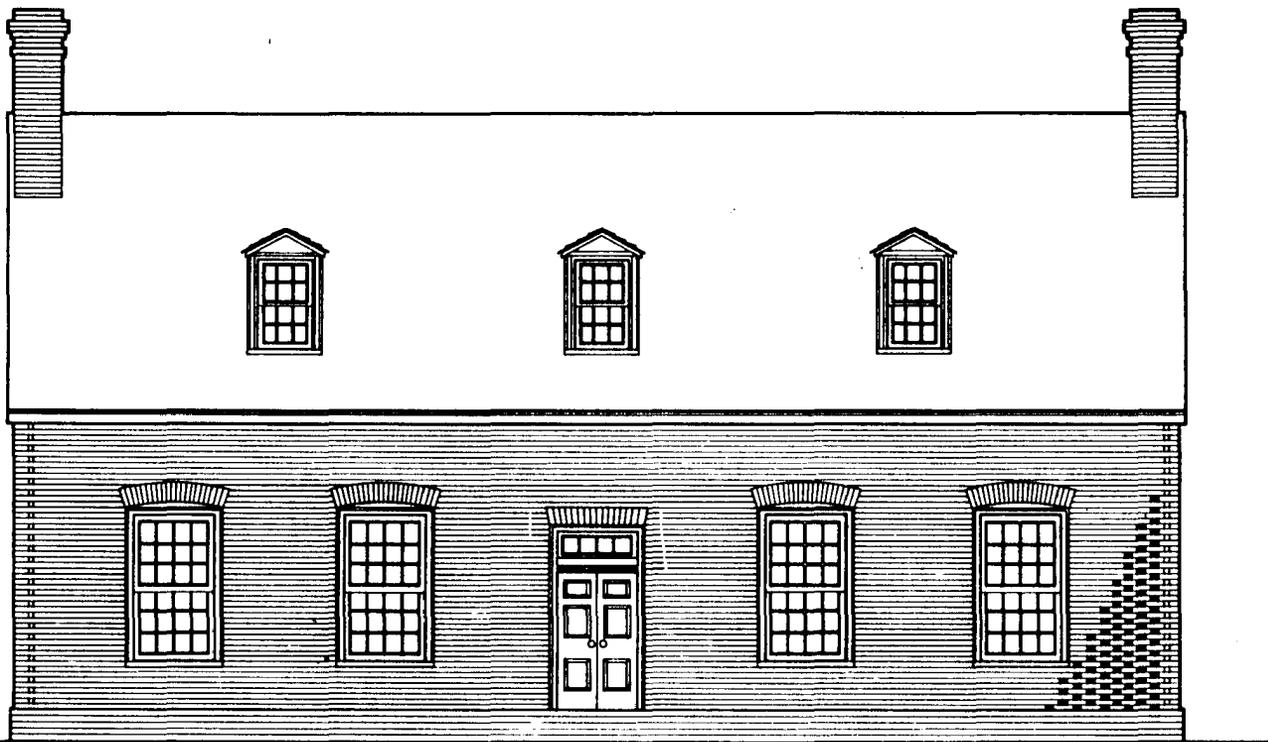
EAST ELEVATION

South gable Flemish bond

- Doorway heightened for transom Period III.
- Period III windows in original openings.

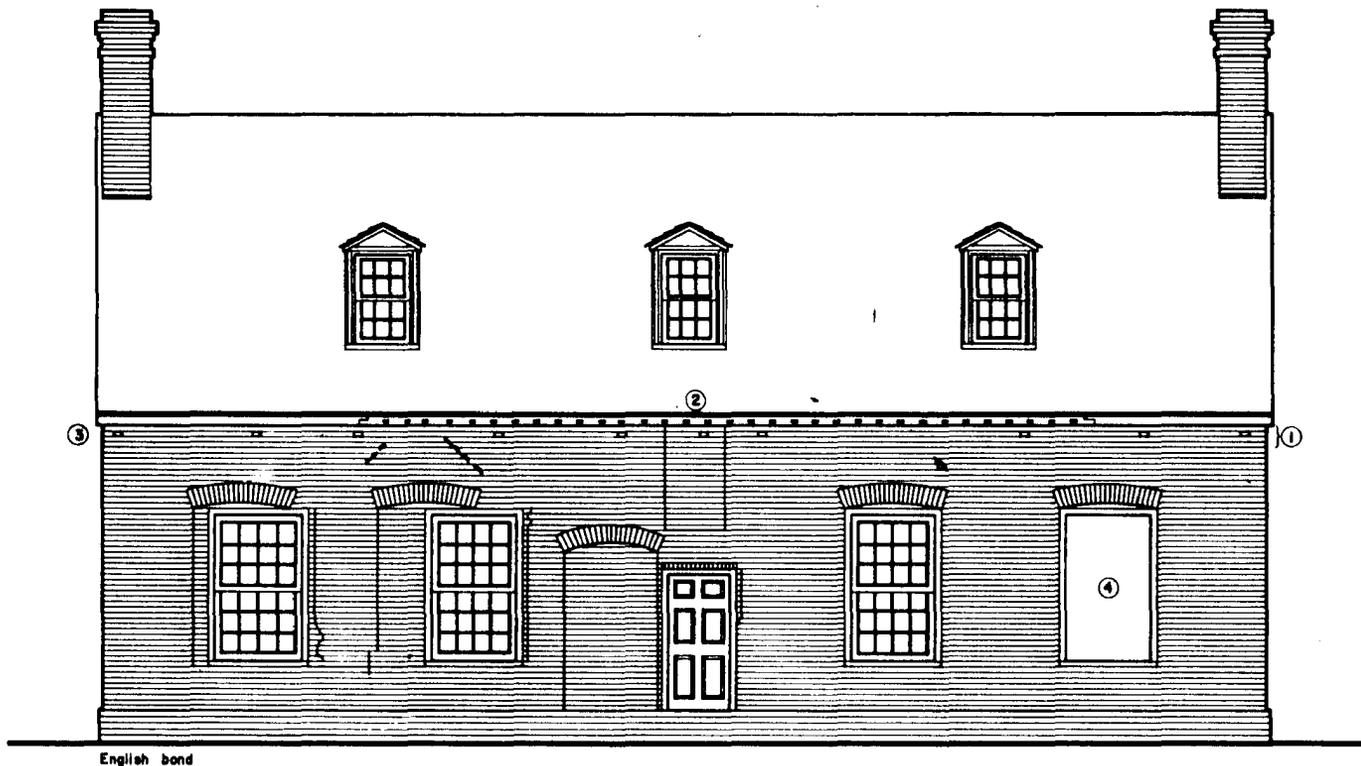
WEST ELEVATION

- Only center section of west plate is original. 2-1/2 x 3/4 x 2" (deep) mortises spaced 12" apart (and pegged every fourth mortise). Probably used to anchor cornice to plate.
- 1 - Mortar joints between four uppermost courses are unweathered. Protected by cove cornice?
- Mortar fragments above second and third windows suggest roofs or pediments (subsequent to cornice).
- 2 - Blocked window on original stair landing.
- 3 - Seats for later porch roof cut out of brickwork.
- Nineteenth-century dormers probably replace earlier dormers.
- 4 - Window enlarged into doorway.

Late 19th-century porch
Columns c. 1920

The two windows of the west end elevation, also of 12/12 sash are neither original nor from the circa 1725 alterations; the front and rear facades, as well as the west end, are covered by deep veranda, added about 1900. The elongated decorative drops of the west end barge boards date from this addition. The roof is of an "A" frame plan with the ridge terminating with single, flush gable, interior chimneys at each end. Both chimneys retain plaster necking bands, a decorative feature seen in Tidewater Maryland architecture throughout the late seventeenth and eighteenth centuries. The three peaked roof dormers on both the front and rear slopes of the roof are all late nineteenth century additions; there is no evidence of any earlier dormer windows.

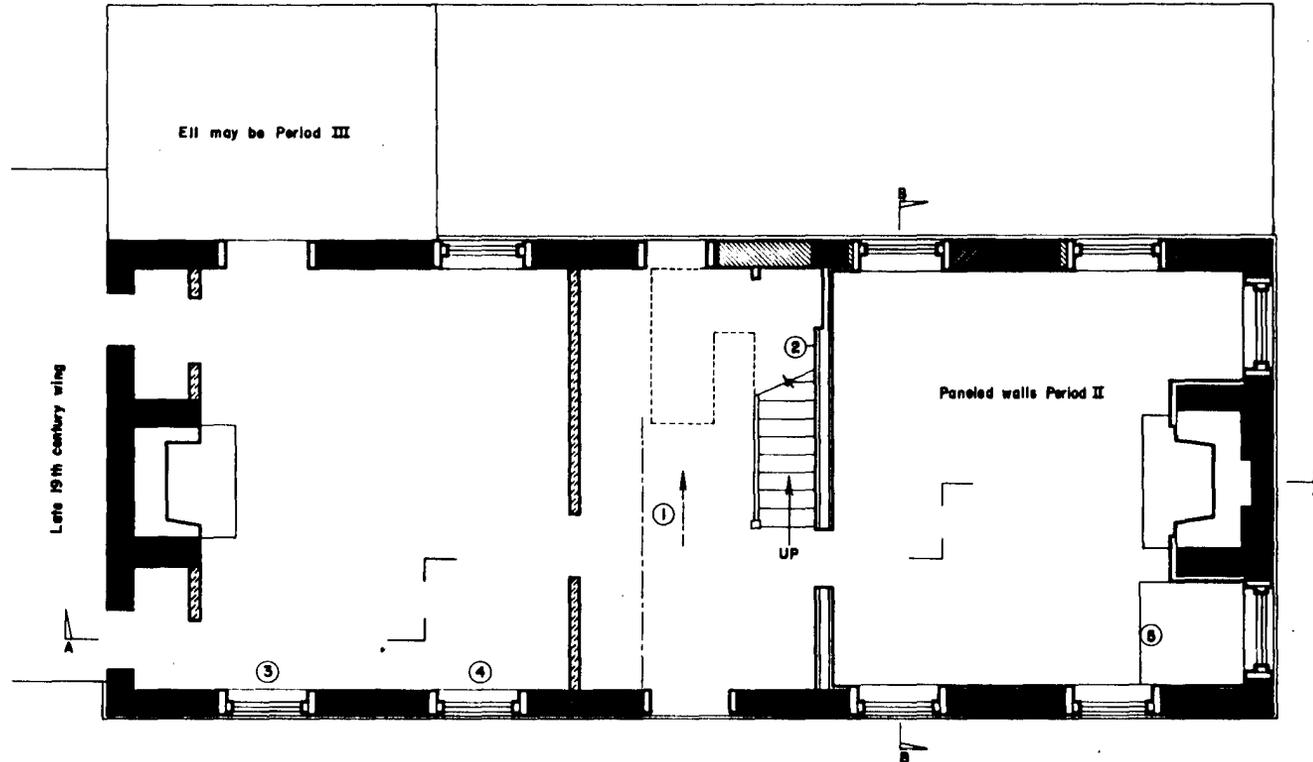
GROUND PLAN

- 1 - Location of earlier (probably original) partition and staircase.
- 2 - Eighteenth-century stair paneling stored under later stairs facing north.
- 3 - Drawer under window ledge.
- 4 - Bottle storage under hinged window ledge.
- 5 - Seam in floor boards.

PERIOD I : "new" 1671 or c. 1700
-

PERIOD II : c. 1725 - 1750
-

PERIOD III : c. 1825 - 1840

In plan, the first floor of Ocean Hall consists of a central hall flanked by a single room on each side. It is believed that when the interior was rebuilt (or extensively altered) about 1725, the floor plan configuration was a hall and parlor, a two room plan typical of this region throughout the seventeenth and early eighteenth centuries. The existing west room retains its original dimensions as well as most of its interior finishings. The present center hall was formed by erecting a second partition wall about ten feet east of the first with a stair along the original partition

wall about ten feet east of the first with a stair along the original partition wall. Both of the latter alterations probably occurred about 1825 since all interior moldings and the general design of the stair are of that period. Unusual but not unique features retained in the east room are wine cabinets and linen drawers beneath the north windows. The stair is interesting because the second flight is positioned away from the east partition wall, between that wall and the first flight and is, in fact, free standing. In the attic are two large bedchambers as well as a small storage room off the short hall at the head of the stair. In the attic, the interior finishings, including plaster and lath, doors, mantles, sash and other woodwork, indicated a late 19th century renovation. These rooms had been finished at an earlier date as eave wall studs were found positioned behind the existing studs, the former bearing traces of lath or sheathing nails. It may be concluded from the repositioning of the wall studs at the south side that the rooms were slightly altered in width in order to provide them with storage areas within the eaves along the south walls.

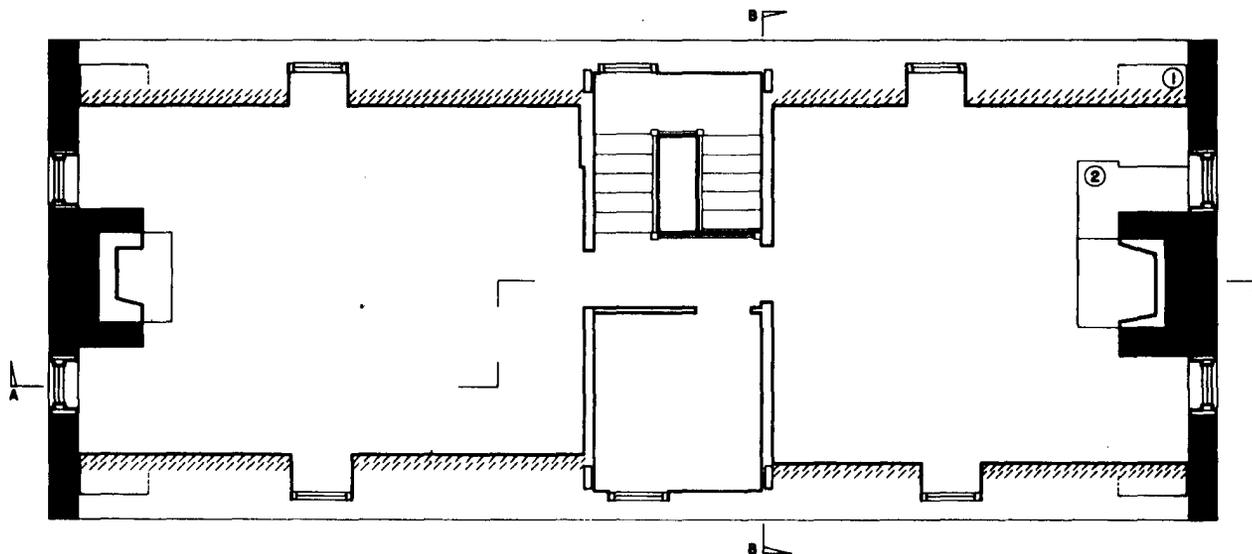
ATTIC PLAN

- 1 - Plastered brickwork indicates closets in all four corners.
- 2 - Seam in floor boards.

- PERIOD I : "new" 1671 or c.1700
- PERIOD III : c. 1825 - 1840

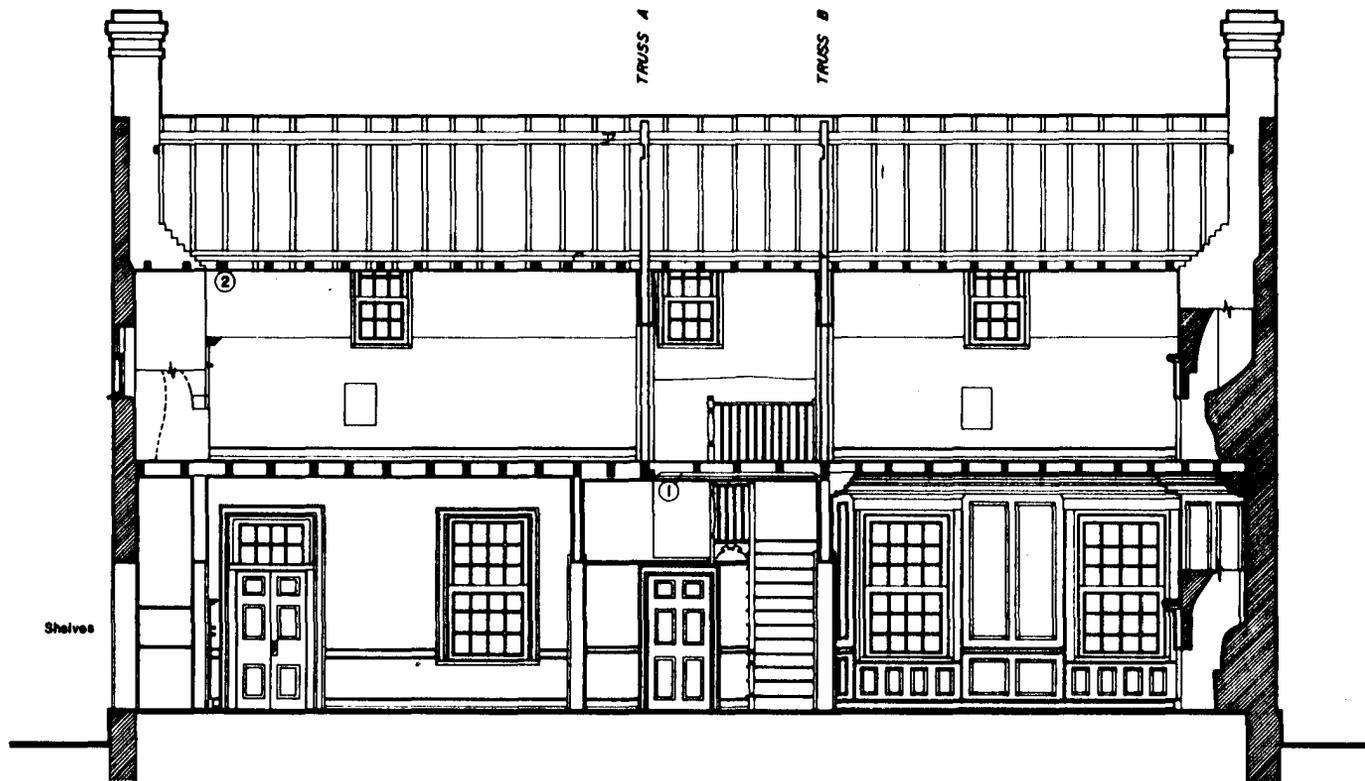
SECTION AT A-A

- 1-Beam framing stairwell chamfered along lower east edge. Chamfer whitewashed.
- 2-Ceiling in south chamber 19th century replacement.
- Panels under all windows in north room Period III.

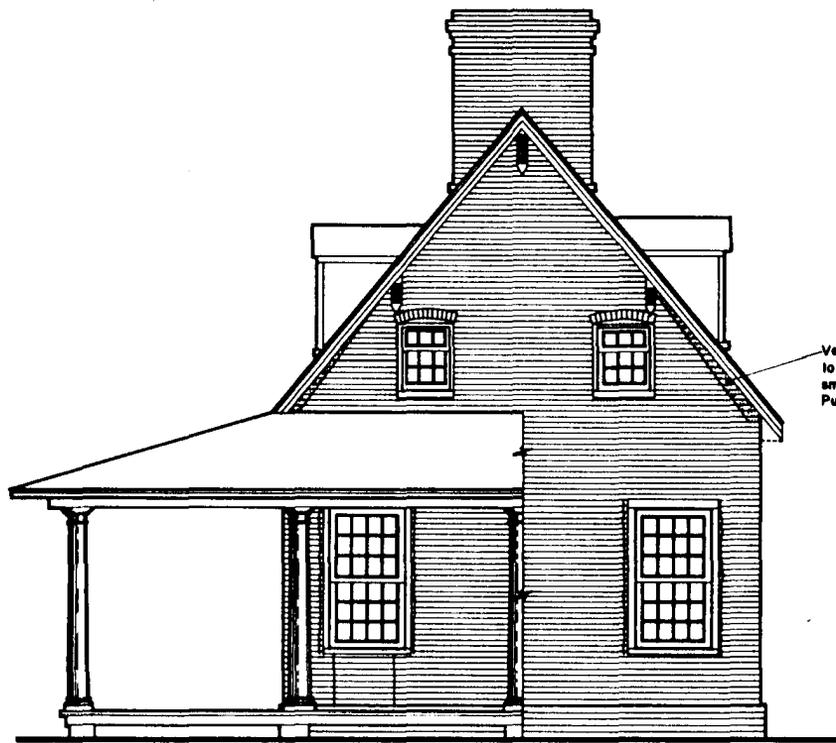
NORTH ELEVATION

East and north porches after c.1920

Straight joints indicate original doorway

English bond

Very early alteration to roof pitch using small yellow bricks. Purpose unknown.

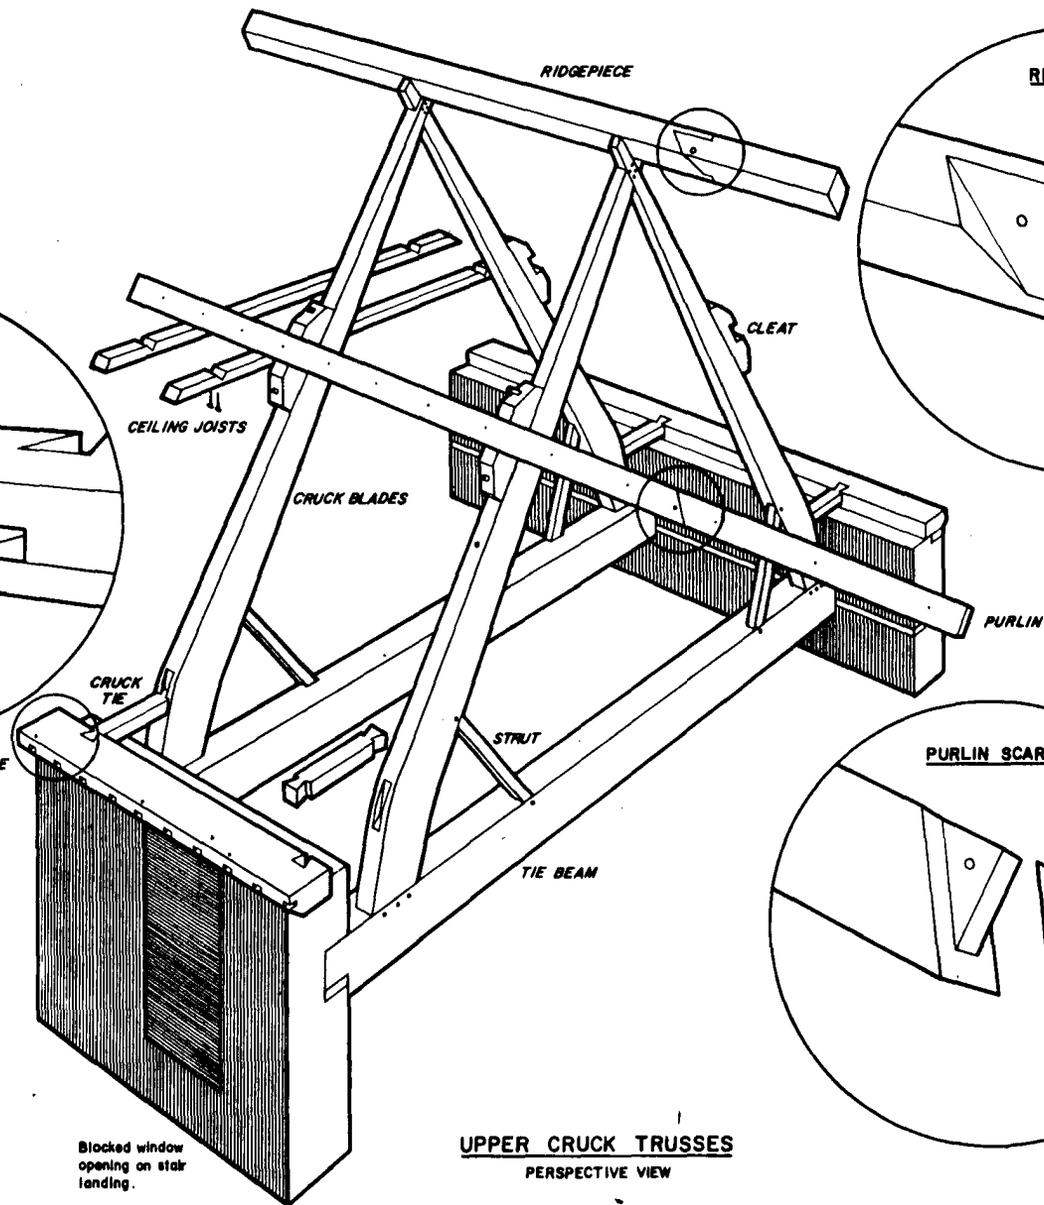
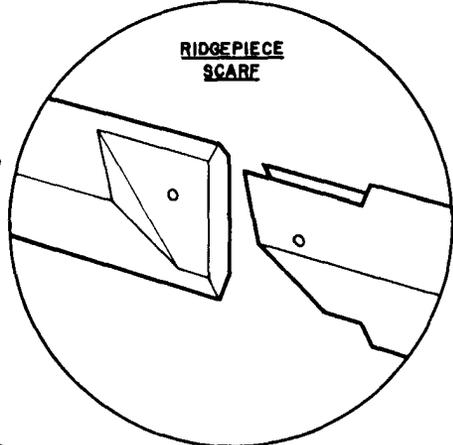
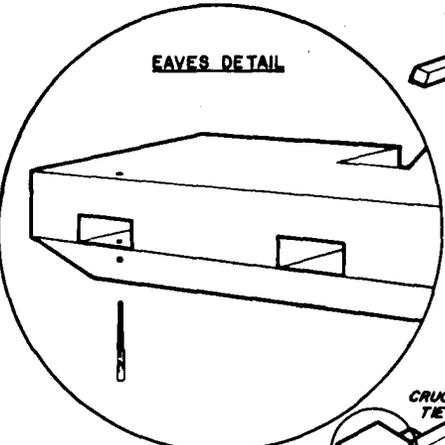
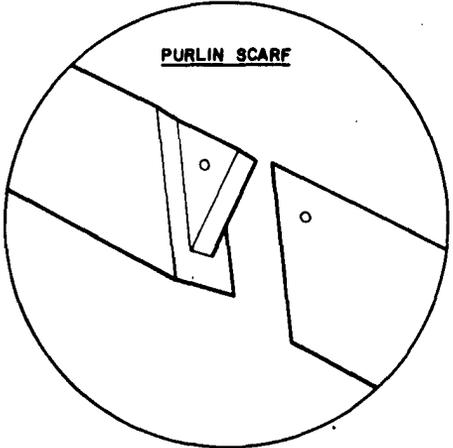
UPPER CRUCK TRUSSES
PERSPECTIVE VIEW

Blocked window opening on stair landing.

FOUR BLADES SAWED OUT
OF SINGLE HEWN TIMBER

The framing system of the roof of Ocean Hall is more generally defined as a crucked roof, one that employs massive curved upright timbers to support a ridge pole which, in turn, supports the remaining roof framing members.

Only two pairs of cruck blades, hewn from an oak tree, are used. They are positioned near the center of the house and are spaced approximately ten feet apart. The bases of the crucks are mortised and tenoned into the upper surface of tie beams that are supported at the ends by channels on the north and south walls just below the wall plates. The top of the tie beams are level with the top of the first floor ceiling joists but their bottom face extends several inches below the base line of the joists. (The tie beams are now enclosed within the existing partition walls of the first floor.) The base of the cruck blades are positioned less than one foot inside the interior face of the brick walls and begin their most pronounced curve toward the center line of the house about one and one half feet above their springing. After narrowing in width as they rise, they are lapped and secured with wood pins where they intersect at the roof ridge; a large ridge pole is supported in the resultant notch. The ends of the ridge poles are

inserted into supportive niches provided for this purpose on the chimney stacks of the end walls. Halfway up the outside face of each cruck blade is a shaped cradle secured in position with wood pins; the cradle supports a purlin, the ends of which are supported by the brick end walls. The roof collars, normally rafter supporting members, are lapped and pinned into the underside of the purlin. It is not known how the rafter ends were joined to the wall plates since they were cut off above the mortise, lap, or butt marks at a later date. The wall plate along the south wall, at present the only accessible place at the eaves level, has also been disturbed and, in parts, replaced.

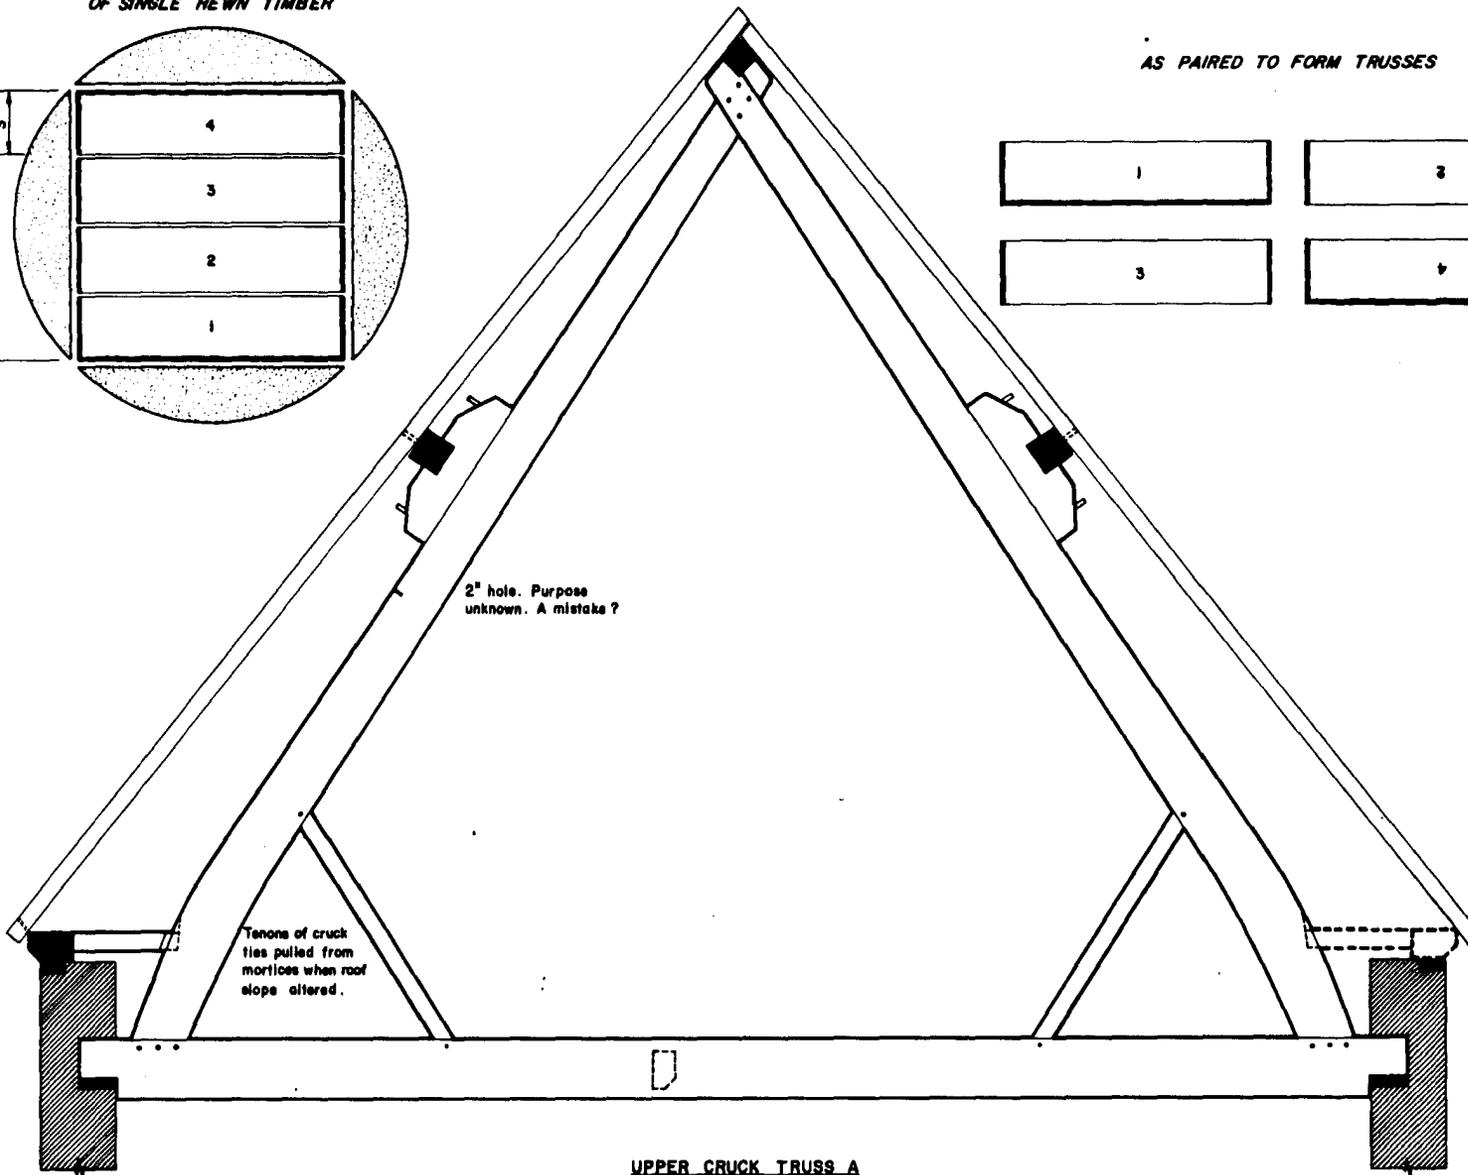
UPPER CRUCK TRUSS A
LOOKING NORTH

2" hole. Purpose
unknown. A mistake?

Tenons of cruck
ties pulled from
mortises when roof
slope altered.

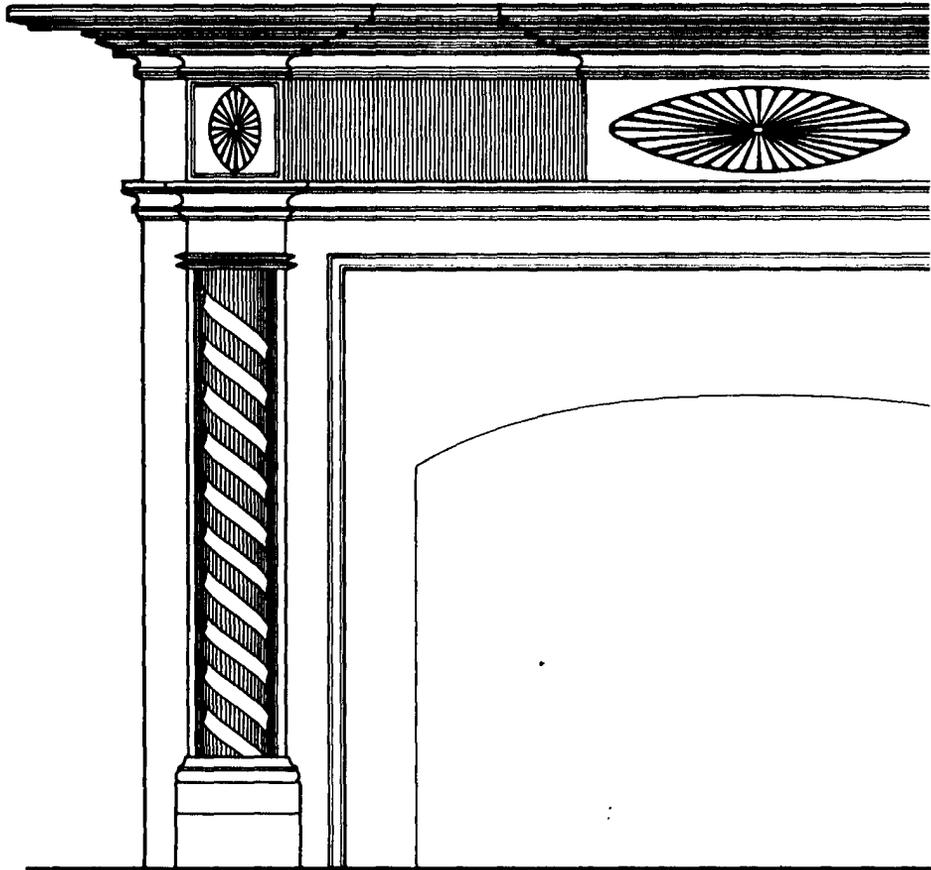
MOLDING PROFILES

MANTELPICE
NORTH ROOM
SECOND QUARTER 19TH CENTURY

RAISED PANELS • North Room

CHAIRRAIL • North Room

BASE BOARD • North Room

CHAIRRAIL • Passage

ARCHITRAVES • South Room

DOOR JAMBS • Passage

DOOR JAMB • North Room

WINDOW JAMBS • North Room

RAISED PANELS (Under windows) North Room

Of all the rooms in the house only the first floor west room retains any of its original work and this, for the exception of the existing mantle, is complete. The walls are sheathed with fielded panels set between stiles bearing quarter round moldings to frame the panels. Above the moulded chair-rail the panels are rectangular in shape and regularly spaced. Narrow fielded panels are set horizontally over the window openings as well as over and around the overmantle panel and the fireplace opening. * The upper edge of the baseboard is heavily molded and there is a deep, six part, ceiling cornice. The mantle, of the Federal period, is a later installation, probably replacing a bolection type of enframement used there originally. The mantle is of an excellent design, however, with a deeply carved bed molding beneath the shelf and reeded panels on the frieze and reeded pilasters. On the end blocks of the frieze above the pilasters are carved, oval sunbursts. The present fireplace opening, corresponding to the size of the mantle, is somewhat smaller than the original opening. That earlier aperture had a segmental arch, rounded interior side walls, and an inset smoke channel. Above the fireplace is an over-mantle painting probably executed by an indentured servant or itinerant artist. It depicts a waterscape, the subject of which may have been the old Wicomico Wharf nearby (now the Bushwood Wharf). The painting depicts several individuals, a dog and a farm cart in the foreground, as well as a river, a wharf, and what appears to be an English, cargo ship. Judging by the costumes of the figures and other details this painting was probably done between 1720 - 1740.
