MULBERRY FIELDS was built about 1760 by Captain William Somerville. The kitchen and office buildings are placed symmetrically with the great house, but off the long axis.

SM-1C  
Mulberry Fields Weaving House  
19700 Mulberry Fields Road  
Piney Point Quadrangle

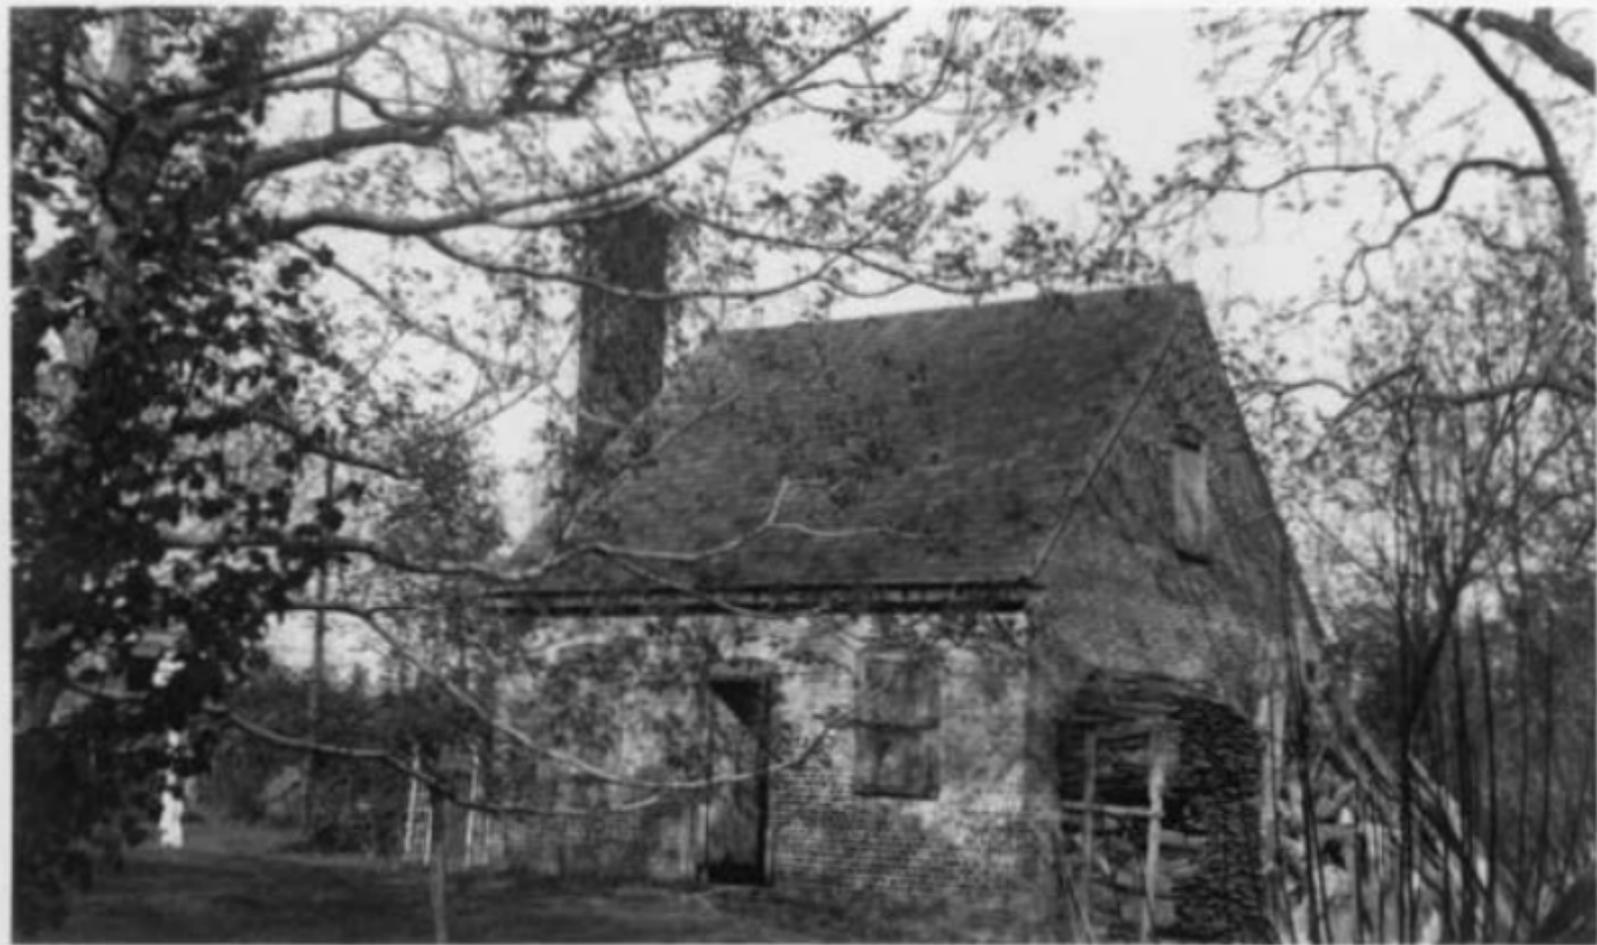
SM-10

Kitchen at Mulberry Field  
before restoration started

W & S Facades

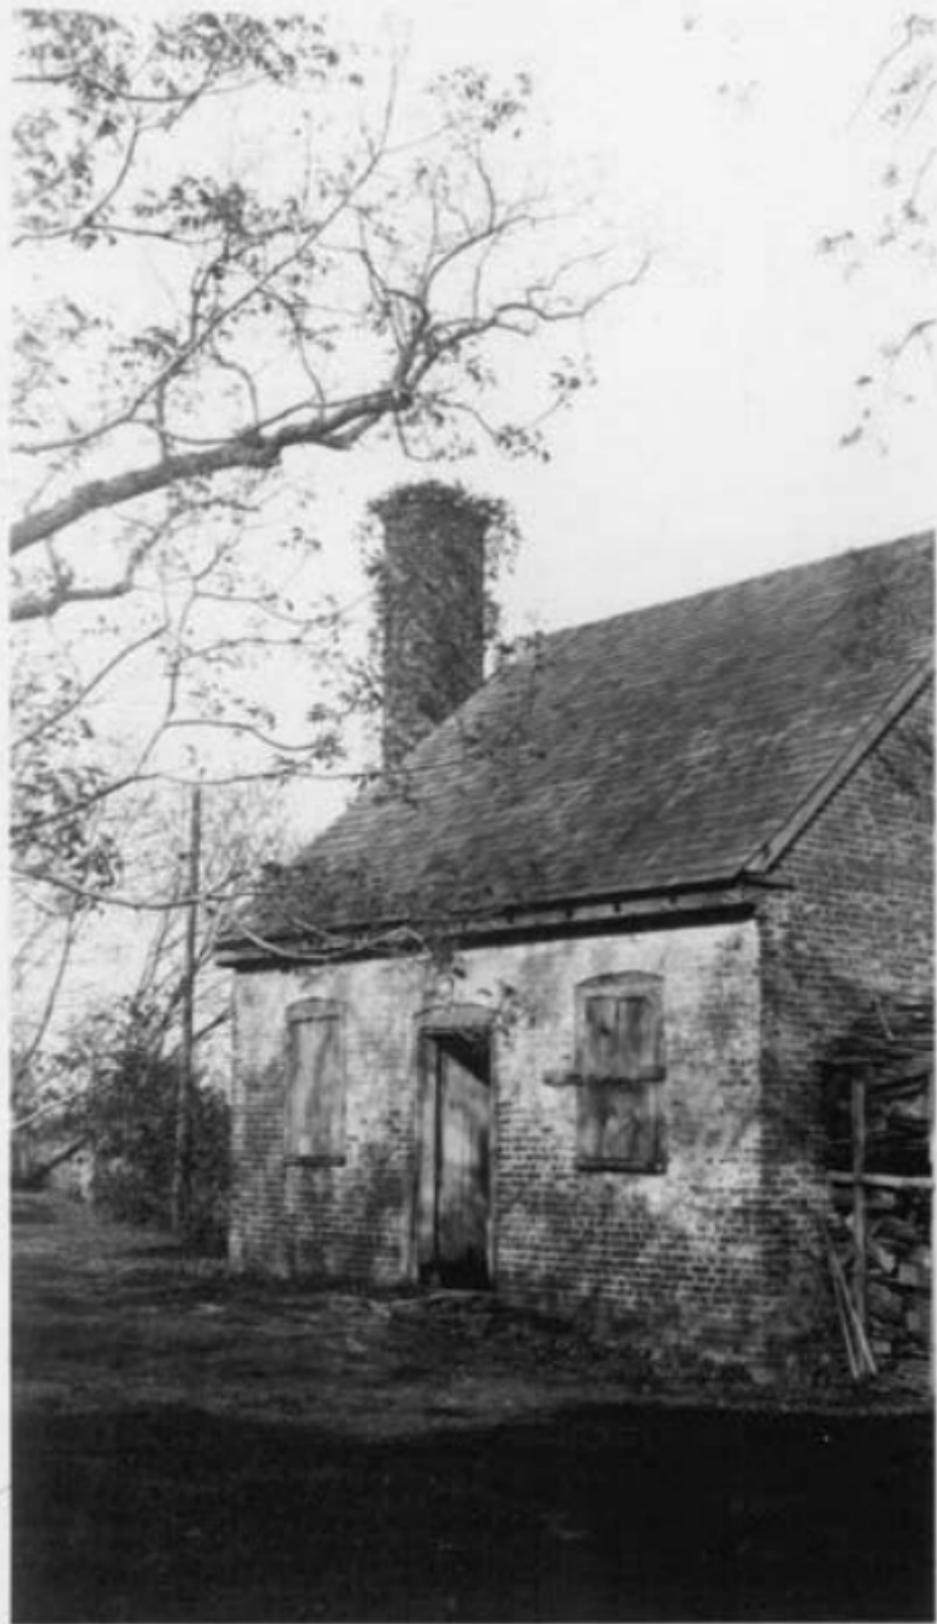
SM-11

Kitchen at Mulberry Fields  
before restoration started.
