SM-4
Resurrection Manor, site
Daniels Road
Hollywood
Private

Maryland Historical Trust
State Historic Sites Inventory Form

Survey No. SM-4

RESURRECTION MANOR

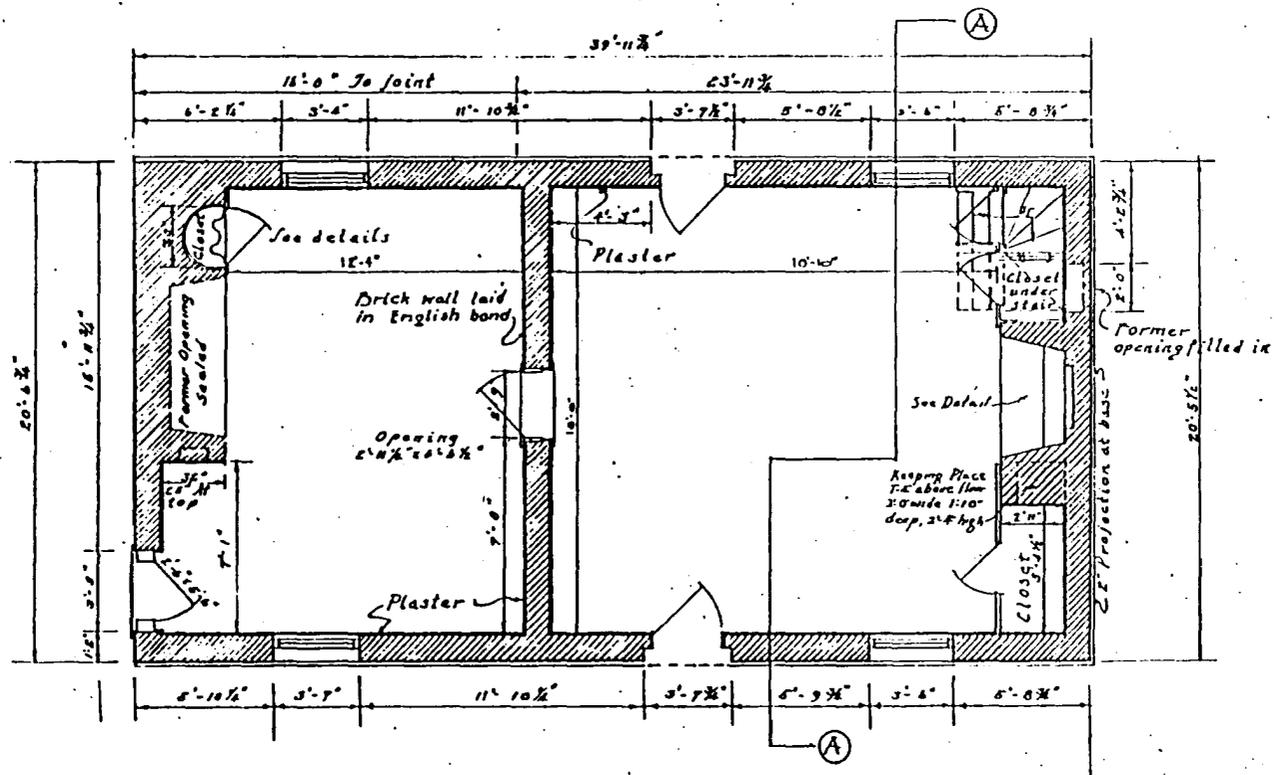
'FIRST FLOOR PLAN'
Scale 1/4" = 1'-0"

Note:- No original window sash remains.
Modern wood floors.

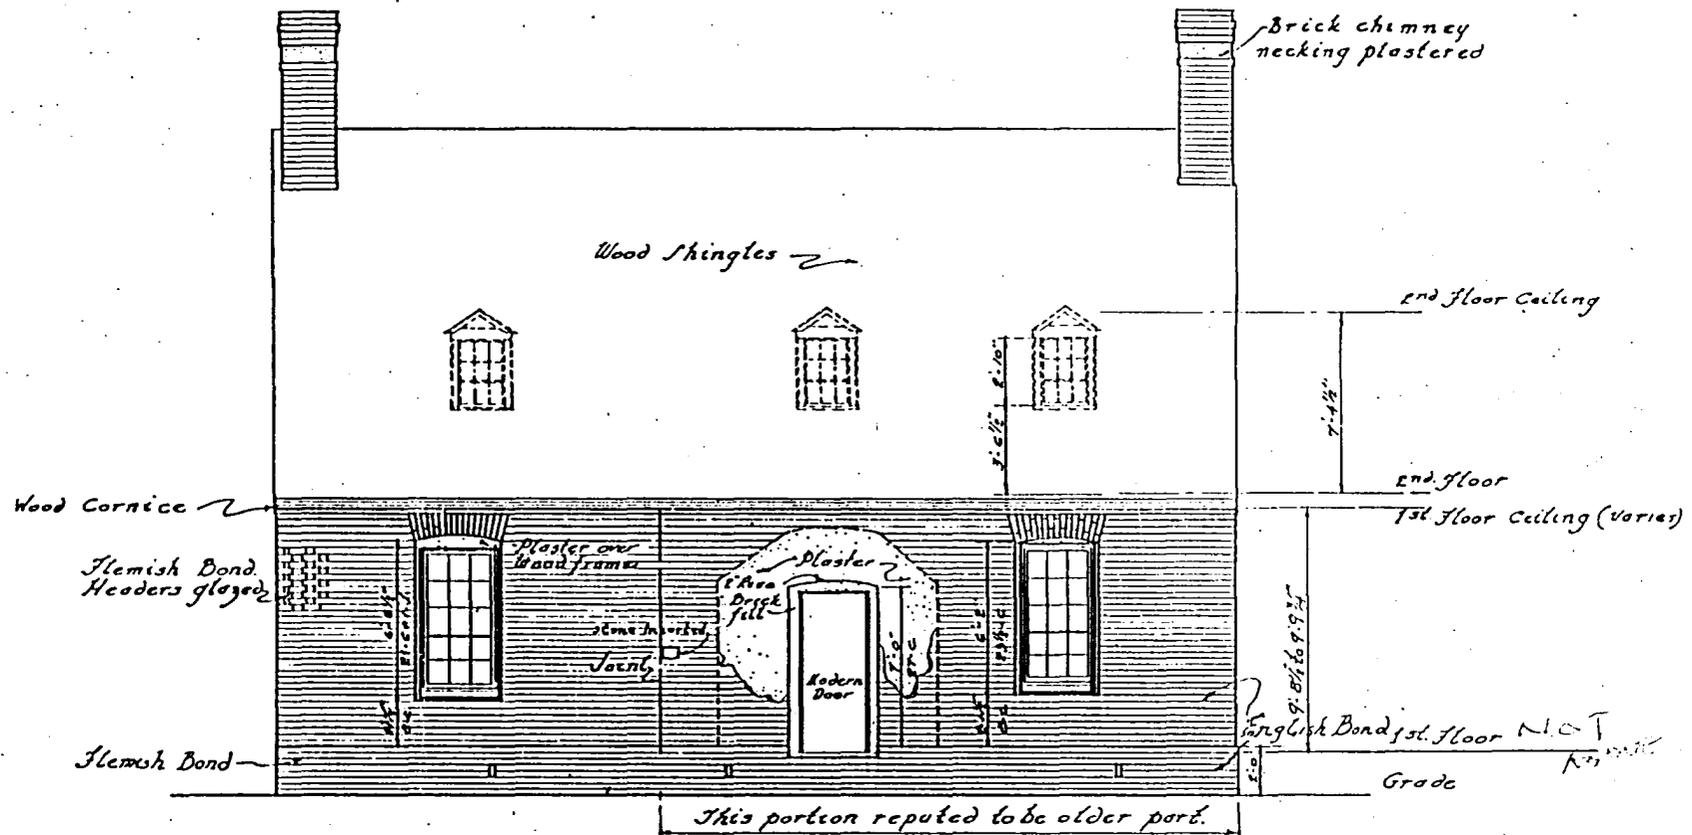
EAST ELEVATION
Scale $\frac{1}{4}$ " = 1'-0"

The brick walls have been white-washed. Plaster still clinging to bed mould of cornice, as in portion over door, suggest that walls may have been plastered over at one time.

Window reveals plastered. Plastered area remaining around door suggests former porch.

The east or primary elevation exhibits a watertable that juts out two inches from the wall surface. The watertable, while not containing molded bricks at its juncture with the wall surface, is laid in two different brick bonds--the northern section in the English bond and the southern section in the Flemish bond. The wall is laid in the Flemish bond with glazed headers and queen closers at the corners--all displaying "grapevined" or scored mortar joints. Another set of queen closers, located twenty-six feet from the northeastern corner of the building and aligned with the line of the differently constructed watertables, indicates two different periods of construction. The original block consisting of the northern section and the addition being the southern part. The entire wall surface was once thinly coated with a whitewash. The elevation's asymmetrical fenestration consists of a middle door flanked on either side by a window opening. HABS drawings indicate that while both windows were nine-over-nine, double-hung sash windows, the north window exhibited a brick, segmental jack arch while the south window exhibited a flat jack arch with plaster applied to give the appearance of a segmental arch. While the door at the time of the HABS visit was missing, a plaster scar roughly in the shape of a small porch still surrounds the door. A box cornice, decorated with a crown and bed molding, extends out at the juncture of the gable roof and wall. Two gable dormer windows, symmetrically aligned with the door and window of the period one section, project from the roof. HABS drawings reveal that this elevation also contained a third dormer window aligned with the one bay on the period two section. All of the dormers probably displayed six-over-three, double-hung sash.

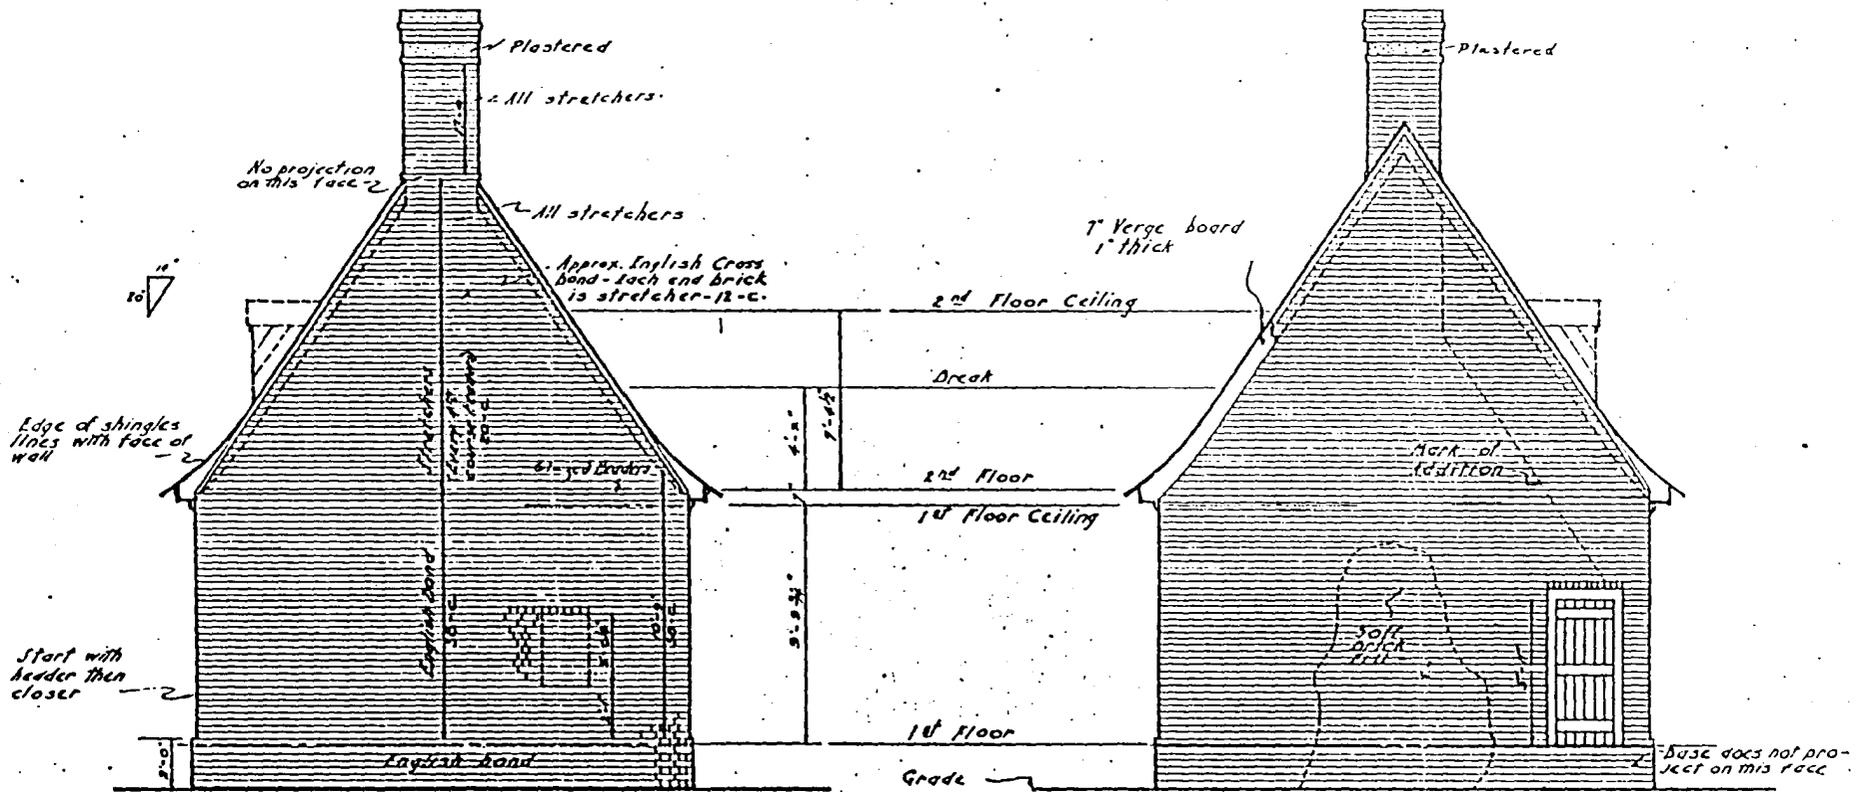
• NORTH ELEVATION •
Scale: $\frac{1}{4}$ " = 1'-0"

• SOUTH ELEVATION •
Scale: $\frac{1}{4}$ " = 1'-0"

The north, gable end elevation consists of an English bond watertable and also an English bond wall surface. Roughly aligned with the cornice, however, the bond changes to a three-to-one common bond with stretchers located at the border of the brickwork and roof. This elevation also contains a single, small window--now bricked over--located near the northwestern corner.

Unlike the other facades, the south, gable end elevation does not contain a watertable. The walls are laid in an English bond that changes at the cornice line to a three-to-one common bond. This elevation also contains a single door (now removed), a scar tracing the roofline of an addition to a gable-end, and a seven-to-one common bond brick repointing campaign roughly located at the position of the interior fireplace suggesting that this fireplace was replaced or repaired.

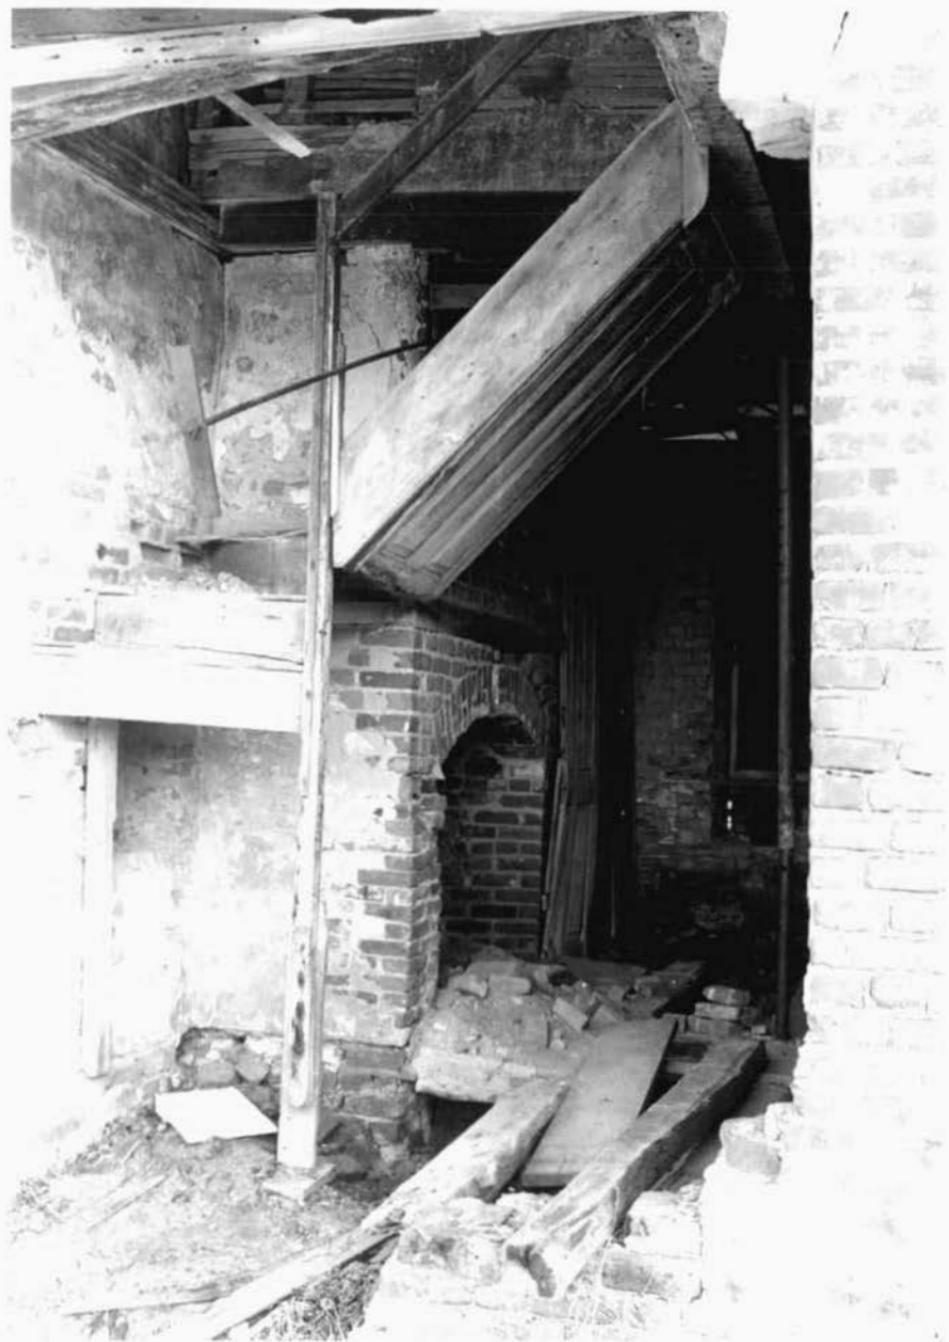
6 of 14

View of N room - looking E

The dwelling's interior contains two rooms. The original, northern room features two entries located on the east and west sides and received the most decorative trim and detailing. Due to substantial deterioration and vandalism, much of the finishes have been removed exposing the first floor and ceiling joists as well as the brick walls. With the flooring removed, a series of unbarked and hewn sleepers that run east to west can be seen in the period one section. These sleepers fit into sockets in the brick walls and are bisected by a large, hewn, intermediate girt laid on brick piers. Portions of plaster have also been removed around the windows and doors. Underneath the eastern window, three rows of bricks are laid on their side and supported by a one-inch, wood, leveling sill that is incorporated into the brick wall. Above the eastern door, a triangular wood arch with brick infill bridges the pressure on the interior of the door while a slender wood leveling sill supports the bottom of the door jamb. A large fireplace (once with a stone hearth), an enclosed box stair to the half-story above, and two closets on the north end of the room were originally decorated with panelling--now partially removed. The back of the panelling displays a roughly hewn treatment while the front surface has been competently planed. T-head wrought nails were used sparingly to fasten the panelling to the wall surface. Wood nailers, located amidst the fireplace bricks, received the nails. Ghosts and wood nailers located just above the floor level and a few feet above it mark the presence of a baseboard and chair rail around the other three walls. The space between them appears to have been plastered. The ceiling plaster and lath has been removed revealing 5 1/2 by 6 inch pit sawn and hewn ceiling joists. These joists support random width, gauged plank flooring.

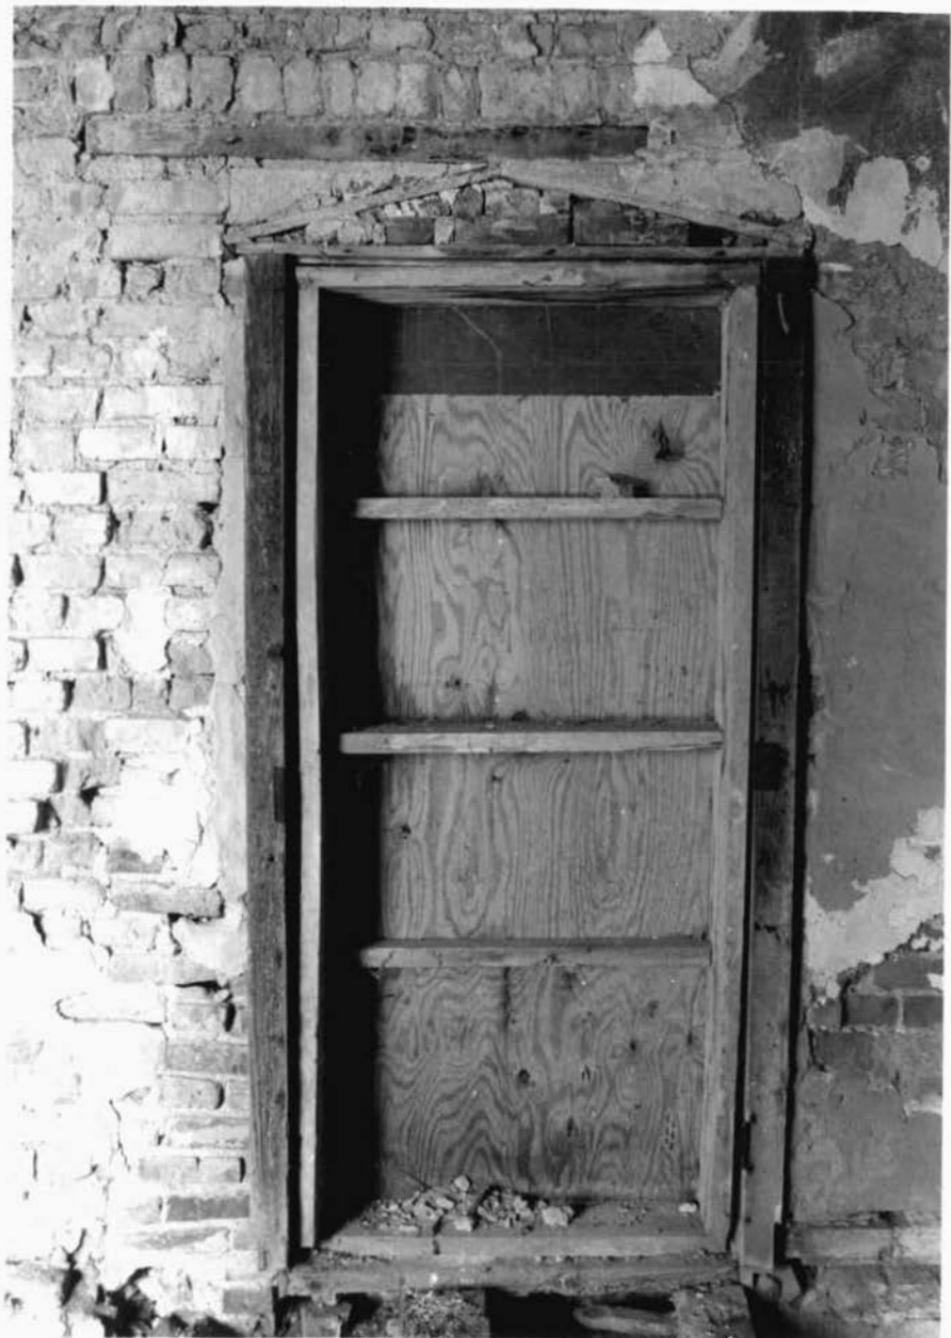
9 of 14

N room - door looking E

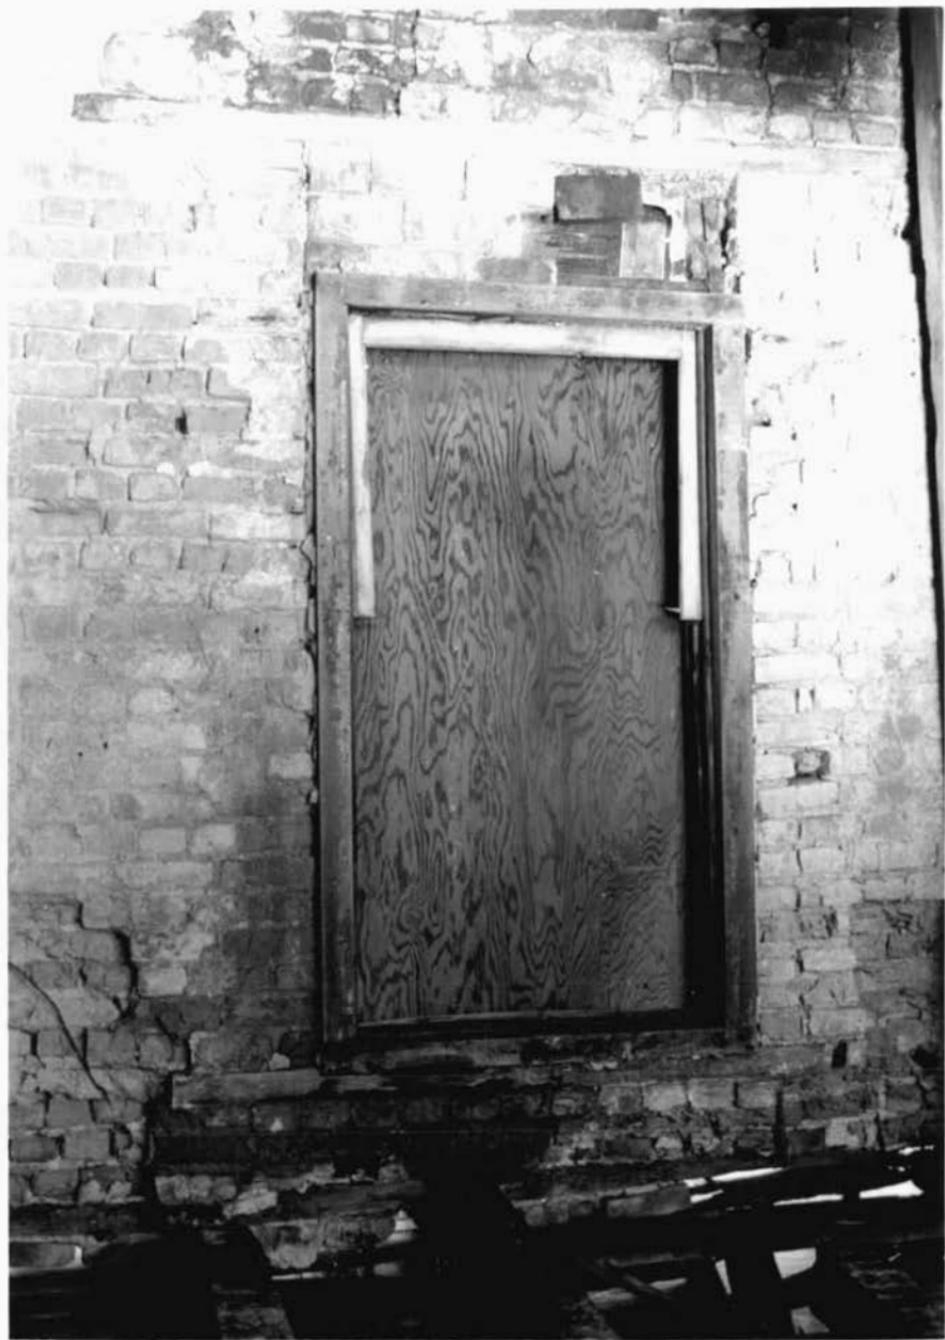
10 of 14

11 room - window looking E

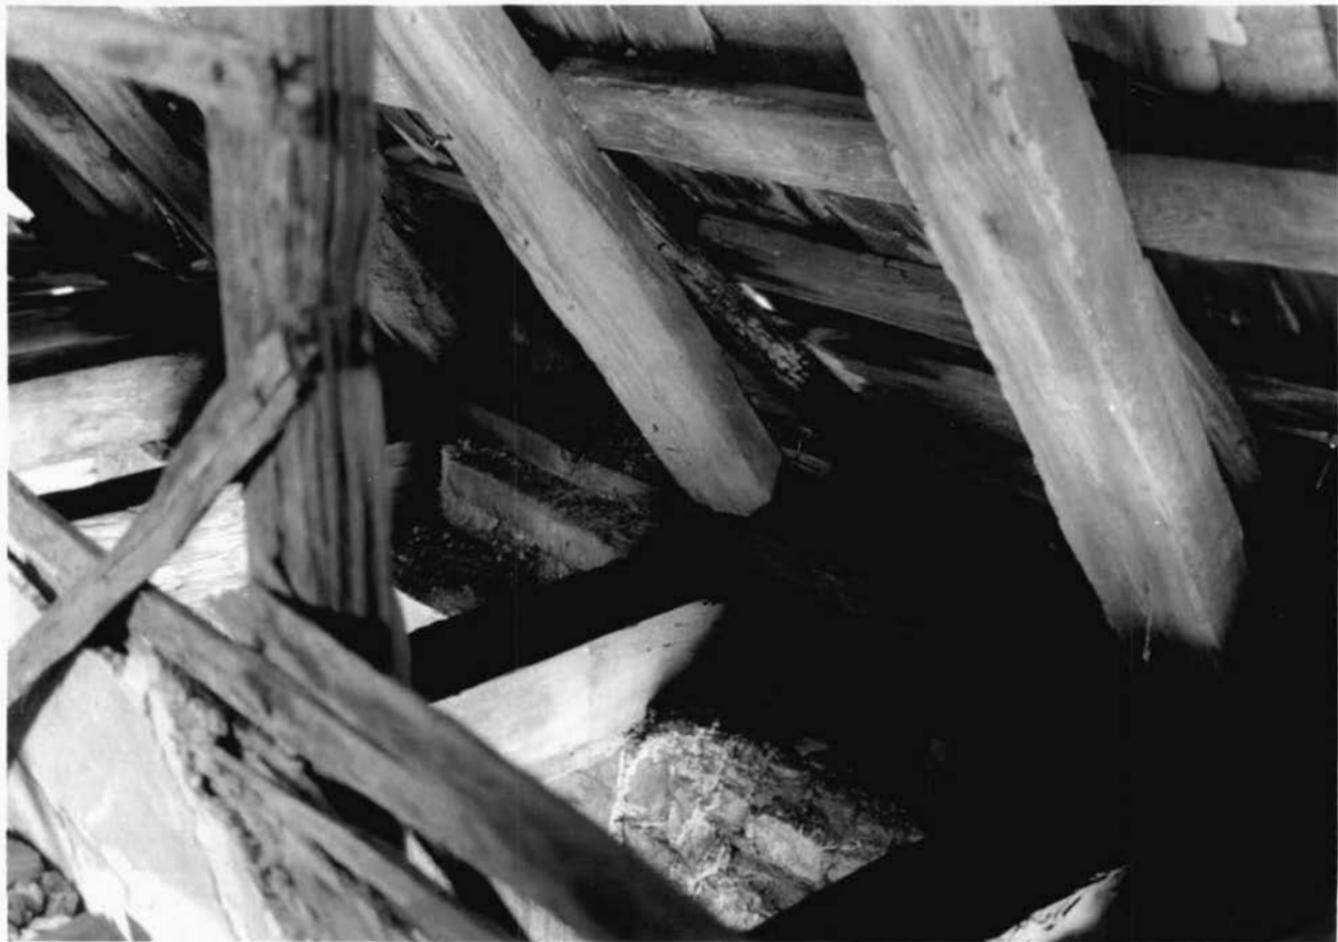
13 of 14

Views of rafter-plate construction Per I. - looking SW

Large amounts of plaster and lath have been removed in the half-story allowing a detailed analysis of the common rafter, roof framing system. The framing over the original section consists of a 7" by 2" inch false plate that rests on the first floor ceiling joists. The first floor ceiling joists extend well beyond the exterior brick wall surface to create a box cornice. The rafters, however, fall short of the joist ends. In order to bridge the remaining space and create the flared eave several split and sawn struts were nailed to the rafters and ceiling joists to bridge the remaining space and flatten out the pitch of the roof. The rafter feet are then beveled into the false plate and held in place with a wood peg that connects the rafter, false plate, ceiling joist, and wall plate. Collar beams are mortise and tenoned into each rafter pair and the rafters are joined at the roof peak with pegged half lap joints. The roof framing over the addition differs from original section's framing system. The rafter pairs are not beveled but nailed into the false plate. Collars are half-dovetail lapped and fastened with wrought nails into each rafter pair. The rafter pairs are then joined at the peak with a half lap joint and fastened with wrought nails. While the two periods of roof construction differ, the kicked or flared eave construction is similar throughout.
