Capsule Summary
SM-464
Potomac View Farm
Tall Timbers
Private

**Maryland Historical Trust
State Historic Sites Inventory Form**

Survey No. SM 464

SM-464, Potomac View Farm
St. Mary's County
7.1 Description

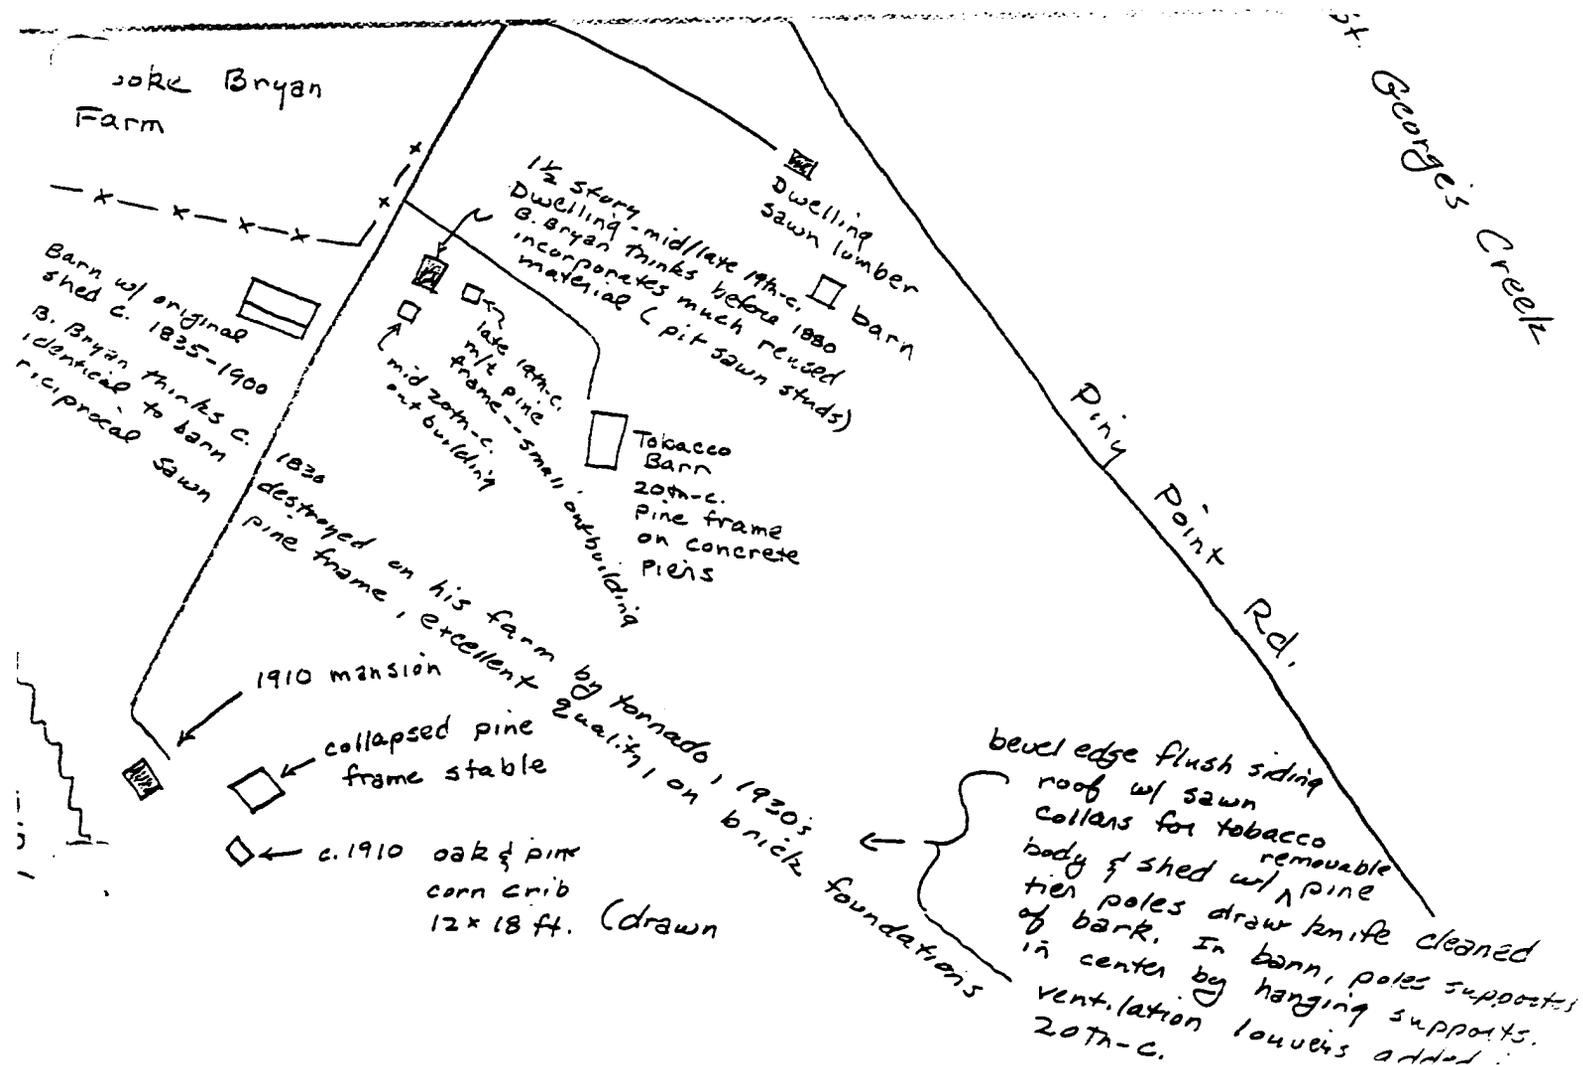
Map of Potomac View Farm and outbuildings drawn by Gary Wheeler Stone in 1980. Few of these outbuildings survive today. The meathouse, which is still standing, does not appear on this map.

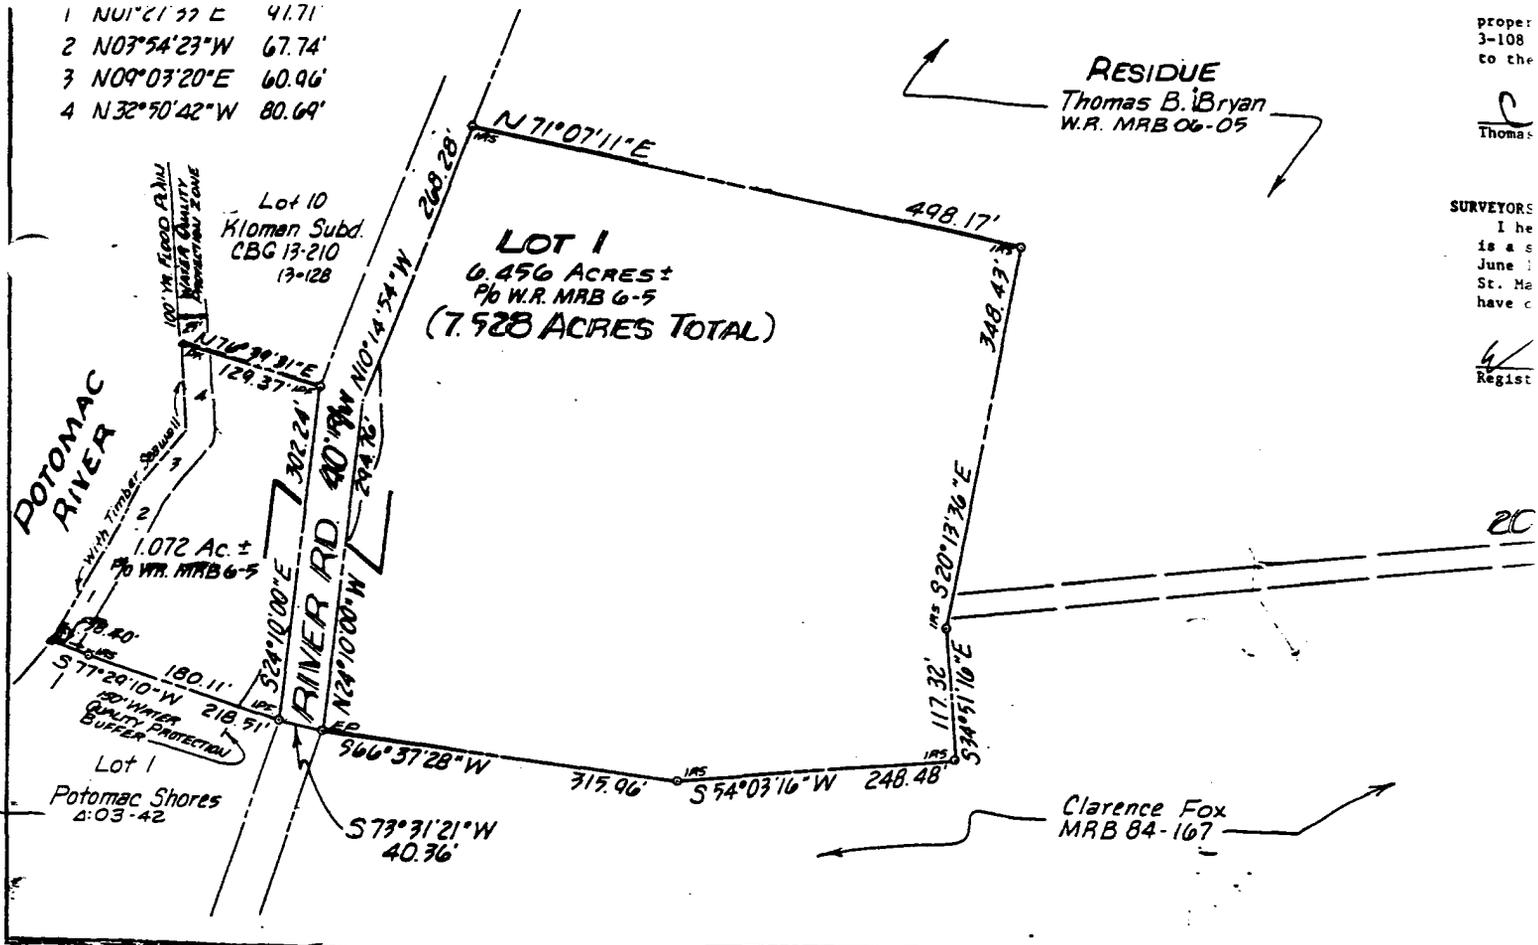
Plat of Lot No. 1 of Bryan Subdivision prepared in 1988.

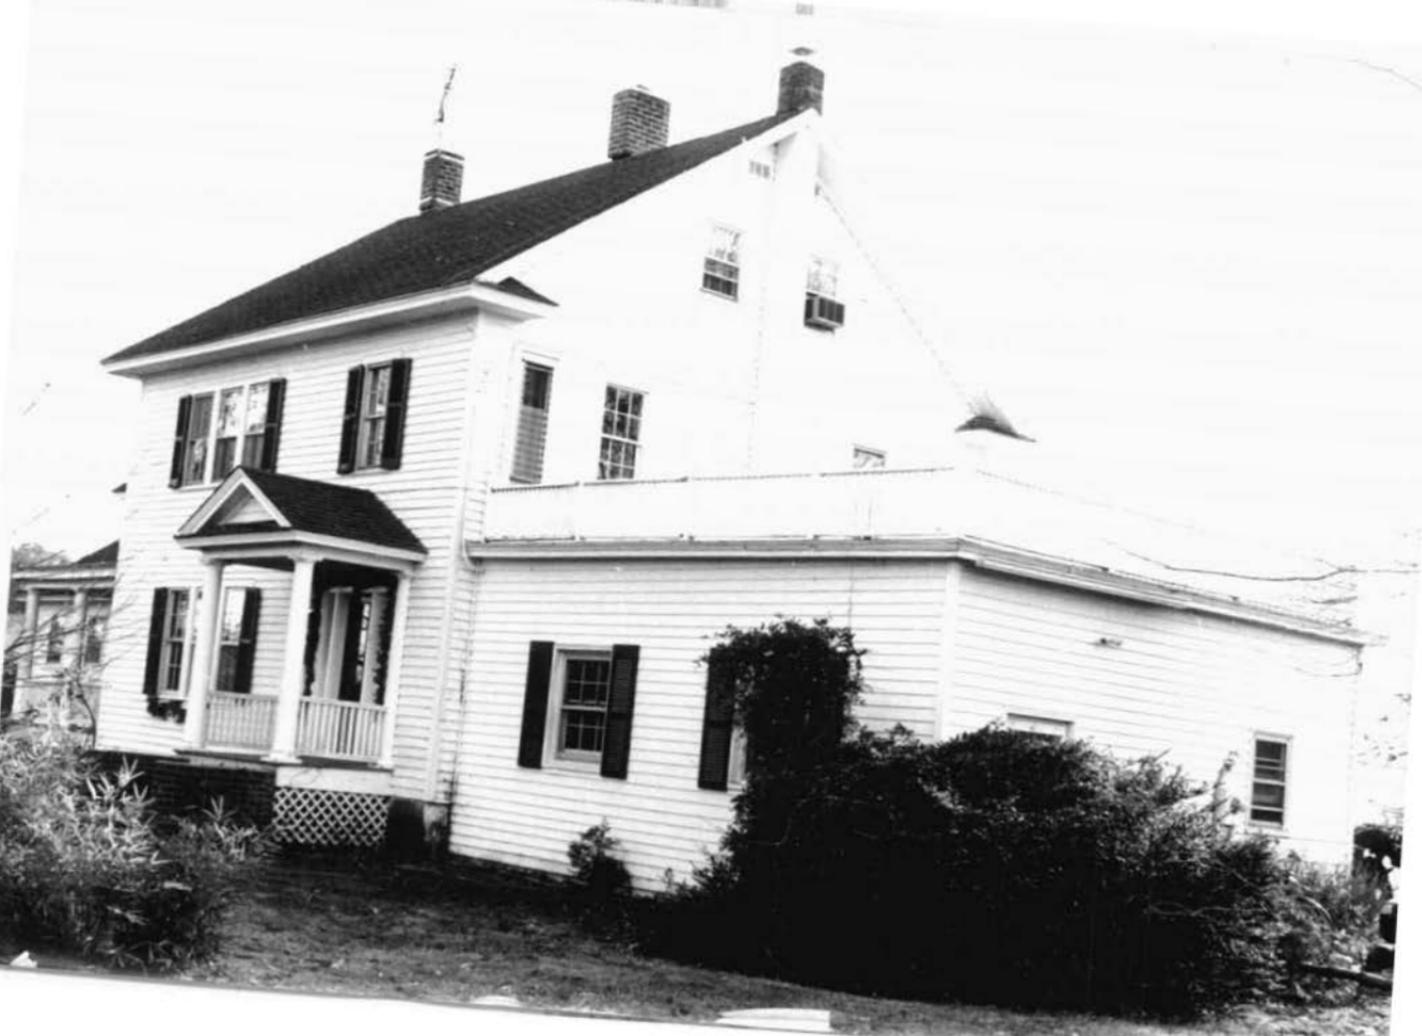
1/5

NW Elevation

The north (main) elevation has a sidelighted fifteen-light entrance door as the western-most bay. A gable-roofed portico supported by Doric columns shelters the entrance. A bank of three six-over-six sash windows with louvered shutters and wide surrounds are located to the east of the door. The second floor is pierced by one six-over-six sash window centered above the entrance door and a bank of three six-over-six sash windows with louvered shutters. An interior brick chimney pierces the center of the roof ridgeline. A modern one-story addition extends to the west of the main block. The addition is pierced by two six-over-six sash windows with narrow surrounds and louvered shutters. Square post balusters line the flat roof of the addition. The eastern one-and-a-half story wing is pierced by two six-over-six sash windows with louvered shutters and wide surrounds on the first floor. A porch, supported by Doric columns and finished with square balusters, extends across the first floor of the wing. The second floor is pierced by two six-light casement windows. The attached one-story addition extending to the east of the wing is pierced by two smaller six-over-six sash windows.

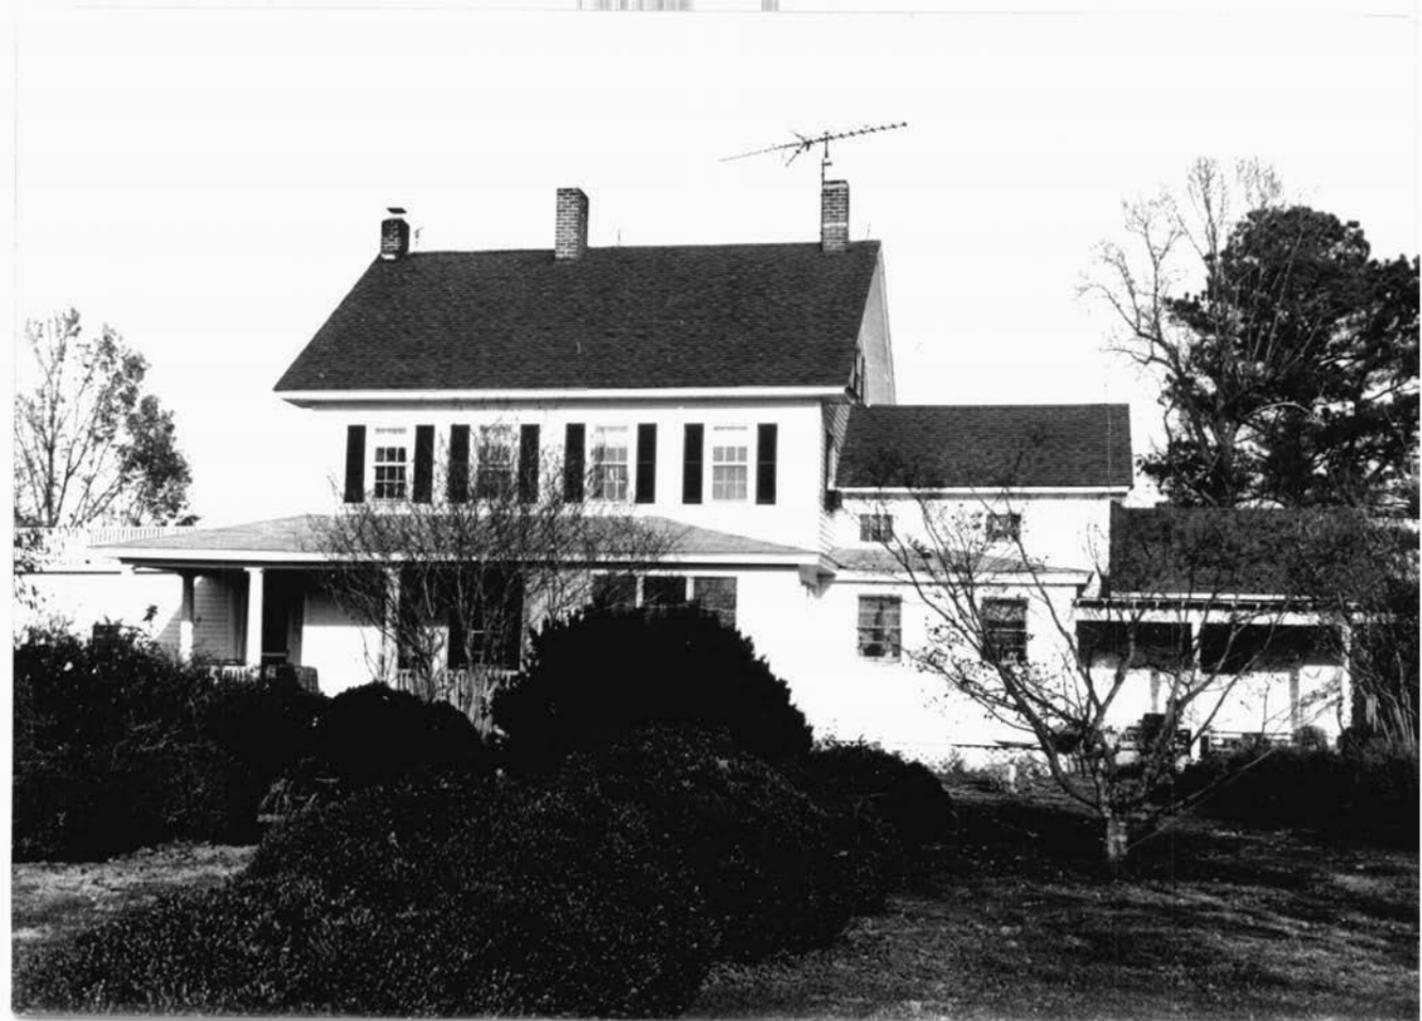
2/5

S Elevation

The south elevation of the one-story wing is pierced by one eight-over-eight sash window. A frame arbor sheltering a brick walkway extends across the front of the one-story wing. The one-and-a-half story wing is covered by an enclosed porch that extends across the first floor. The porch is pierced by two two-over-two sash windows with narrow surrounds. Two six-light casement windows light the upper half story of the wing. The main block is pierced by a twelve-light-over-one-panel entrance door and a six-over-six sash window with louvered shutters and wide surrounds. A porch, supported by Doric posts and finished with a square post baluster, extends across this first floor. The eastern section of the porch is enclosed with siding and louvered windows. The second floor of the house is pierced by four six-over-six sash windows with wide surrounds and louvered shutters. The one-story, western wing is pierced by one six-over-six sash window with narrow surrounds and a six-light-over-two-panel entrance door.

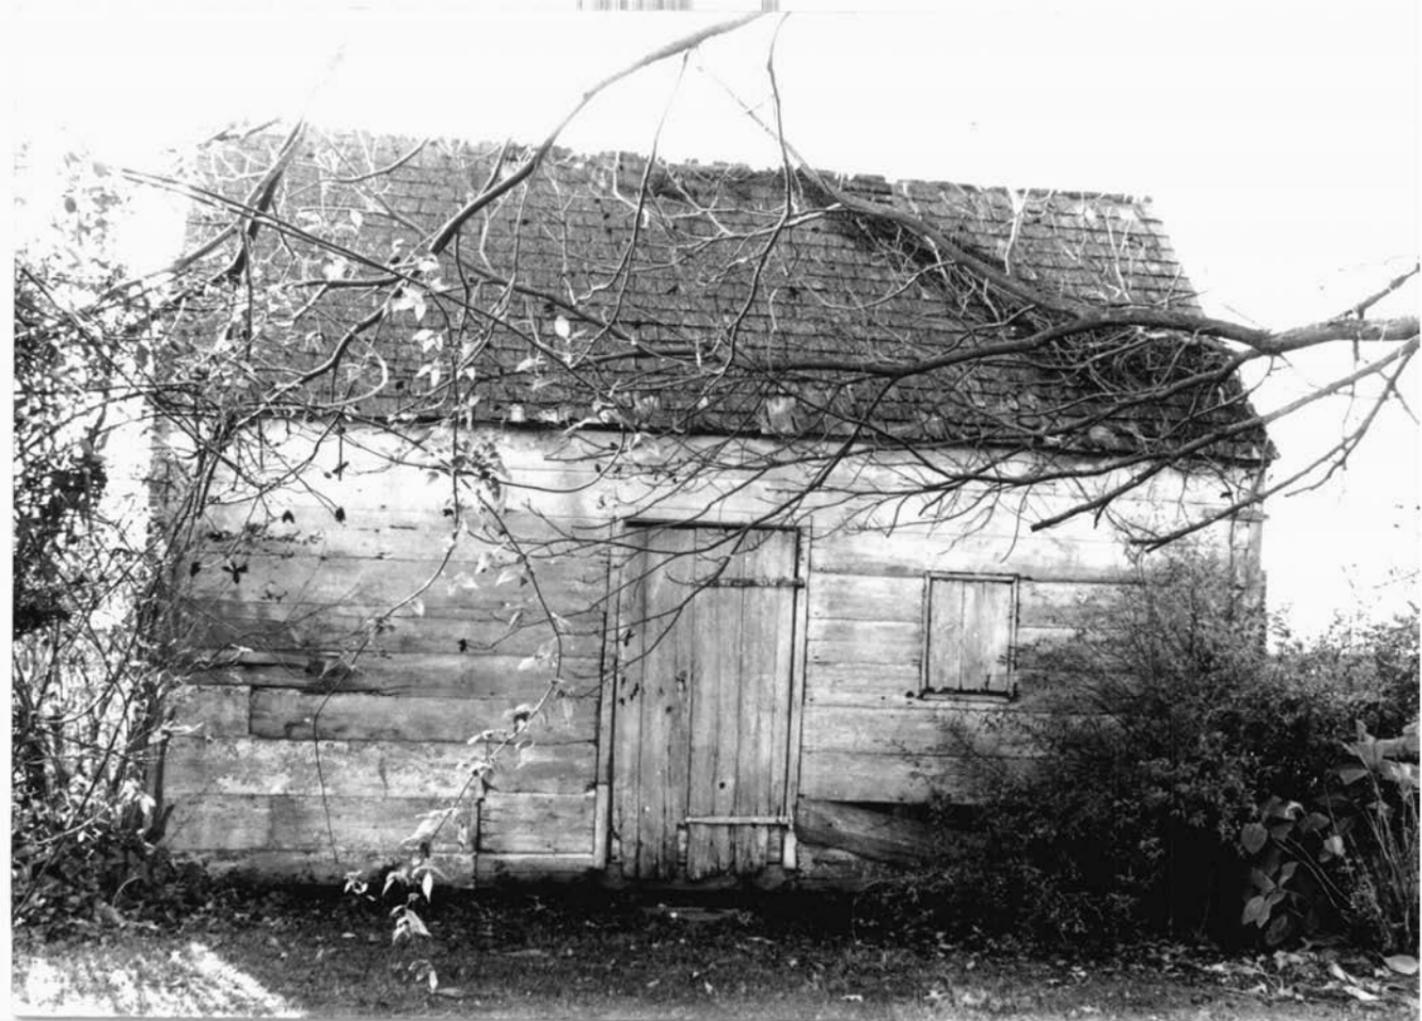
3/5

Meathouse - N elevation

The north elevation of the meathouse is pierced by a vertical panel entrance door with horizontal battens. It is hung on wrought metal strap hinges and opens outwards. The remnants of a metal box lock survives on the inside of the door. The door opening measures three feet in width by six feet in height. A shuttered window opening is located west of the door. The shutter, hung on a metal butt hinge, has been nailed shut. The window opening measures one and a half feet in width by two feet in height.

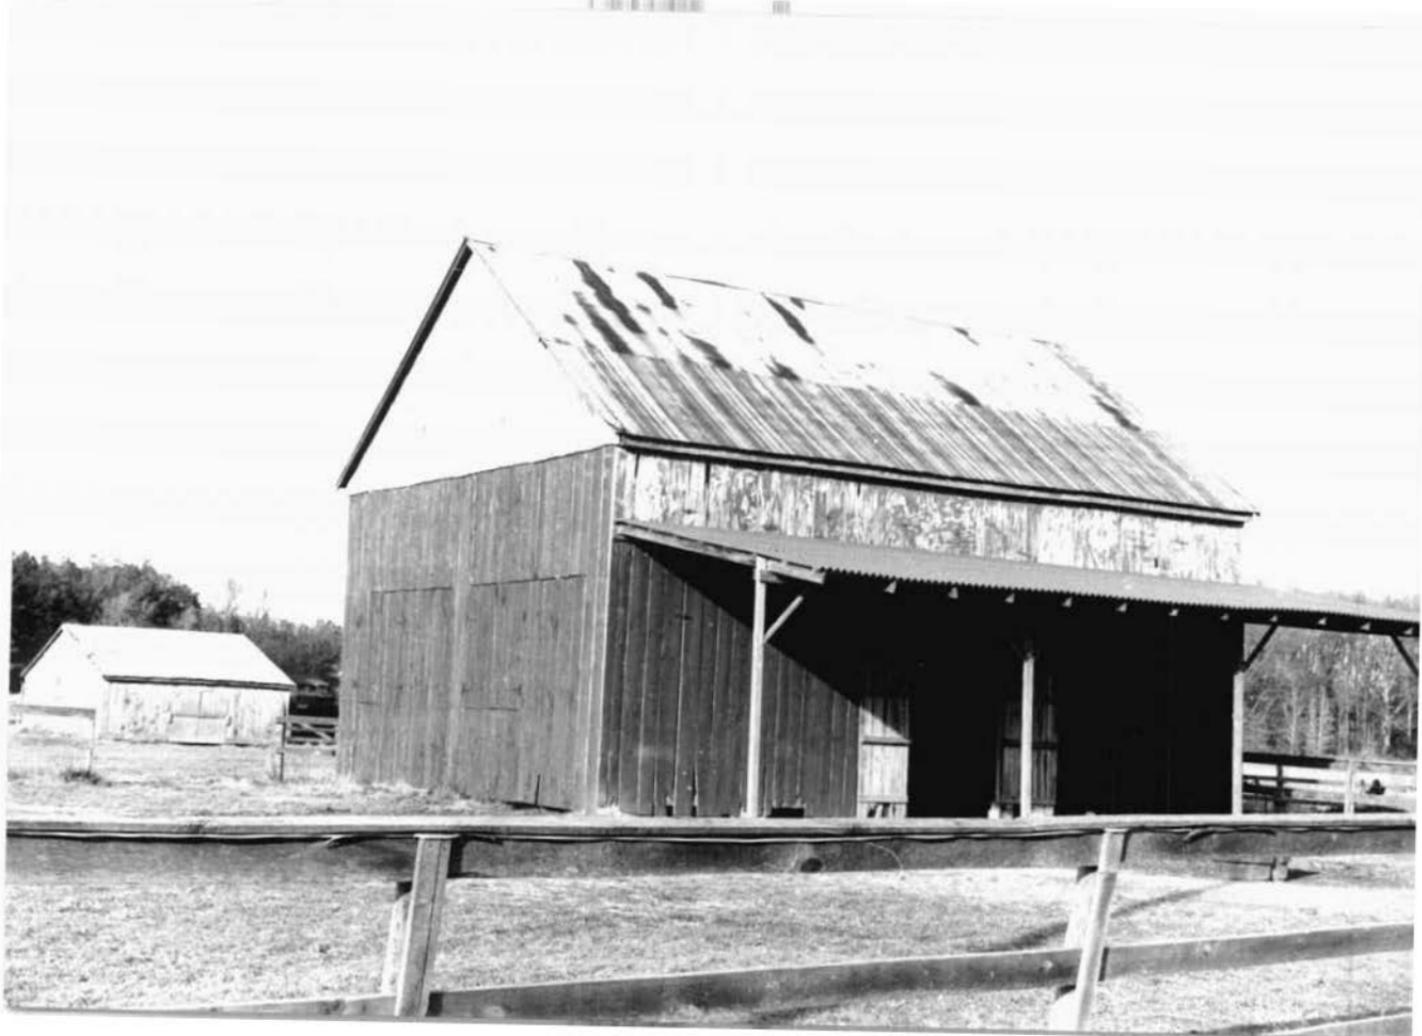
1/5

Barn - now set as a stable.

A frame tobacco barn and a former corn house are located west of the house. Both are sheathed with vertical board siding and roofed with metal. The tobacco barn has been converted for use as a stable. The corn house is currently used for storage. Here, the owner has stored the framing of a slave quarter that once stood on the property. The quarter was originally located on the south side of the house on the site of the grape arbor.

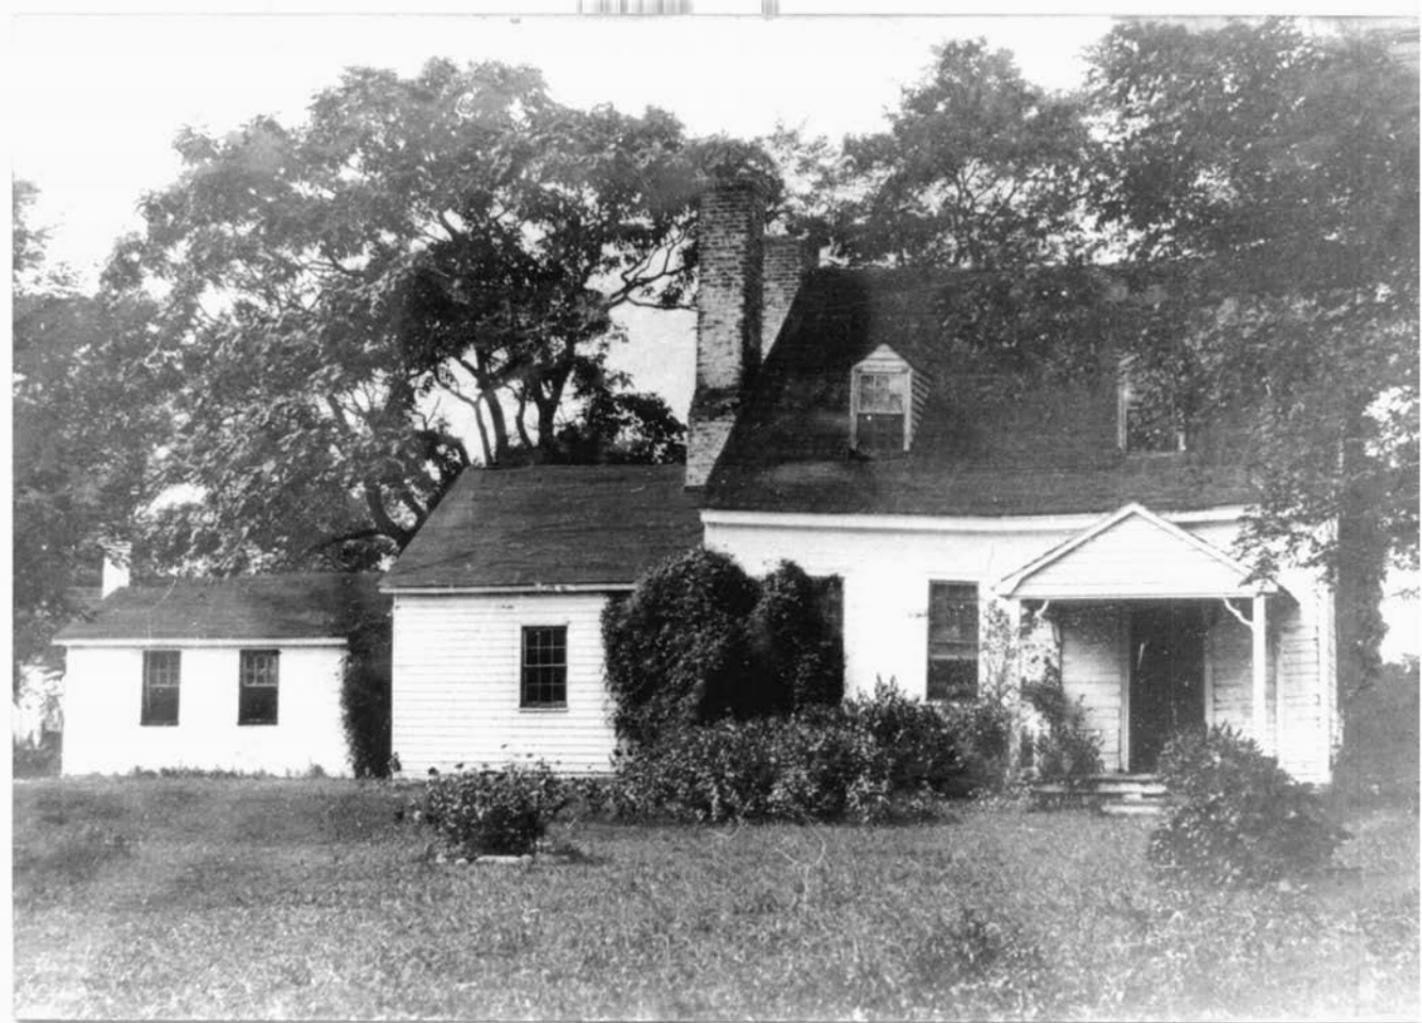
5/5

Historic photo of house formerly located on
site (according to local tradition)

During Mary Oldham Bryan's ownership, the old house was razed and a new building was erected on its very foundation. The new building was built in a style similar to that of the old house. A historic photo shows the Thomas Shadrick House to be a telescope style dwelling consisting of a two-story, two-bay main block with a one-story wing. In 1968, Mary Bryan died and devised her property to her three children. The house remained in the family until 1988.
