### **Buoy Shed (SM-511), Point Lookout Light Station**

# Maryland Historical Trust State Historic Sites Inventory Form

**SM-511, Buoy Shed  
Point Lookout Light Station  
St. Mary's County, Maryland  
Section 7 (Description)**

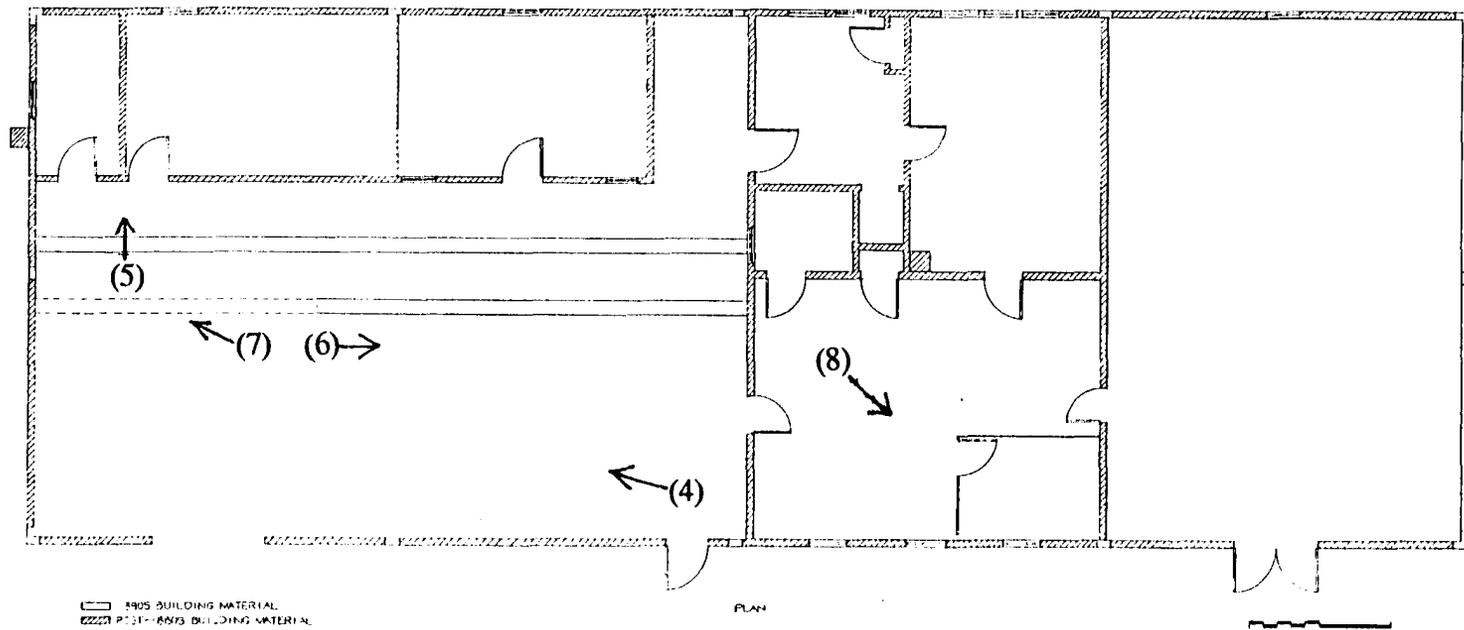
PLAN

——— 1905 BUILDING MATERIAL  
 ■■■■ 1921-1923 BUILDING MATERIAL

**KEY TO PHOTOGRAPHS, BUOY SHED**  
**POINT LOOKOUT LIGHT STATION, POINT LOOKOUT, MARYLAND**

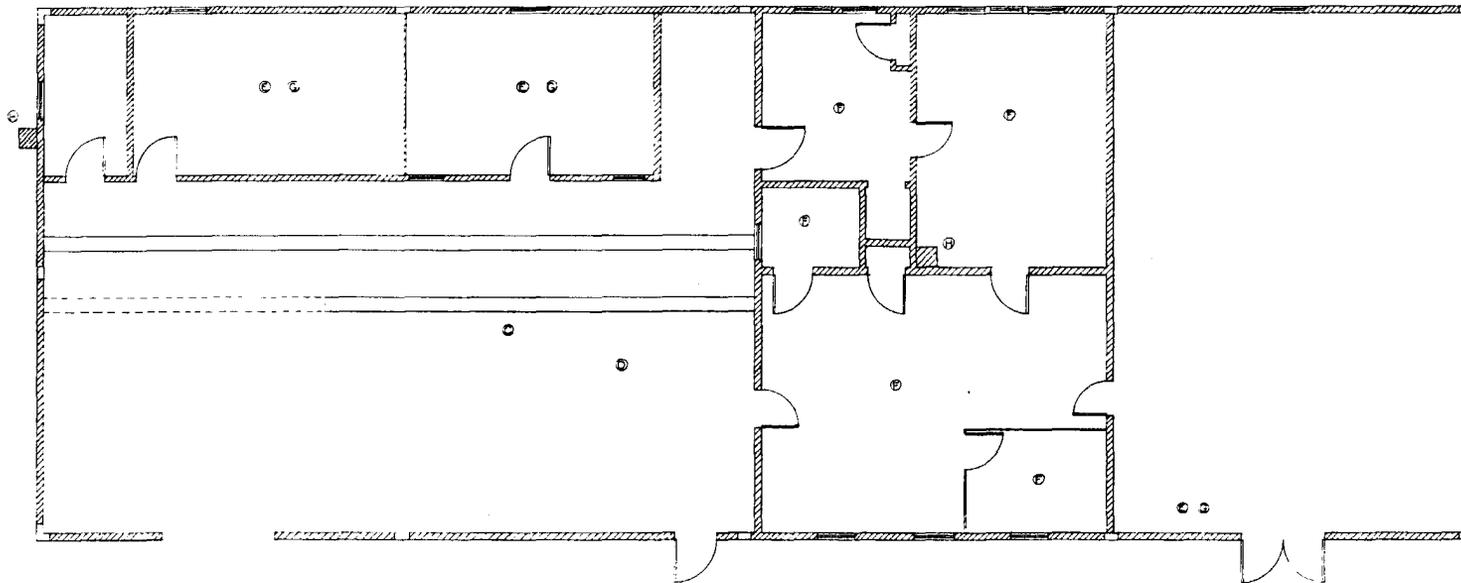
PLAN

- NOTES:
- ① REMAINS OF WOOD BRACE FRAMING
  - ② DRY-LAY BRICK FLOOR
  - ③ THESE ROOMS FEATURE EXPOSED BRACE FRAMING AND OPEN RAFTERS
  - ④ WOOD FLOORS AND LOWERED CEILINGS
  - ⑤ CONCRETE SLAB FLOORS
  - ⑥ CHIMNEY INTERIORS NOT REVEALED

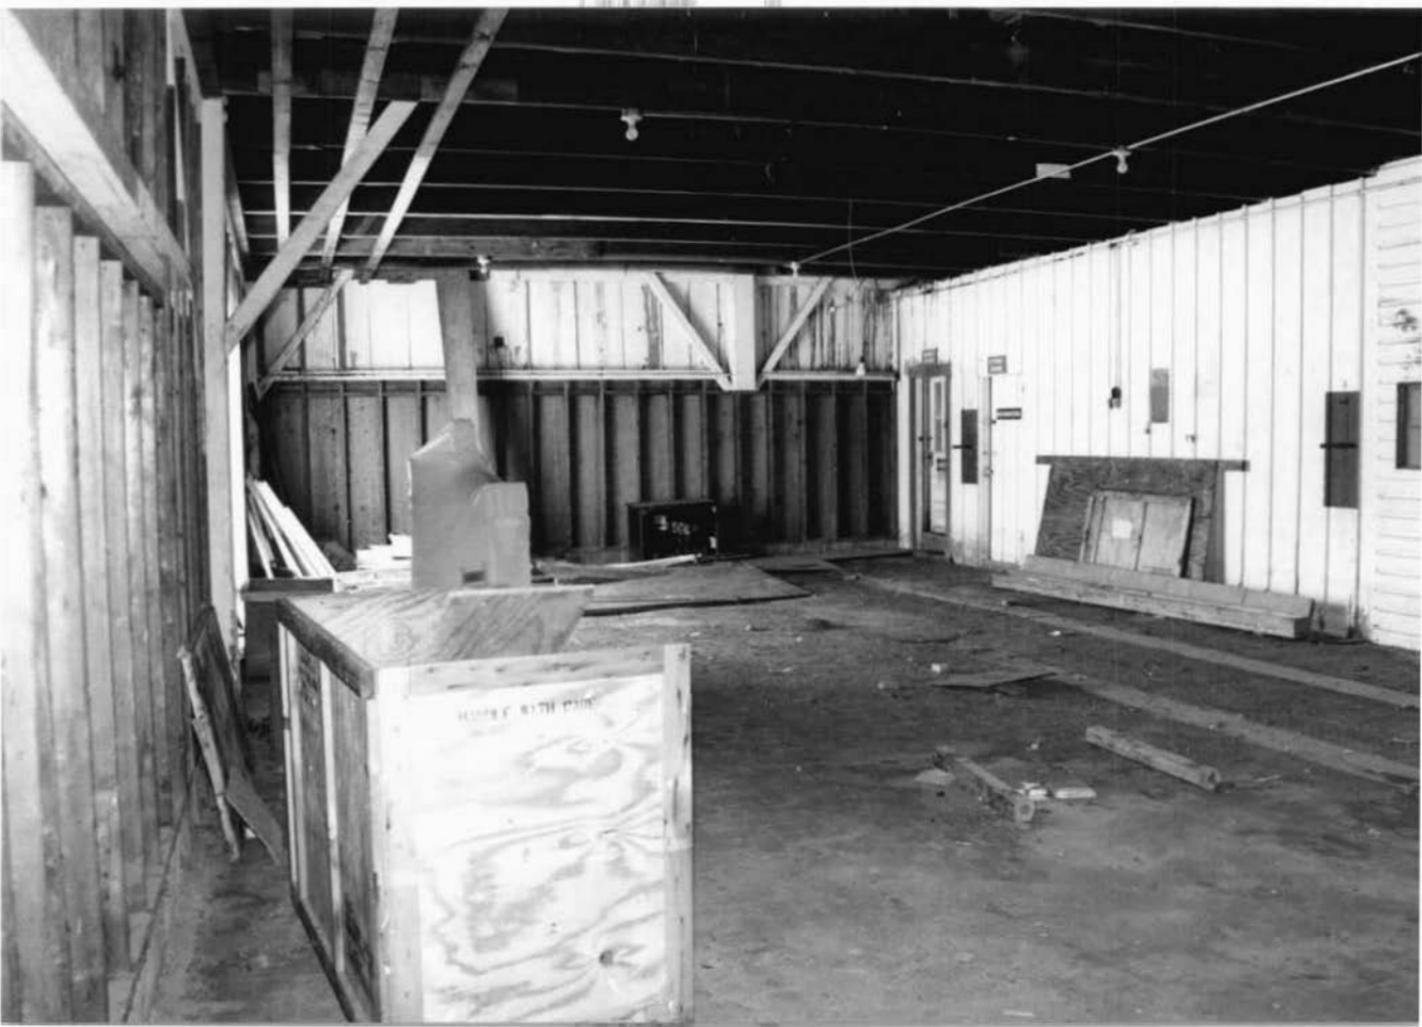
RADIO  
ROOM

STORE  
ROOM

Three rooms a radio room, a store, and a shop have been framed on the north side of the westernmost room. The exterior walls are framed with board-and-batten siding and horizontal sheathing indicating that these rooms were added before the original bays were enclosed. These rooms have poured-concrete floors with narrow-width, possibly tongue-in-groove, wood ceilings. The interiors are sided with horizontal and vertical board sheathing.
