Maryland Inventory of Historic Properties number: SH-517

Name: 18017/MD 238 OVER NELSON RUN

SHA Bridge No. 18017 Bridge name MD 238 over Nelson Run

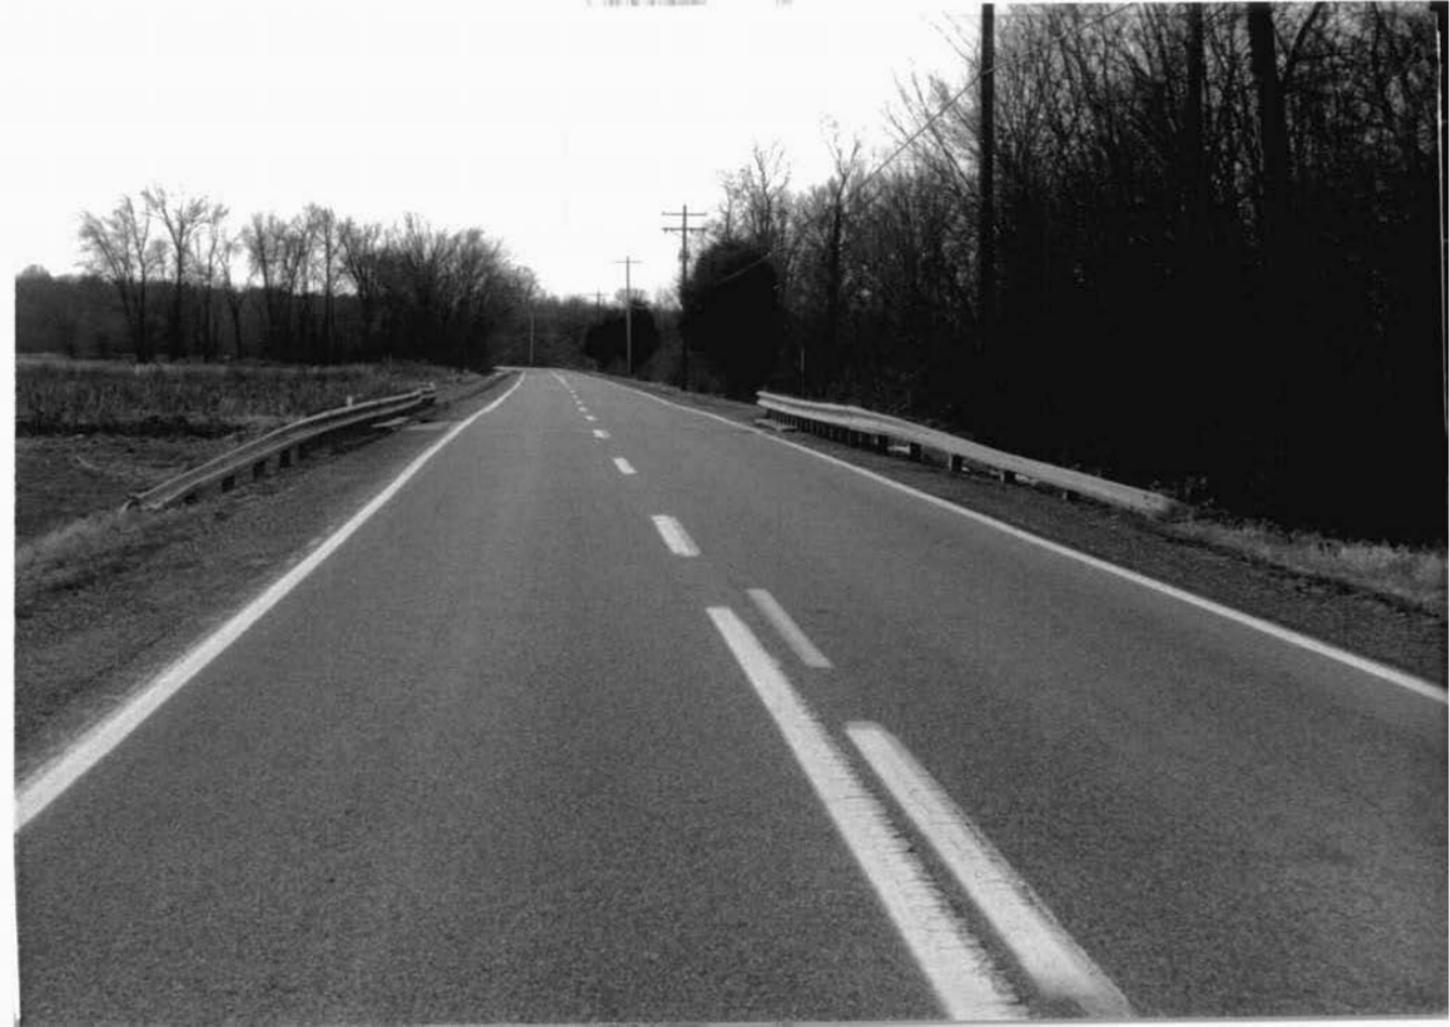
1 OF 4

LOOKING SOUTH ON MD 238

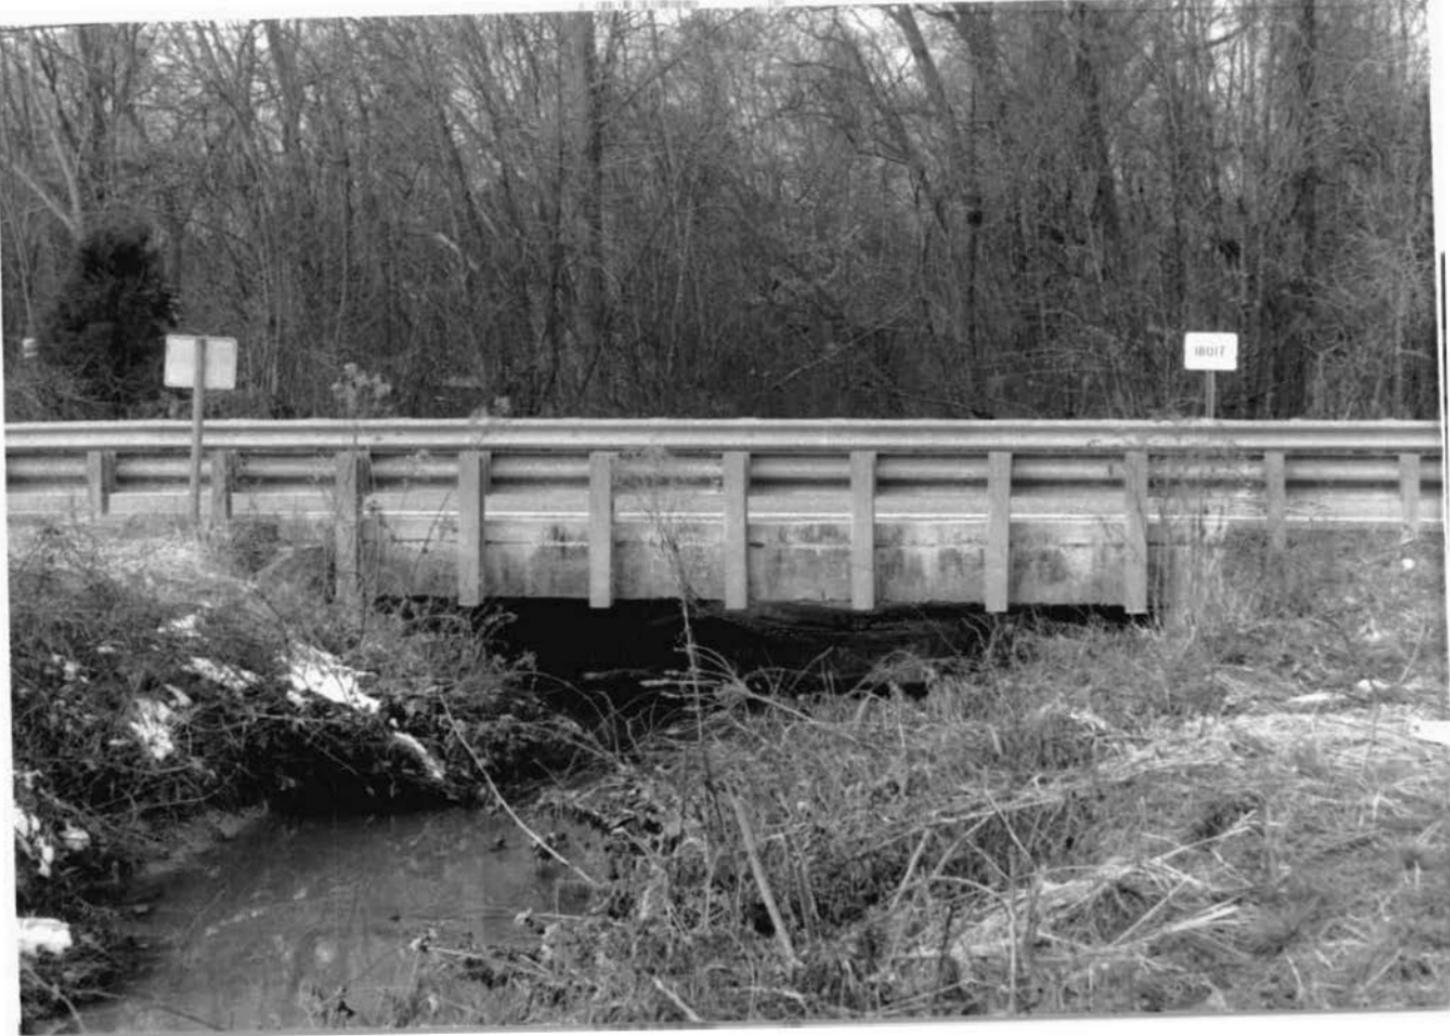
2 OF 4

Bridge No. 18017 over Nelson Run is a single span concrete slab bridge built in 1929. The span length is 20', the total bridge length is 23', and the clear roadway width is 24' between the curbs. The superstructure, consisting of the slab and the roadway and the parapets, is in fair condition. Both deck fascias have a longitudinal cracks running from abutment to abutment. There is also fine cracking and heavy efflorescence along both sides. The 4" bituminous roadway surface is in good condition. State Highway Administration records report that the bridge and approaches were repaved in July 1995. The parapets were removed at an unknown date and replaced with standard W-beam guardrails. This missing element, and the lack of available information, has prevented the State Highway Administration from classifying this bridge as a standard plan. The bridge is not currently posted.

LOOKING WEST (UPSTREAM FACE)

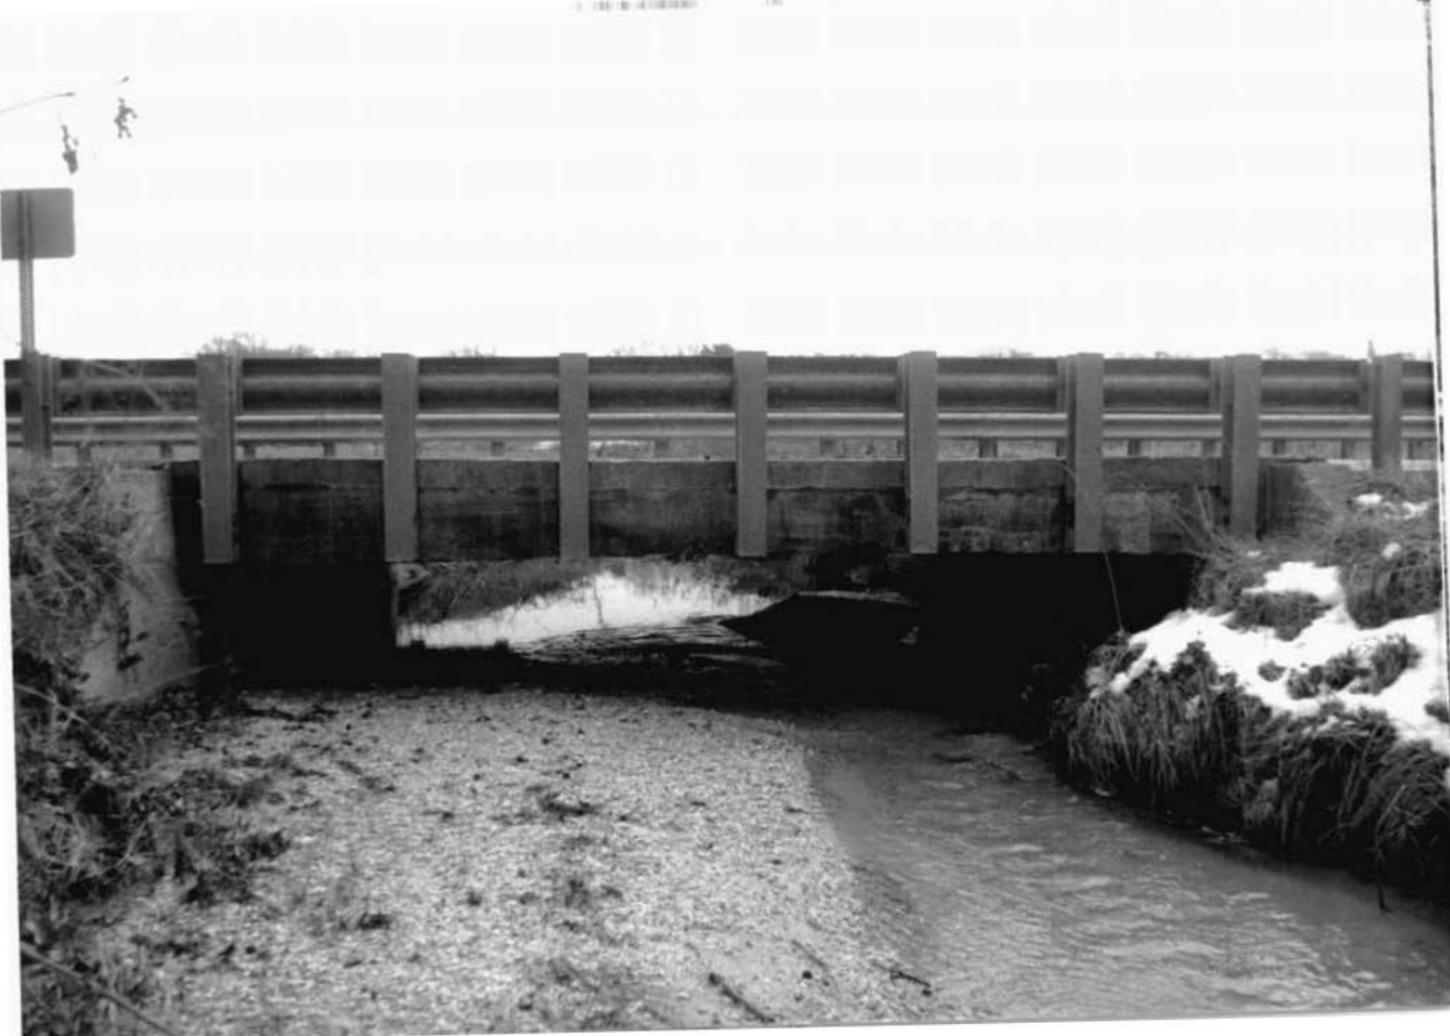
3 OF 4

The substructure consists of the abutments and the wingwalls. The concrete abutments are 24'-6" wide and the concrete wingwalls are short, straight and covered with vegetation.

LOOKING EAST (DOWNSTREAM SIDE)

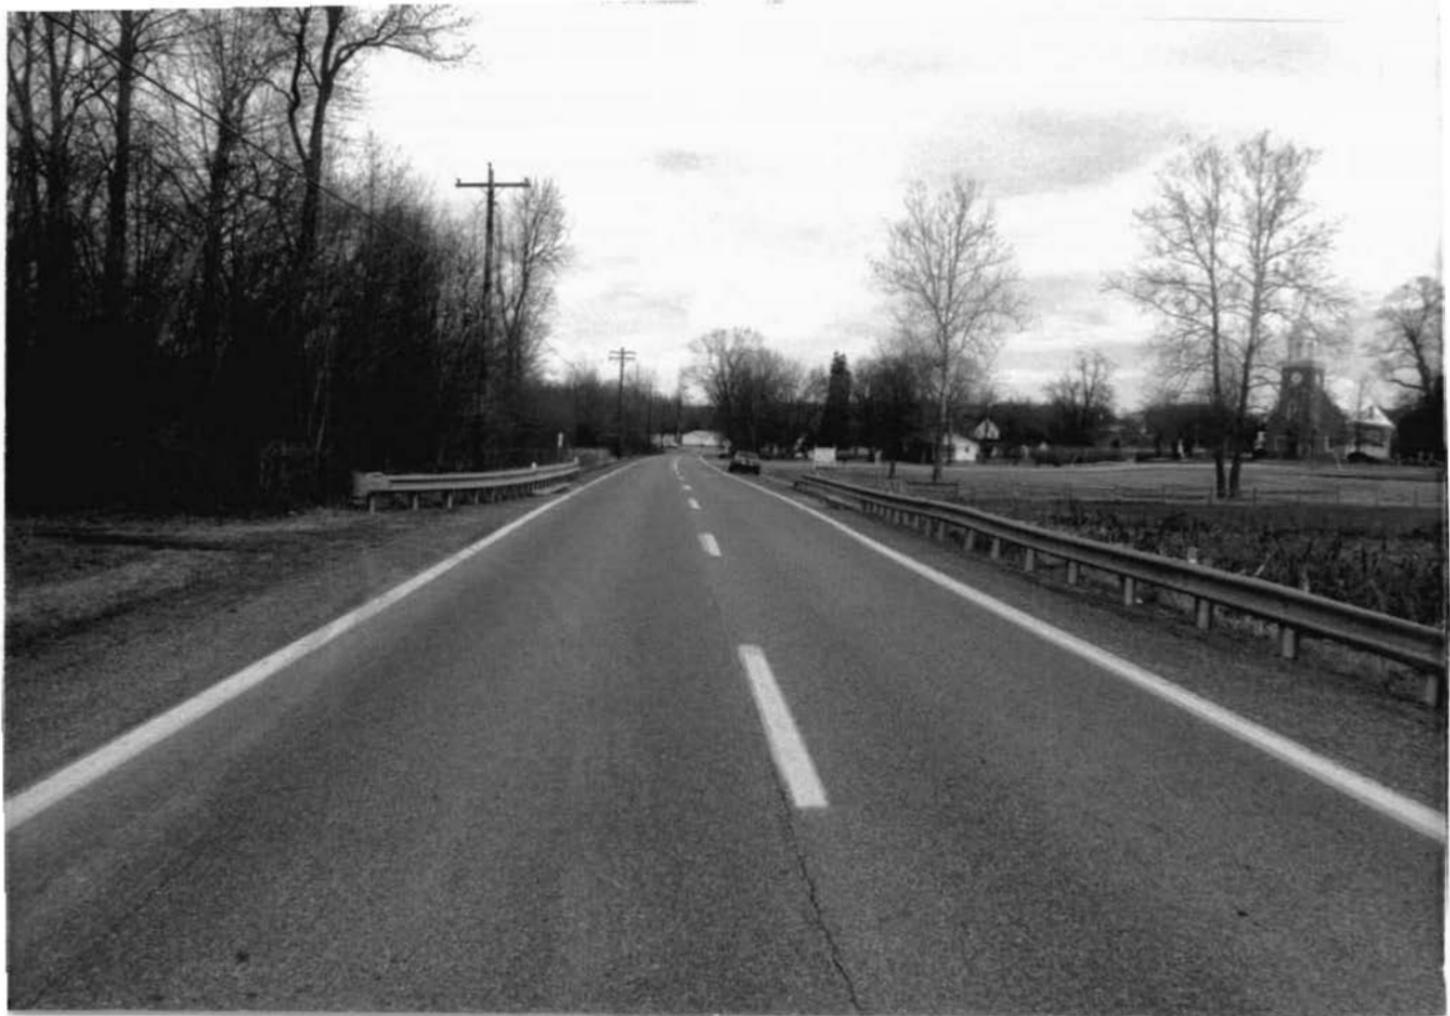
4 OF 4

The concrete parapets were removed at an unknown date and replaced with w-beam guardrails.

LOOKING NORTH ON MD 238
