**NATIONAL REGISTER OF HISTORIC PLACES
CONTINUATION SHEET**

SM-52
Buena Vista
St. Mary's Co., MD

Constructed in the 1840s, the main block of Buena Vista is a two-and-a-half story, three-bay, side passage, double-parlor plan, frame dwelling with Greek Revival-style architectural elements located in Leonardtown, Maryland. The most prominent, character defining exterior feature is a full width, one story, pedimented portico located on the south elevation. The portico has four, square, Tuscan columns that exhibit a distinctive entasis. The interior is decorated with window and door architraves, mantels embellished by free-standing, rounded Tuscan columns and a banded frieze, molded plaster ceiling medallions, and a stair with a panelled box, heavy scroll sawn brackets, rounded balusters, and a slender newel. Judging from architectural evidence, a two story, three bay, frame, service ell was attached to the main block sometime after the 1840s. Evidence suggests that the ell may predate the main block and was moved from another site to its present location. The interior of the service ell is noticeably less decorated. Smaller door architraves, a plain mantel, and a modest winder stair

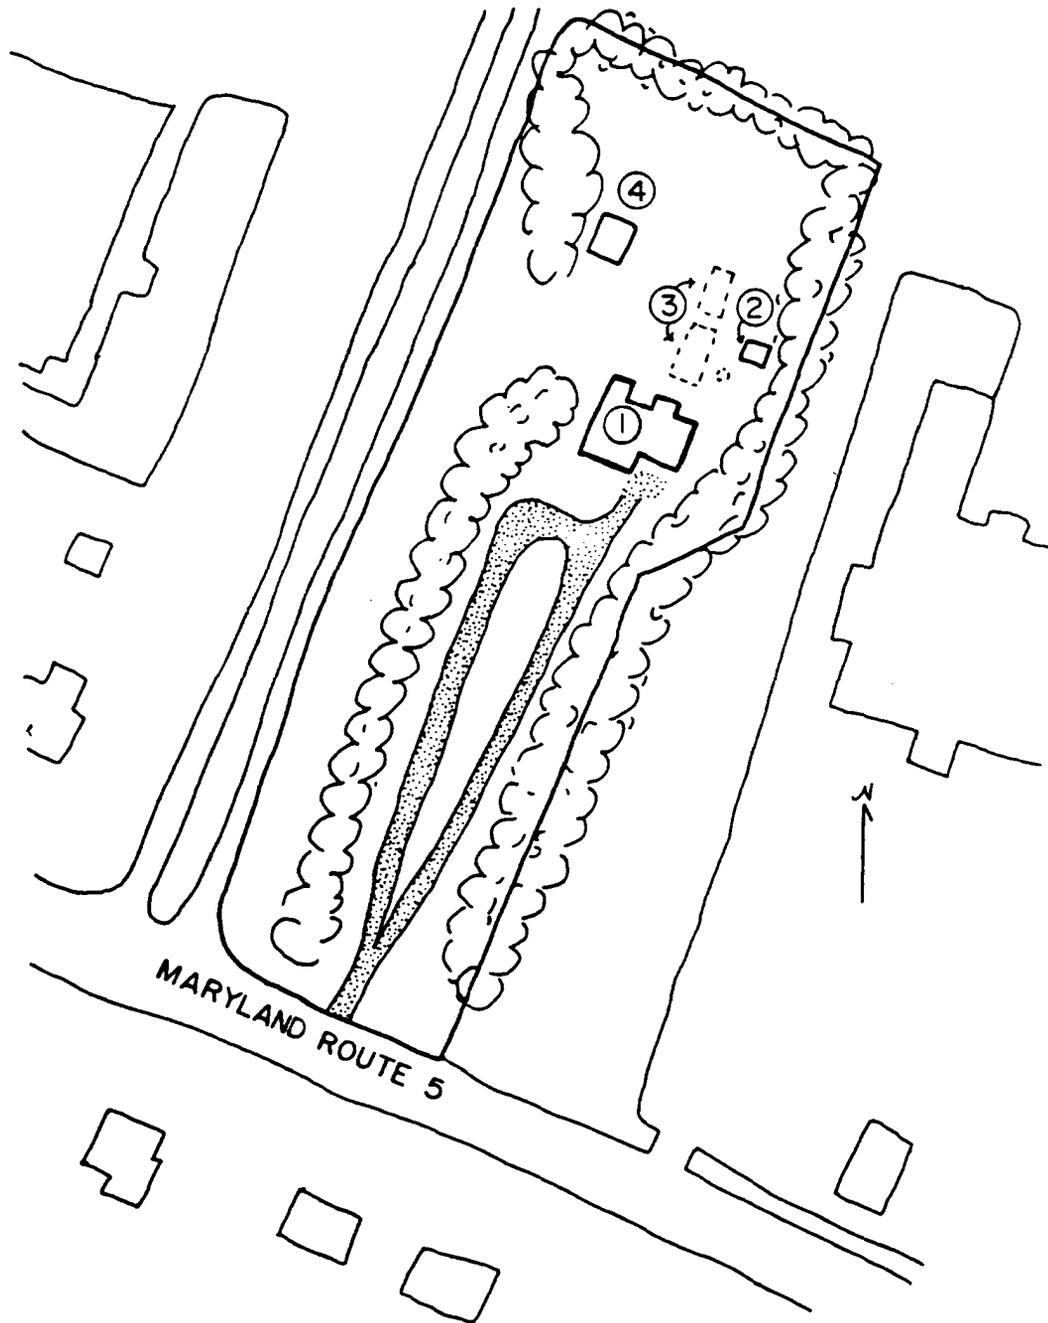
Site Plan
BUENA VISTA
SM-52
LEONARDTOWN, Md.
SITE PLAN

- ① - MAIN HOUSE
- ② - MEAT HOUSE
- ③ - SITE OF OUT-KITCHEN/QUARTERS
- ④ - STORAGE SHED

Immediately to the north of the dwelling is a braced frame meat house. The structure rests on a low brick foundation and is clad in flush, horizontal, chestnut boards. At the intersection of the exterior walls and

Just to the southwest of the meat house was a well (now filled in) and a roughly square raised pad that marks the probable location of a detached kitchen/quarter--apparently abandoned and/or demolished soon after the addition of the present ell. This feature is situated to the southwest of the meat house and just north of the main block. During one dry summer in 1992, Francis Burch measured the outlines of the kitchen/quarter. The frame building was approximately sixteen feet by 23 feet and probably had a brick chimney.

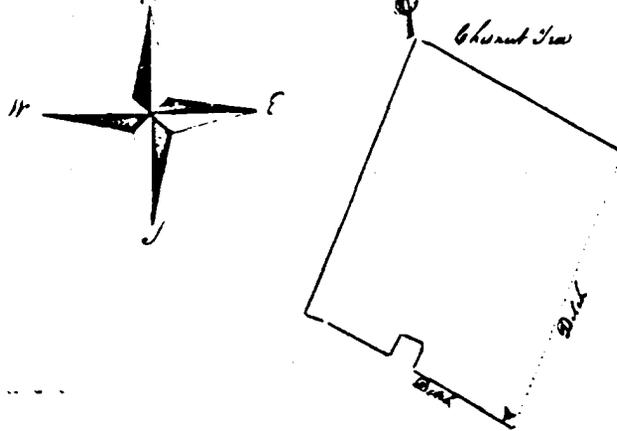
At the request of H. G. S. I have carefully surveyed a parcel of land, it being part of a tract known by the name of America Felix Secundus lying and being in that county being and acknowledged from Benjamin Tippet at the corner of a ditch on the south side of the road at A. and running the following course

Plat by Benjamin Tippet showing the boundaries of "part of America Felix Secundus" that was sold by H. G. S. and Henrietta Key to William J. and Ellen Edelin. The 96 acre tract would later be the home farm for "Buena Vista" St. Mary's County Land Records, St. Mary's County Courthouse, Liber JH 9, Folio 159.

- 1 N 65° E 26 ft. to a Cedar tree the beginning of the lot of Wesley Chapel
- 2 S 26° E 12 ft. 16 links north side ditto
- 3 S 69° N 12 ft. 16 links north do
- 4 S 26° N 12 ft. 16 links to a Cedar tree standing on the ditch
- 5 S 65° N 25 ft. 9 links north the ditch
- 6 S 66° N 9 ft. do
- 7 S 20° E 140 ft. to marked Chesnut tree standing on South side
- 8 S 65° E 111 ft. to a ditch

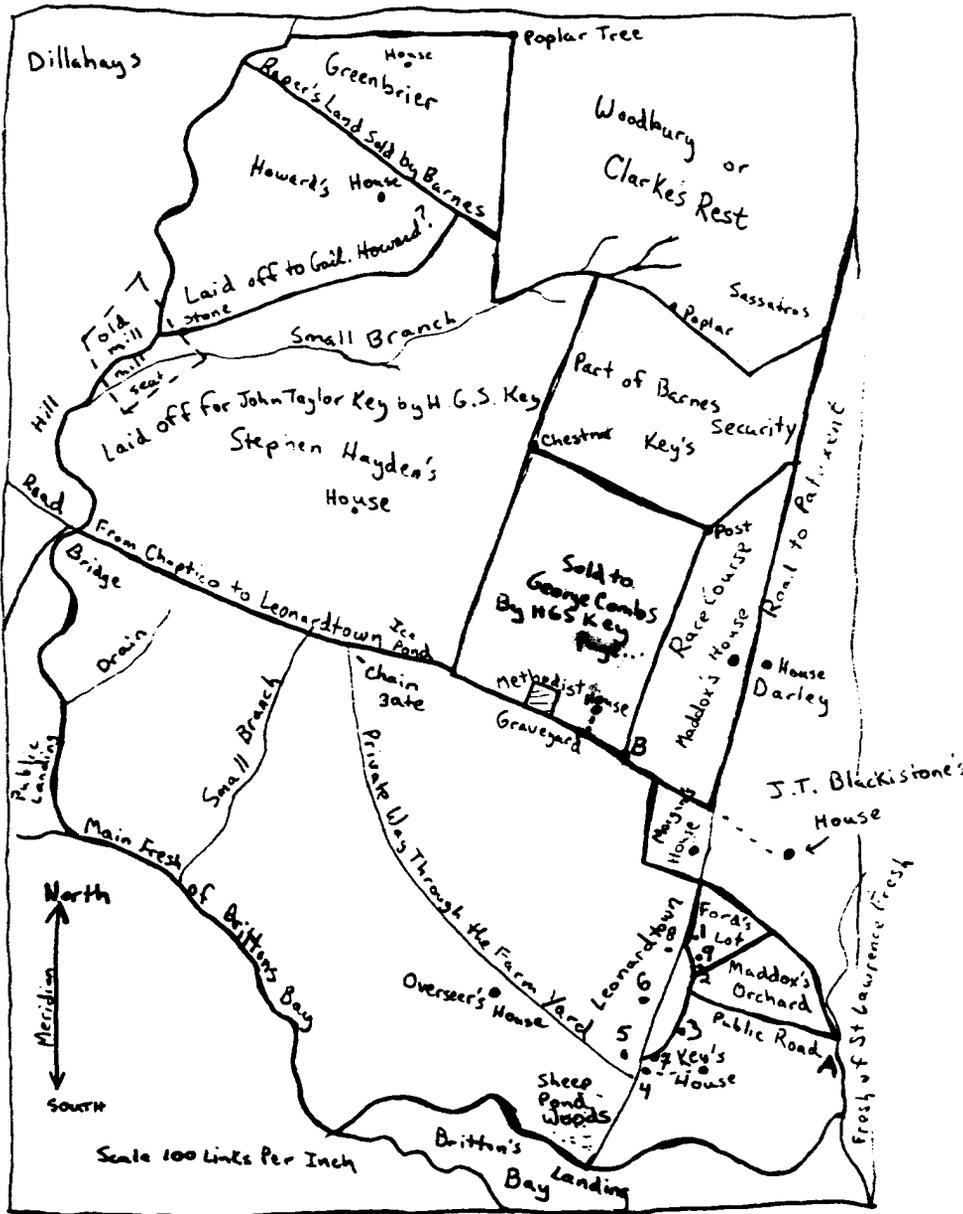
1. The Catholic Church
2. The Methodist Church *
3. The Washington Hotel
4. The Court House
5. The County Jail
6. The Union Hotel
7. Printing Office
8. Benjamin G. Harris's * House
9. Rob Ford's House
- A. Beginning of America Felix Secundus and of Maddox's Orchard
- B. Beginning of George Combs' land

1850s map of Leonardtown by the surveyor Benjamin Tippet. Benjamin Tippet's Survey Book, 1852-1878, St. Mary's County Courthouse, Land Records Office, unmarked page. Map redrawn by Kirk E. Ranzetta.
