MARYLAND HISTORICAL TRUST
NR-ELIGIBILITY REVIEW FORM

Property Name: Glendale/Foster House Inventory Number: T-1139

T-1139. Glendale Farm/Foster House

Maryland Historical Trust Maryland Inventory of Historic Properties Form

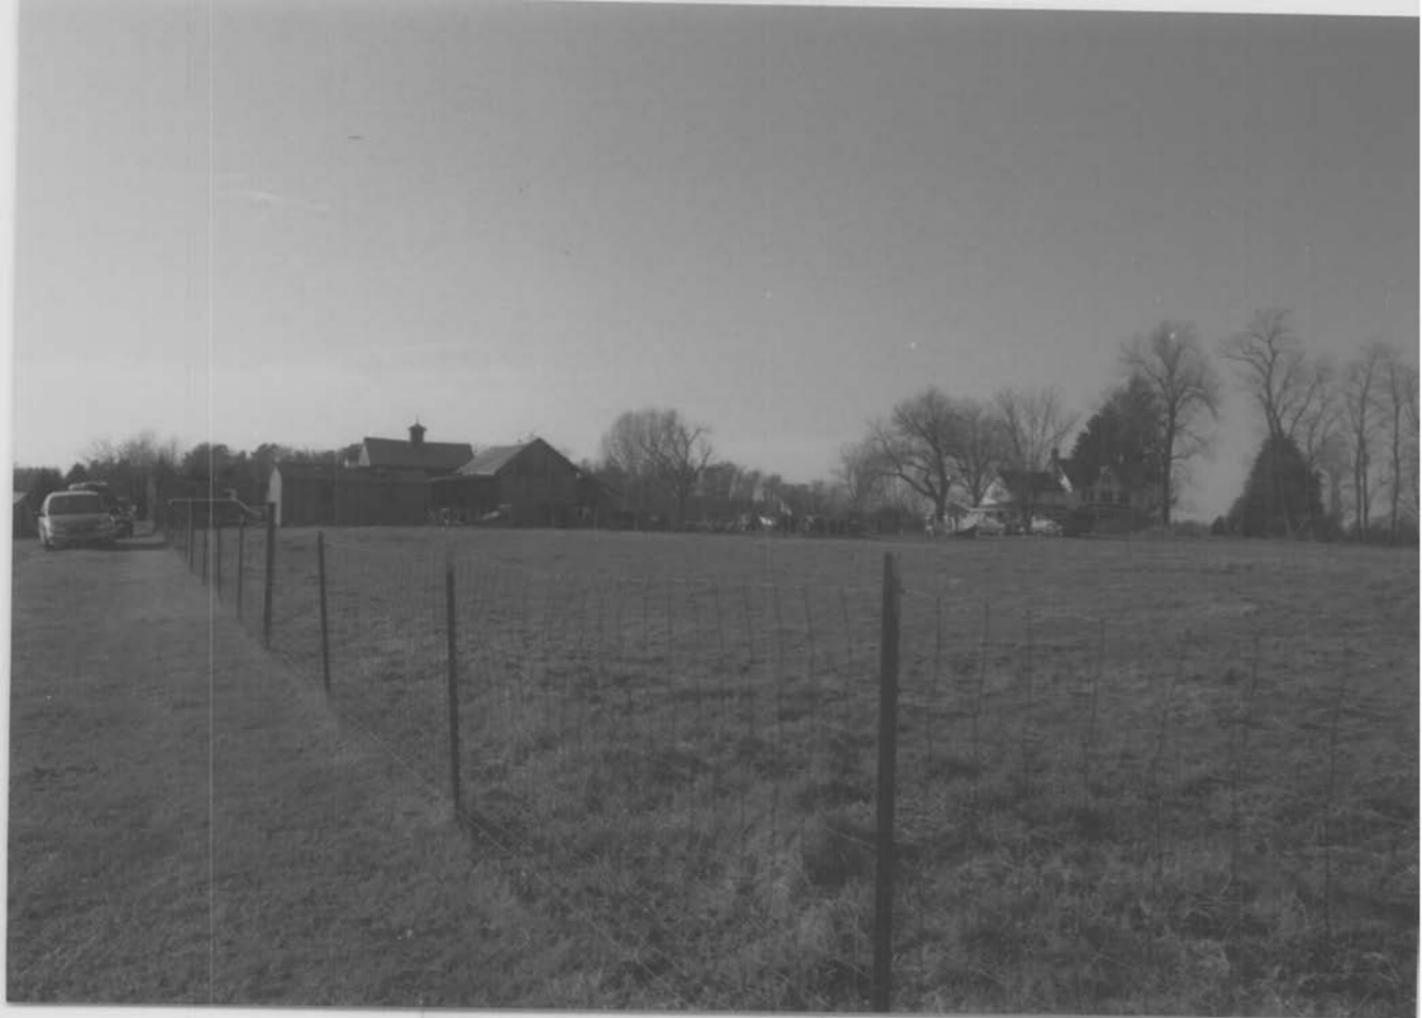
1/5

Farmstead, view to
West

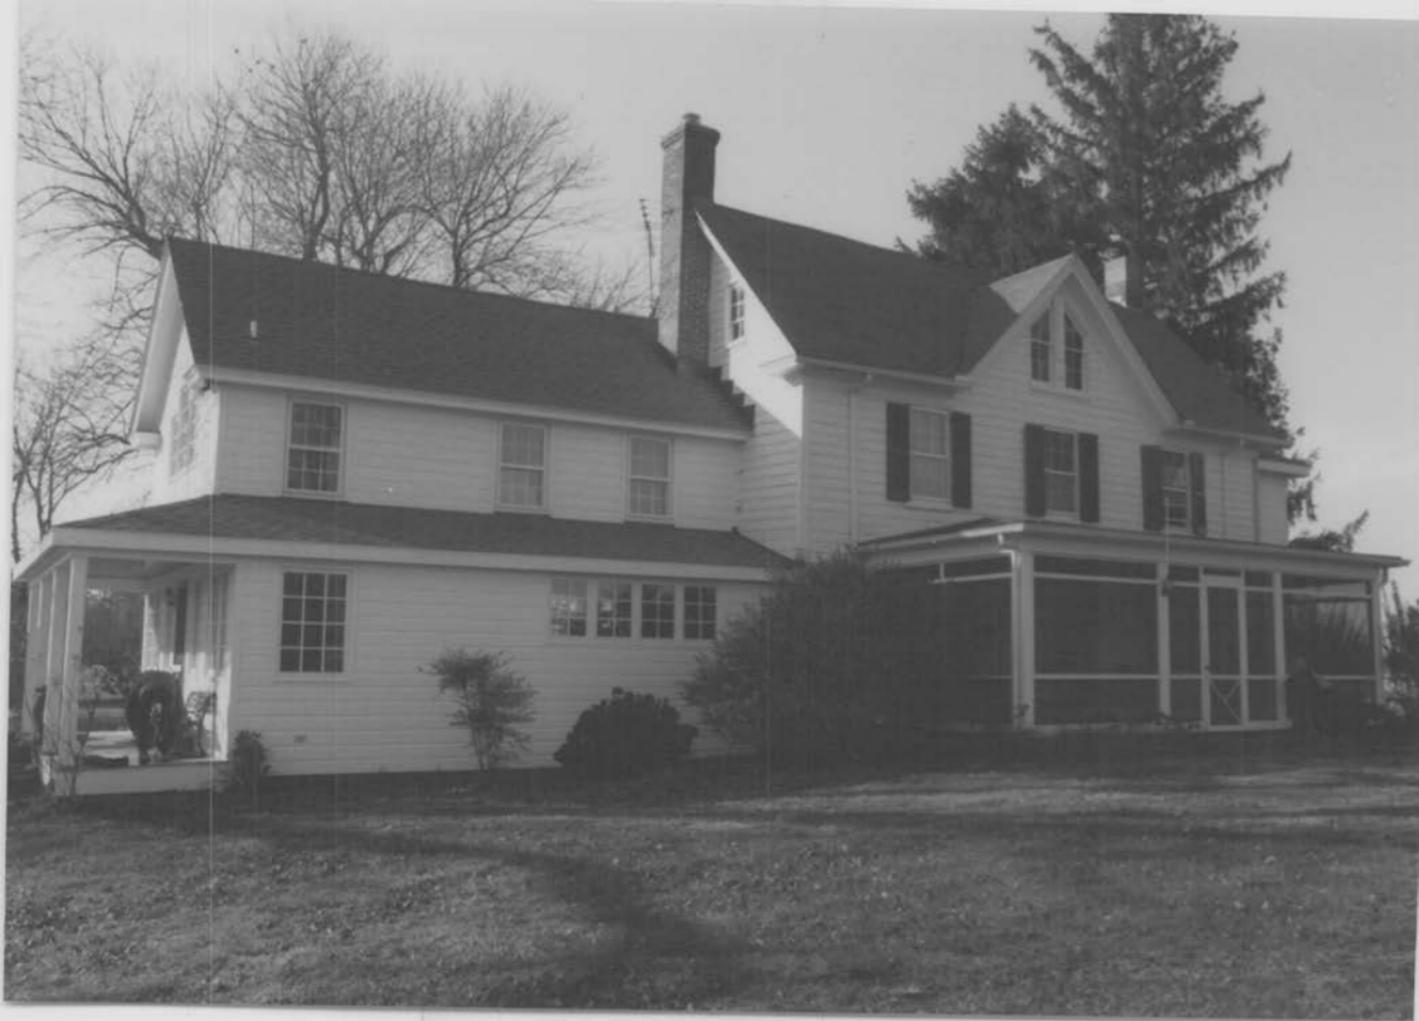
2/5

The house is a 2½-story wood frame vernacular building with a rectangular plan. The house appears to have been built in two stages. The older block is a rectangular cross-gabled two-story building on which has been built (to the southern side) a two-story frame gable roof addition. The original block, which was constructed on brick piers, has a screened entry porch with a hip roof and measures three bays by one bay. There are two external gable end brick chimneys. The western (principal façade) has symmetrical fenestration and a central cross gable with a lancet window. The house's original block has wood double hung sash (6/6 lights) windows with added metal storm windows. Clad by clapboard siding, the original block's roof has cornice returns and is clad by composition shingles.

House, east elevation

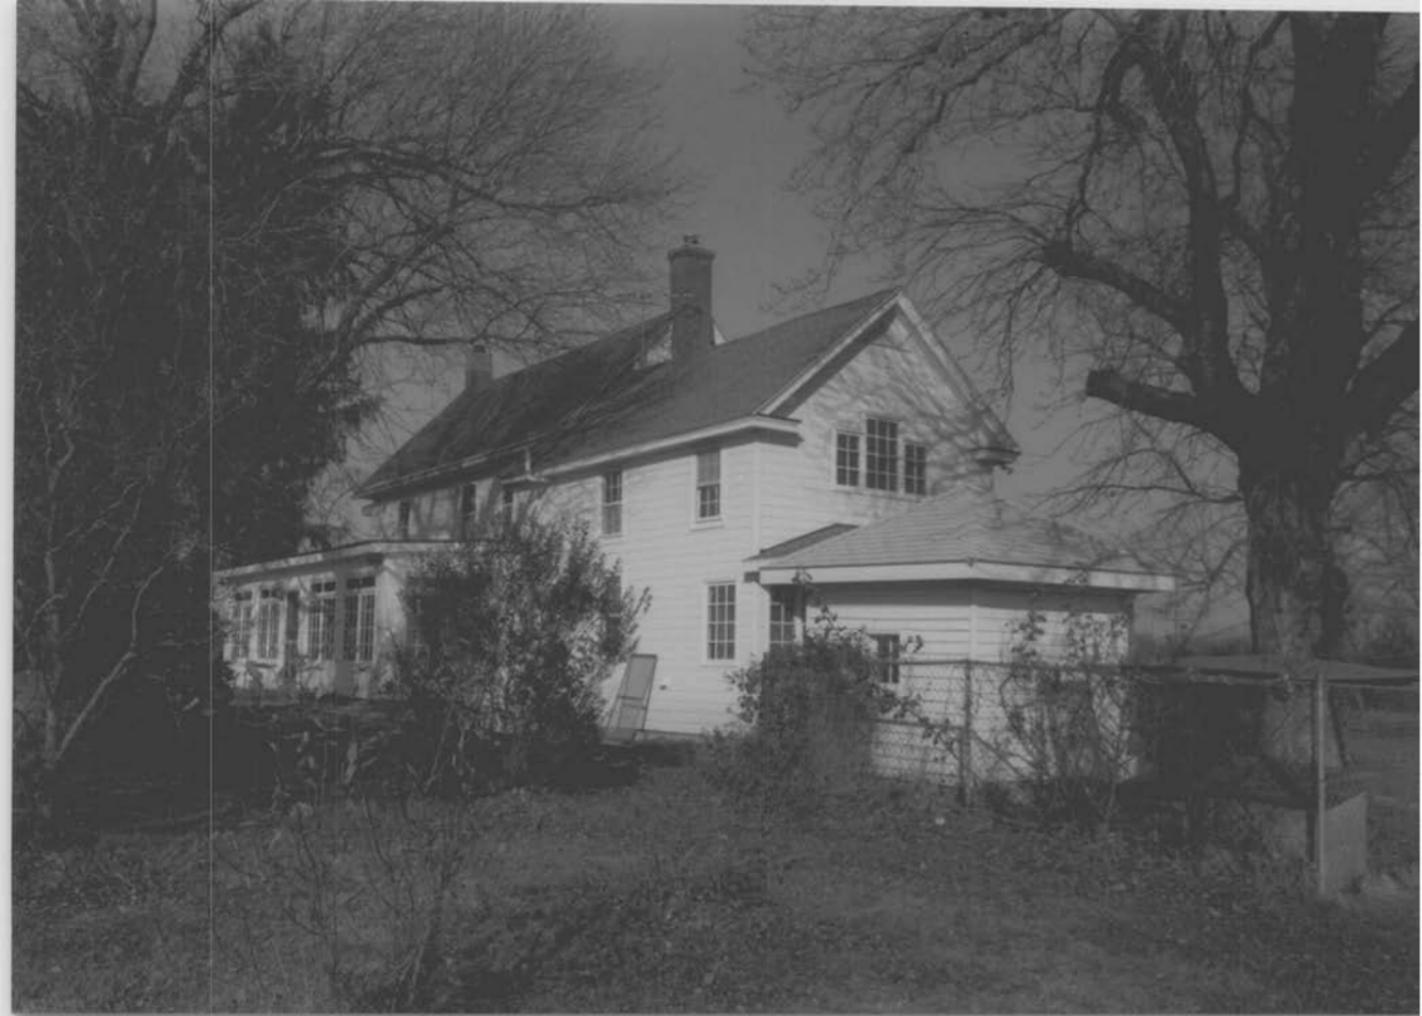
3/5

The two-story gable roof addition to the south has a partially enclosed wrap-around hip-roof porch and a gable end door. The porch is supported by square wood posts and windows in the addition include six-light casement windows and wood double hung sash (6/6 lights) windows. The addition is clad by wood drop siding and its roof, which has cornice returns, is clad by composition shingles. According to the owner, the southern addition was once a separate building located on another part of the farmstead that was moved by a former owner and added to the main house.

House: West elevation
and rear/side
additions

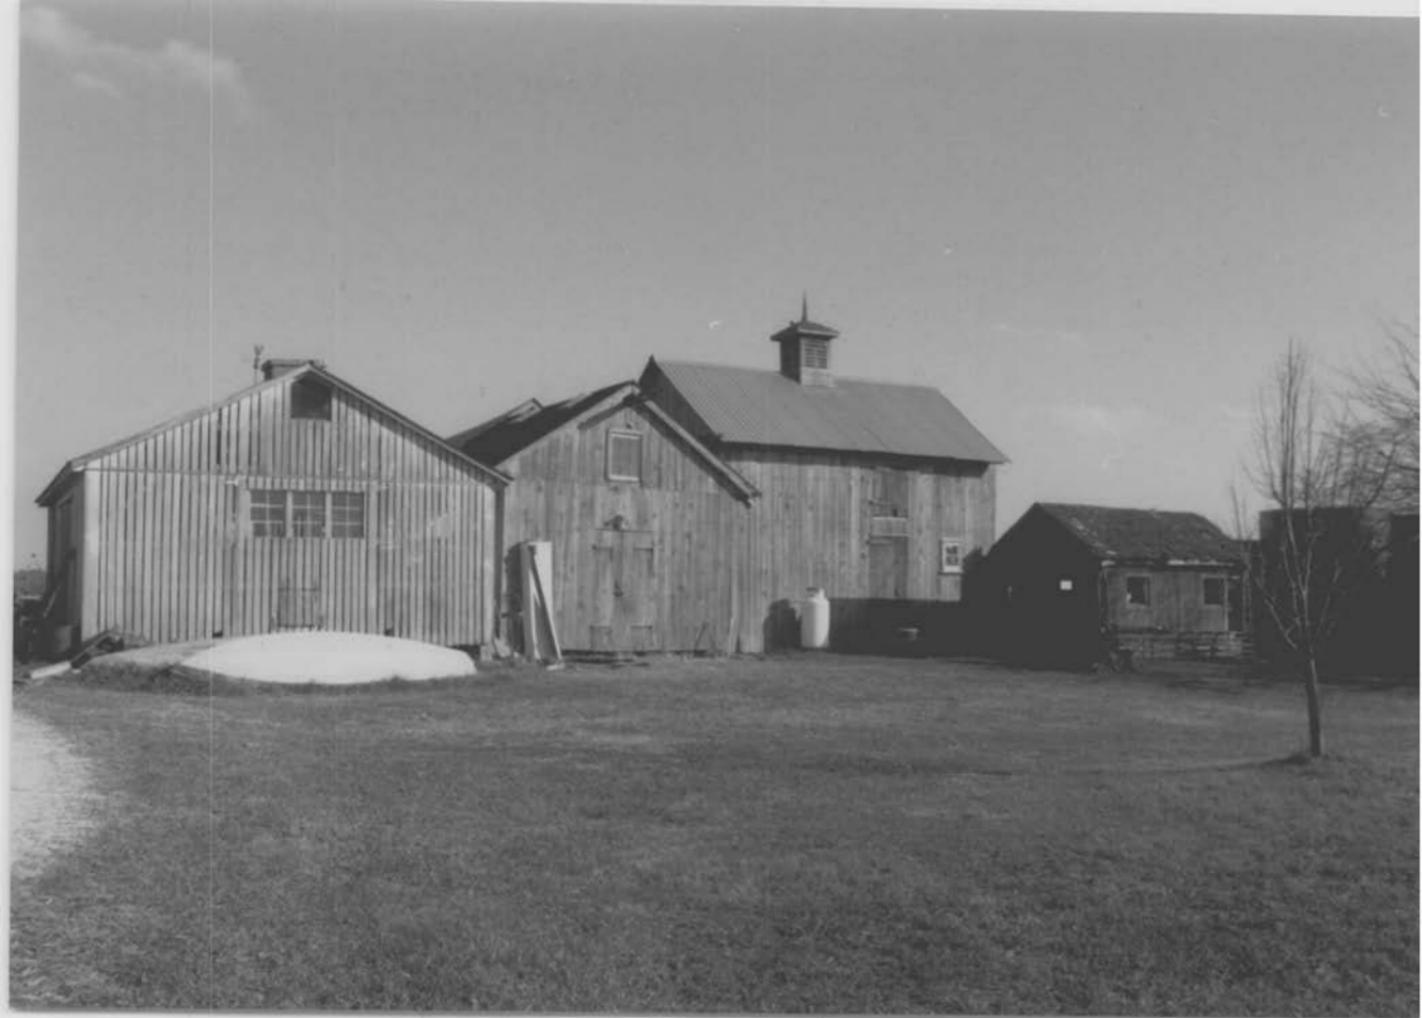
4/5

To the south of the house is a complex of wood frame agricultural buildings and the ruins of a rockfaced concrete block barn. The outbuildings include a gable roof stable clad by vertical wood plank siding with a corrugated metal roof and a louvered cupola ventilator. Adjacent to the stable are other wood frame buildings, including a corn crib and shed, as well as an open gable roof stable.

Agricultural buildings
cluster, view to
Southeast

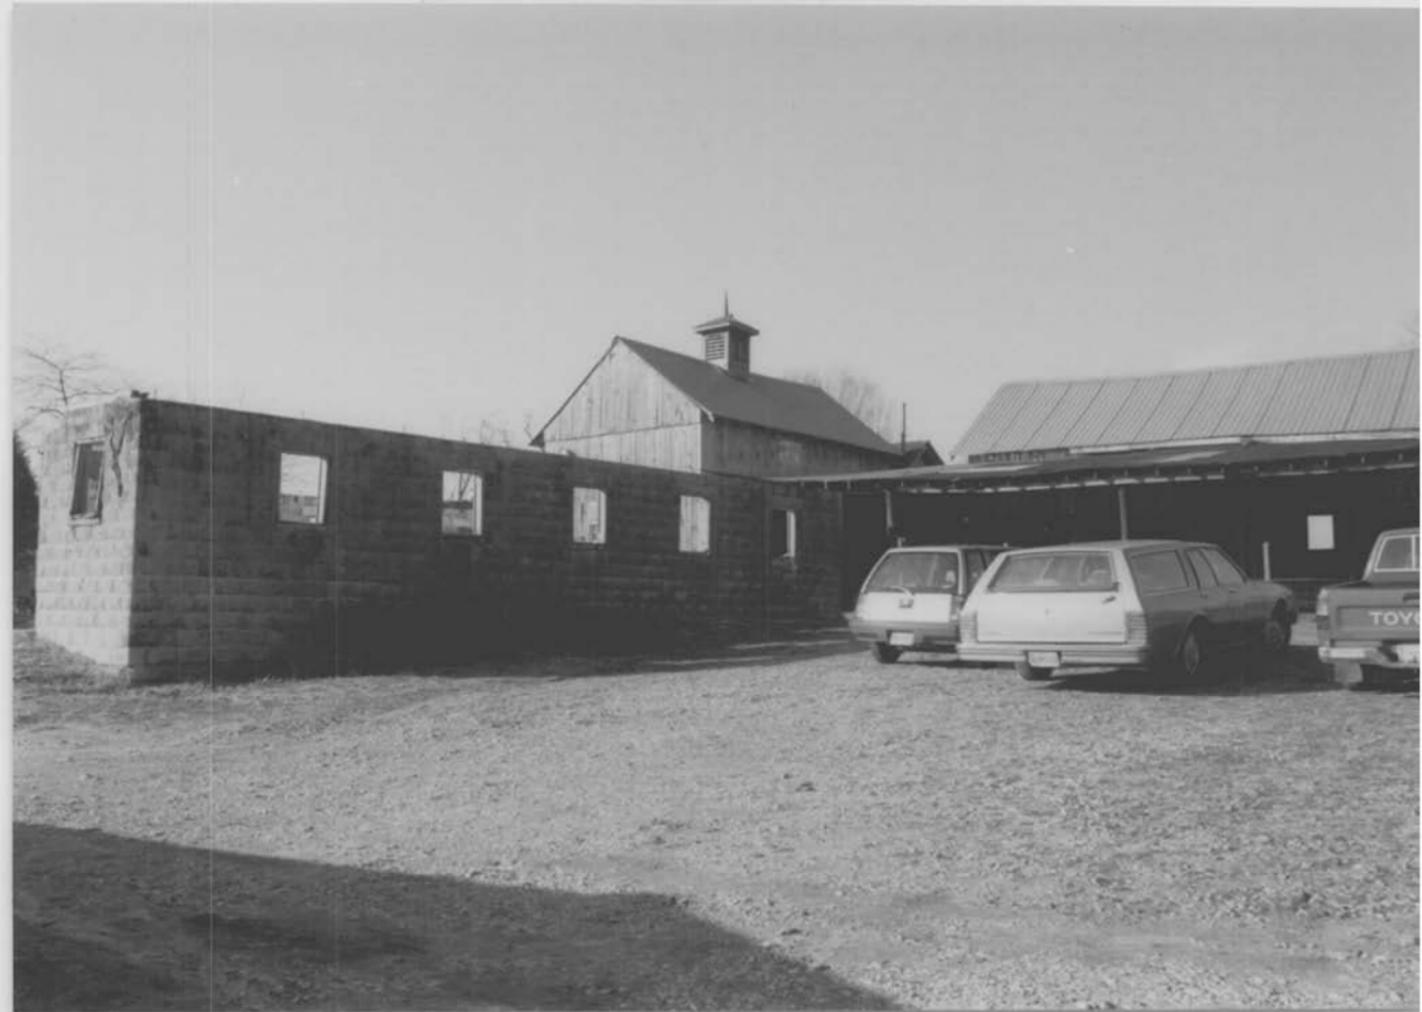
5/5

Agricultural Buildings,
view to Northwest
