Harrison's Florist
115 North Washington Street
Easton, Maryland 21601

T-23
c1795-1800

INVENTORY FORM FOR STATE HISTORIC SITES SURVEY

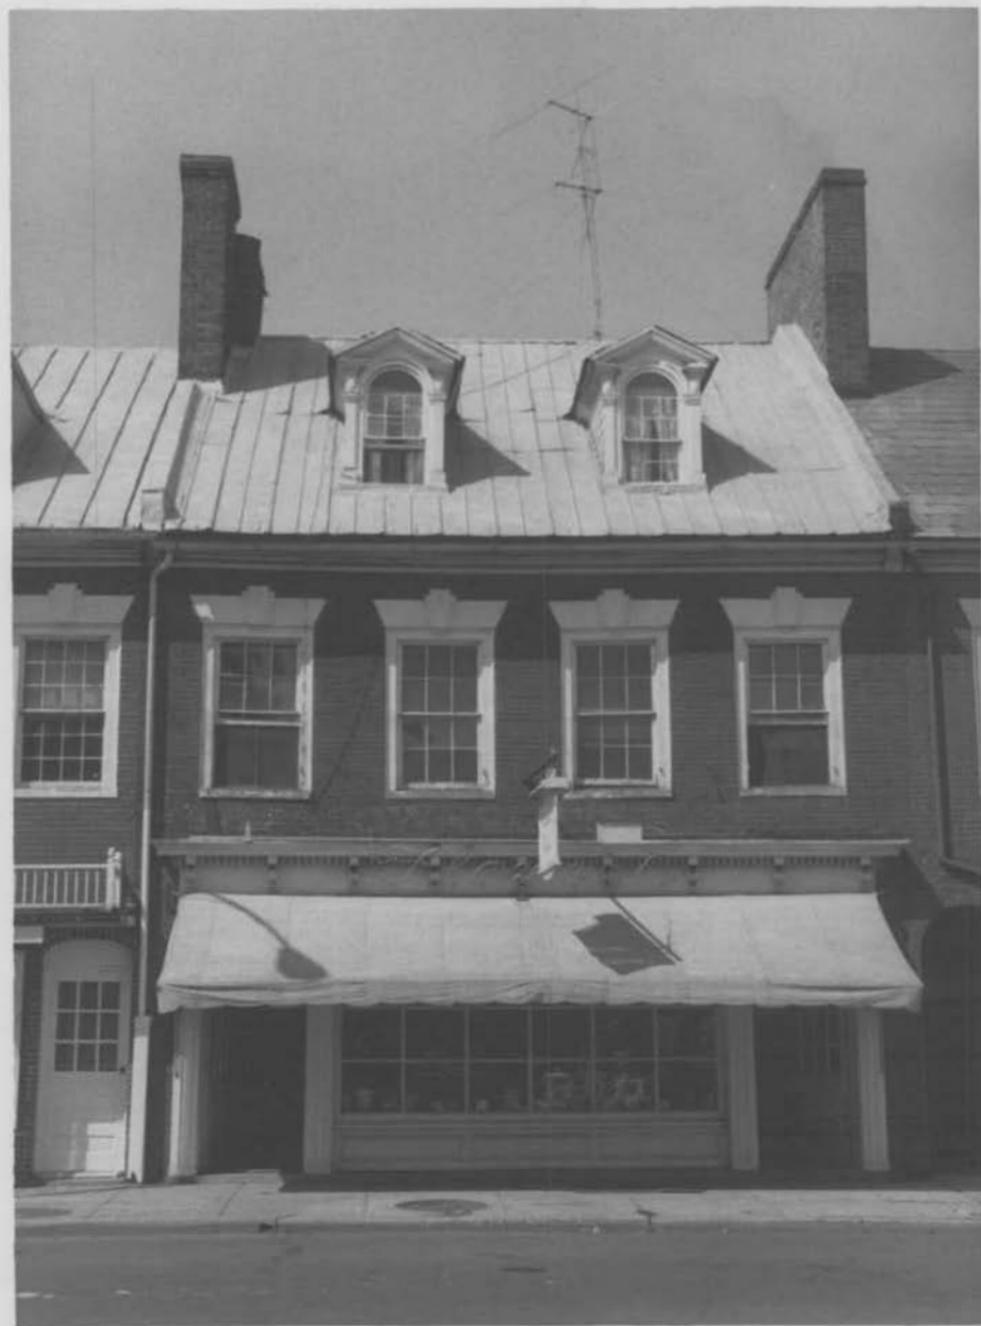
Harrison's Florist
113-115 North Washington street, Easton
East Parade

This is a four bay brick building, two-and-a-half stories in height. It is covered with a gable roof with two dormers in each roof slope. Two double chimneys at the south gable end have corbelled caps and are connected by a brick curtain. Brick roof curtains rise above the gable-end bearing walls and visually separate this building from its neighbors.

The Flemish bond brick of the front facade was laid with great skill; the narrow mortar joints are tooled into a bead. The bricks themselves are deep red in color and perfectly formed.

Windows are evenly spaced on the second floor. The openings are topped with stone double keystone arches, tooled in an elegant pattern of flutings and reedings. Frames trimmed with a bead and quarter-round back bond, hold six over six sashes.

Decorated gable dormers similiar to those at 119 North Washington, (T-24), the Perrin-Smith House show typical Federal detailing, especially in the fluted pilasters topped with a sunburst and the round-headed upper sashes. There is a cornice and return; beneath the cornice is a line of wood molding carved in an elaborate chain pattern.

The roof cornice, identical to that on the two adjacent structures and other of Easton's Federal buildings, has intricate carved wooden chain motif in the position of the bed moldings. It terminates in carved stone blocks.

On the first floor a twentieth century store front has replaced the original facade. A bracketed cornice surmounts a twenty-four-pane store window. There are entrance doors in the end bays. The first floor store has an attractive tin ceiling.

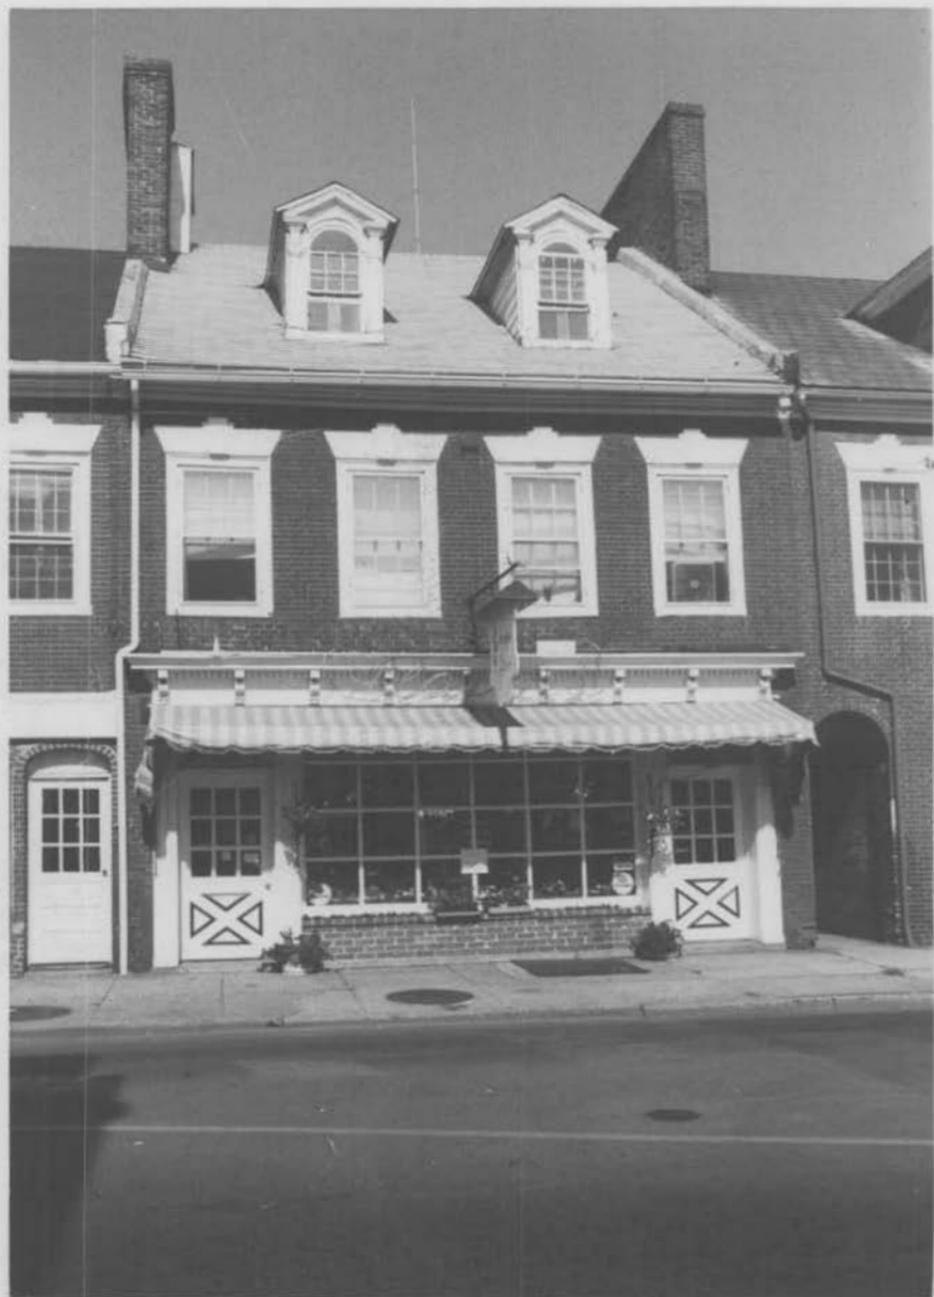
East Facade

T-23

115 NORTH WASHINGTON
STREET
