T-41

INVENTORY FORM FOR STATE HISTORIC SITES SURVEY

Lednum House

130 North Washington Street

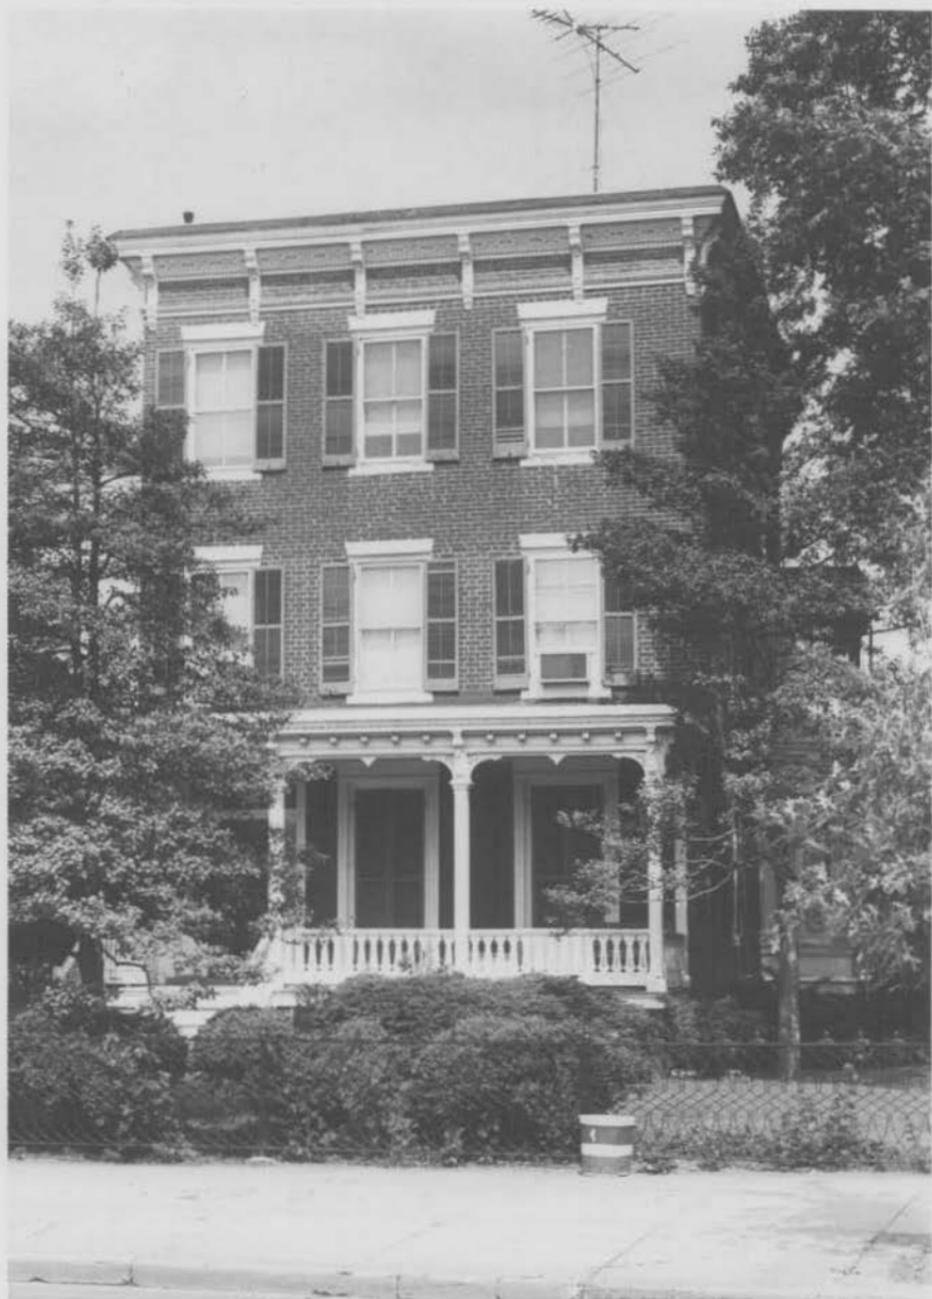
- WEST FAÇADE
- July 1976

The main portion of the dwelling faces west. Three stories in height, it is made to seem taller with a parapet wall with a cornice; there is a flat roof. To the rear, entered from the north side, center bay, is a two-and-a-half story ell. It is two bays in length and covered by a gable roof. A board and batten gable roofed outbuilding at the rear was constructed after 1877.

As it stands now, this is a Victorian townhouse which would appear to date from C1880. The bracketed cornice is of the type also seen on numbers Two and Four North Washington Street (T-401, T-402) and numbers 13 and 25 South Washington Street. (T-2, T-411). There are tall wooden brackets which are decorated by pierced work in a stylized floral pattern.

A one story porch runs across the front of the building. Its flat roof is carried by four square posts. Small pierced work brackets top the posts and the roof cornice has a line of small, closely spaced console-type brackets. The balustrade is a screen of fret work in a urn-like motif.

THE LEDNUM HOUSE
130 No. WASHINGTON STR.
EASTON, MD

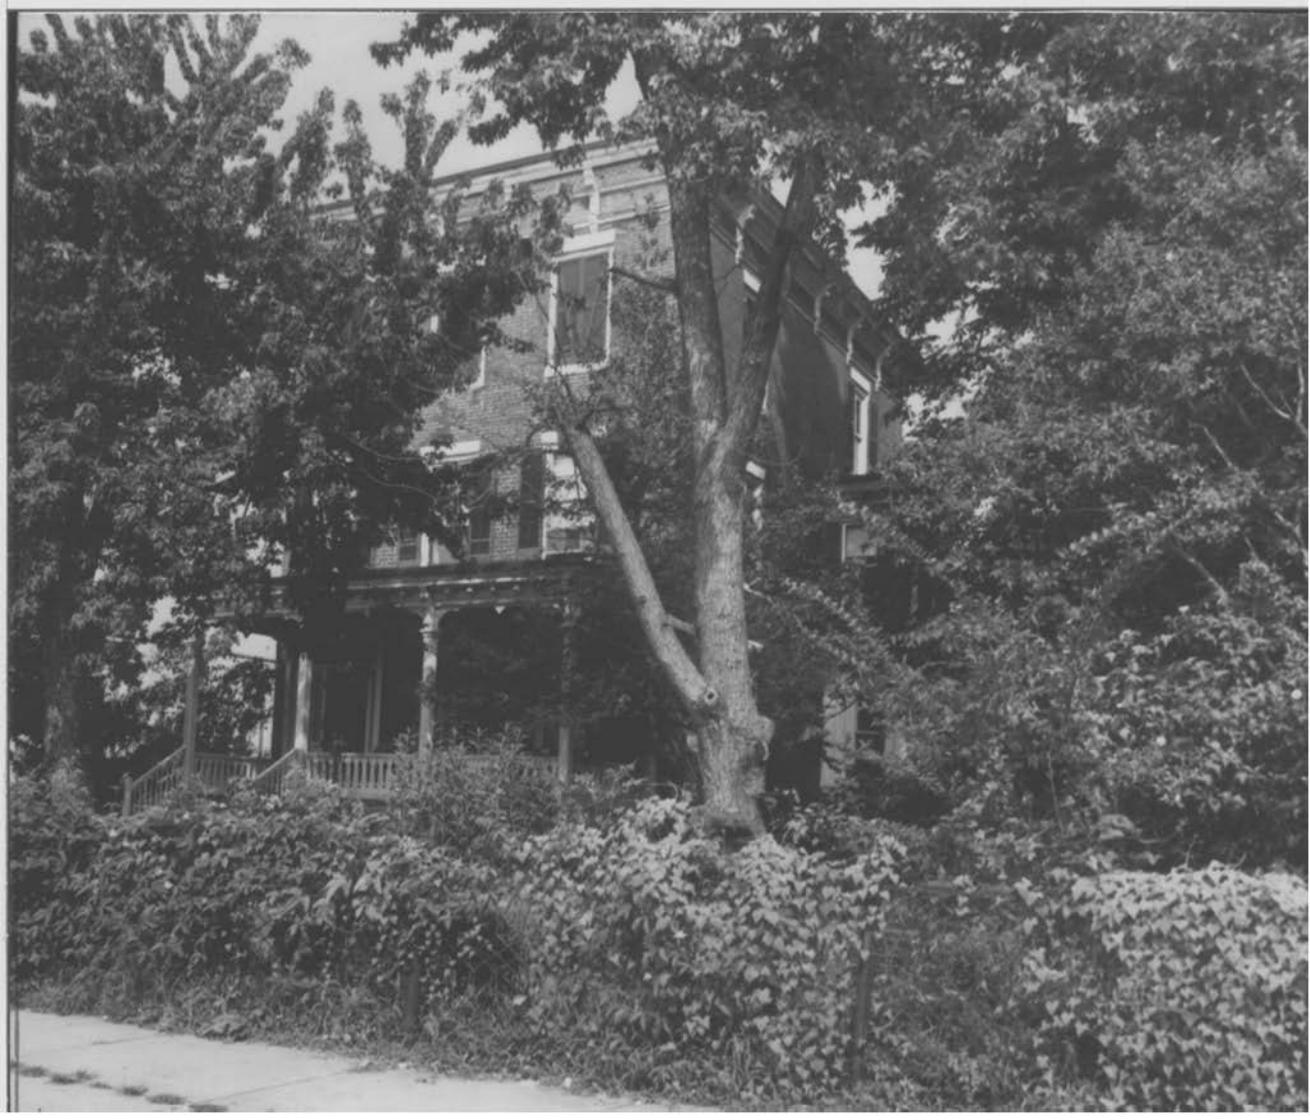
Southwest Facade

These openings are evenly spaced on all floors. The window trim on the upper floors is wide and flat and holds two over two sashes. On the first floor tall windows are surrounded by symmetrically molded trim with a cornice. Louvered shutters are found on all windows; those on the first floor frequently being used to close the windows. There is an octagonal bay window in the south facade, east, first floor.

Lednum House

130 North Washington Street, Easton
