T-~~478~~ 489
Defender House
Trappe vicinity
Private

Maryland Historical Trust State Historic Sites Inventory Form

and/or common Defender House

Survey No. T-489

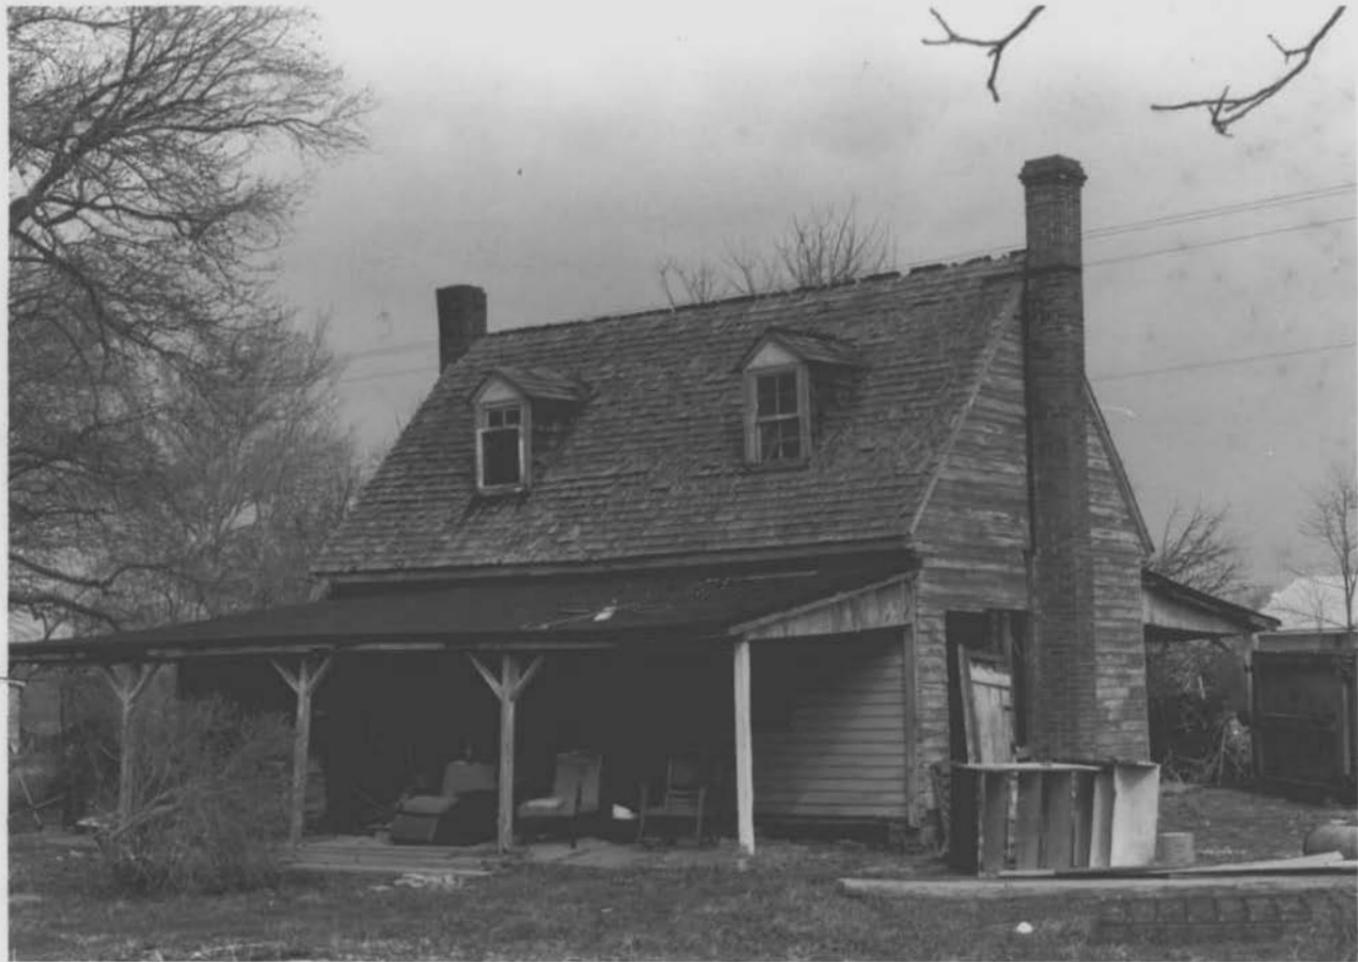
T-489 Defender House
Trappe vicinity
Orlando Ridout V March 1982
South Facade

The rear facade is similar to the front facade, with a door near the center flanked by a single 6/6 window on each side. There are two pitched roof dormer windows on this facade. The east dormer is fitted with early 4/4 sash; the west dormer has later 2/2 sash. Both dormers are trimmed with the ogee backband crown molding found on the front dormer. The majority of the siding has been replaced; the cornice and roof match the front facade.

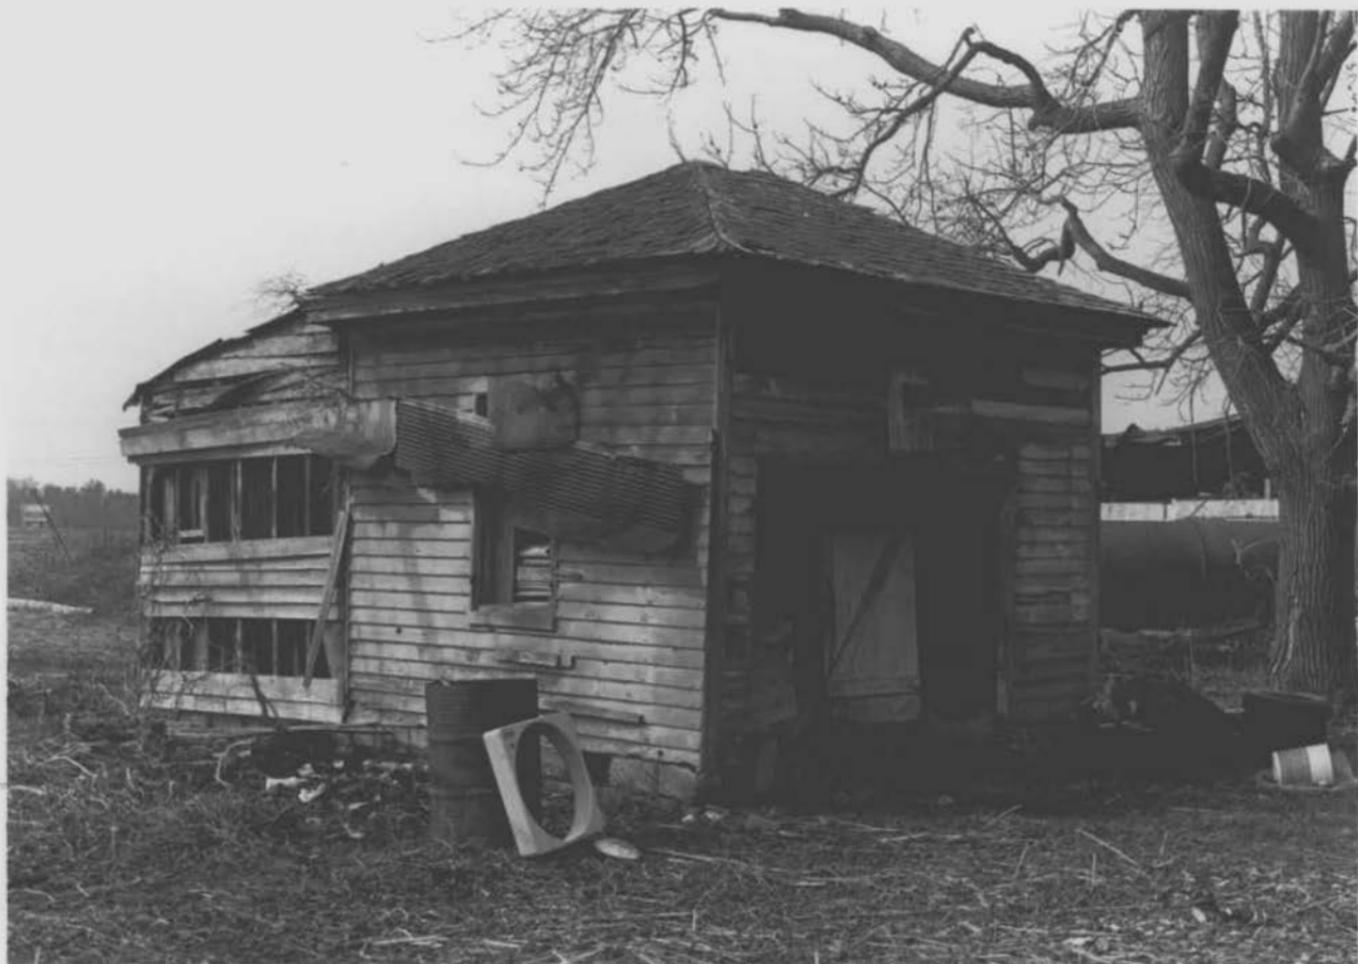
T-489 Defender House
Trappe vicinity
Orlando Ridout V March 1982
Outbuilding

Outbuilding: A small frame outbuilding is located approximately 50 yards to the south of the house. This building measures 12 feet by 13 feet and was also moved to this site, presumably from Trappe. This nearby square building with a hip roof has been altered by large openings cut in the north and south wall. Original window openings remain visible on the east and west walls. The eaves are boxed in and trimmed with a handsome complex crown mold of the

Greek Revival period and a smaller bed mold. The interior was plastered with machine sawn lathing secured with machine made nails. The framing members are circular sawn and the studs are close-set. An enclosed stair rises against the west wall to a small loft space. The original ceiling joists have been cut out and a later, lower ceiling has been inserted.

The original function of this building is unknown. The size of the building and the close-studding are typical of meat houses in this region, but the plastered walls and original windows suggest a more formal use such as an office. The circular sawn framing timbers, machine sawn lathing and Greek Revival cornice suggest a date of circa 1850s.

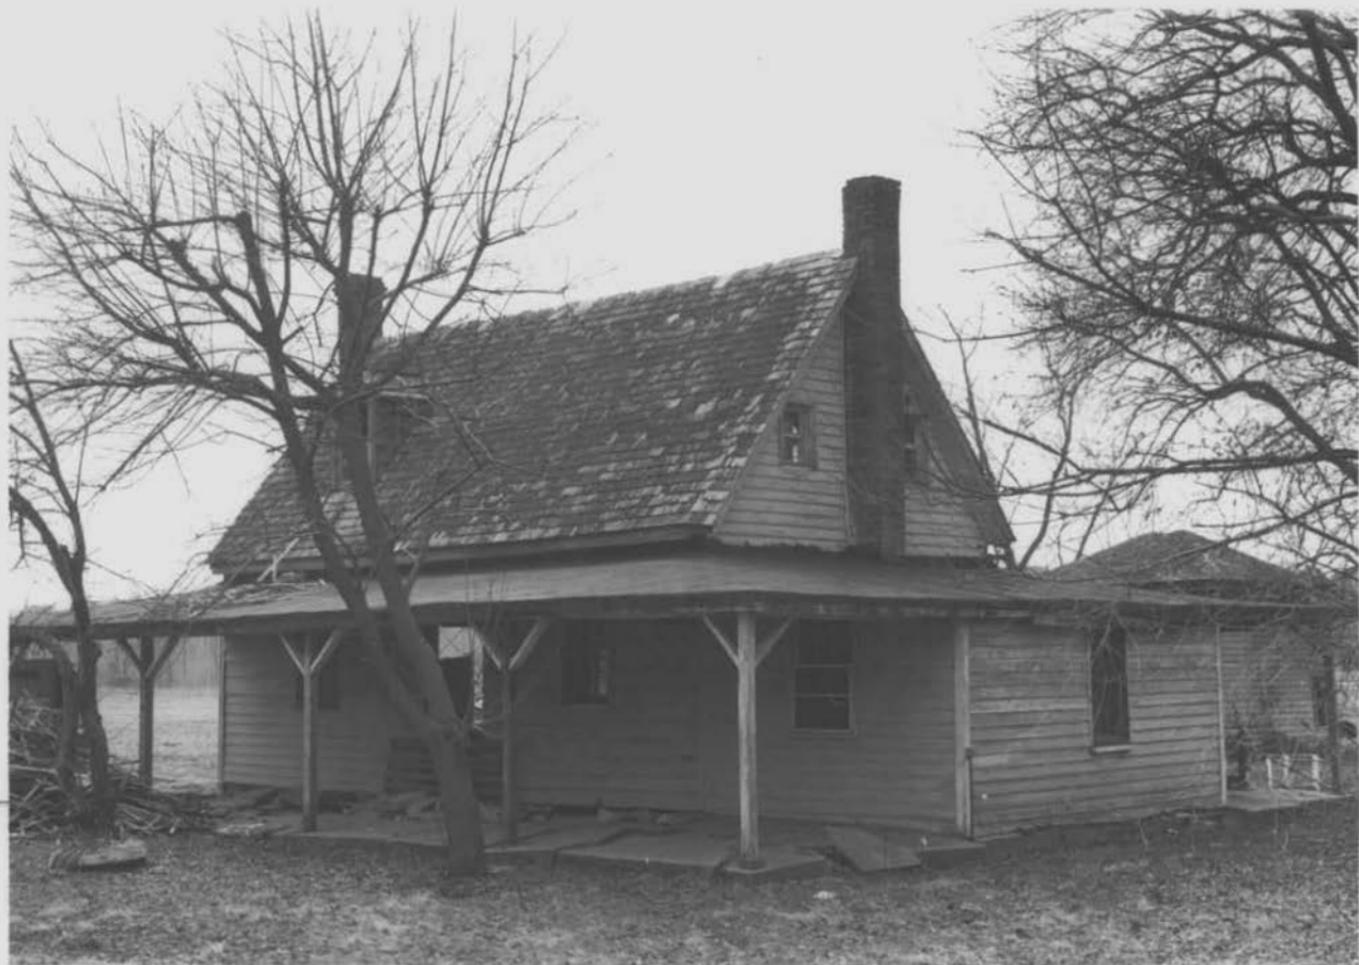
T-489 Defender House
Trappe vicinity
Orlando Ridout V March 1982
North Facade

The north or front facade of the house faces Back Town Road. The principal entrance is located in the center bay of this facade flanked by a single 6/6 window on each side. One pitched roof 4/4 dormer window is located in the east bay on the second floor. The windows are set in beaded frames. Early wide random-width weatherboard siding survives on the upper portion of this facade; the lower wall is sheathed with later plain siding. The eaves are boxed in and trimmed with a small crown mold applied against a beaded fascia; the roof is covered with wood shingles. The dormer window in the east bay is trimmed with an ogee backband trim framing the opening and a complex crown mold in the pediment.

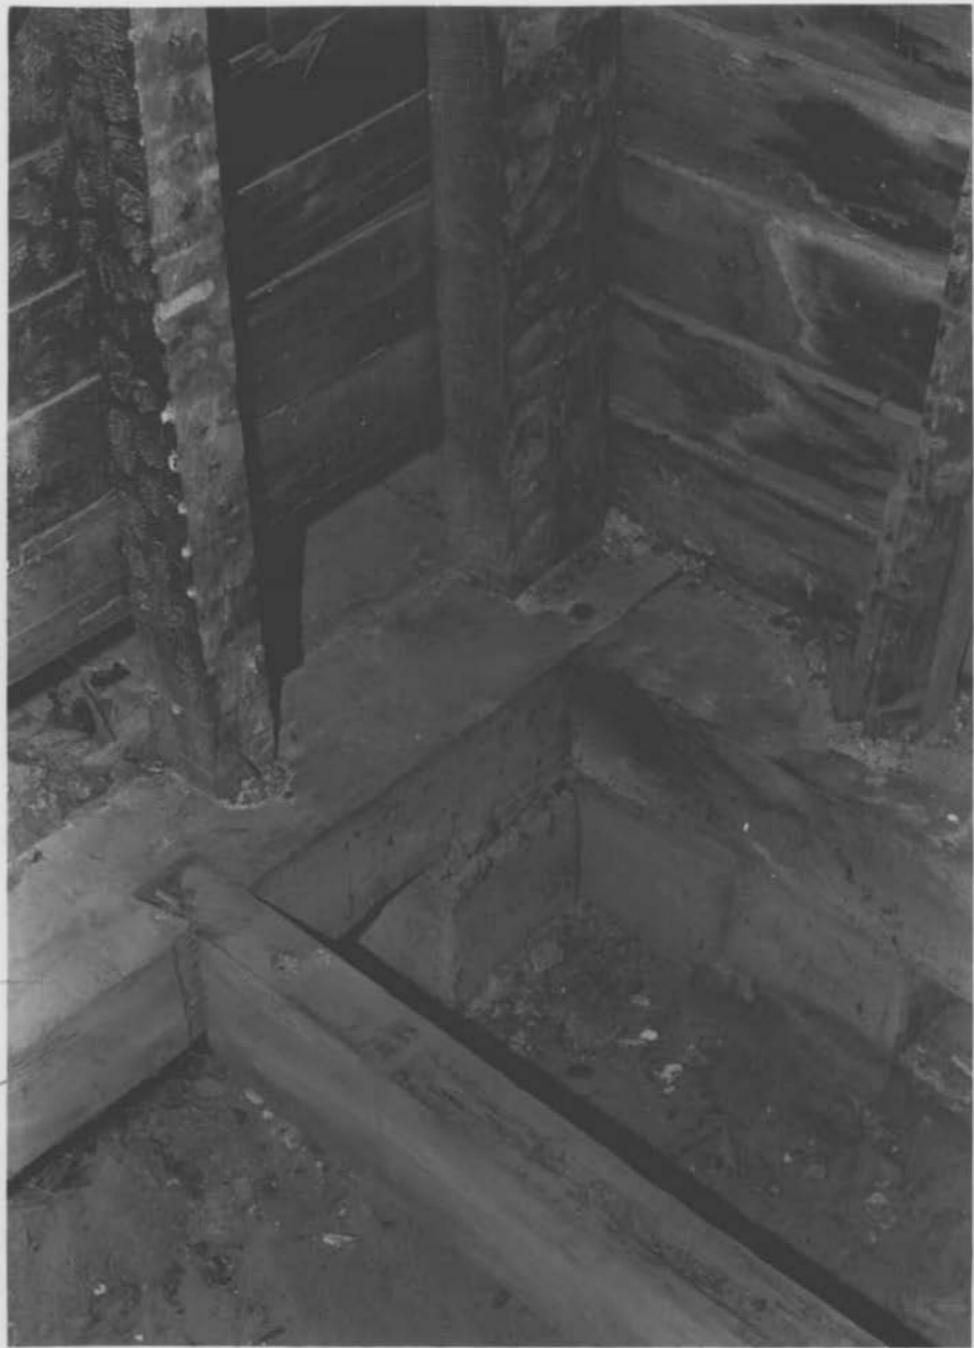
T-489 Defender House
Trappe vicinity
Orlando Ridout V March 1982
Dovetailed joints/sill
 connection

The interior framing of the house has been exposed by a renovation project now underway. The door and window openings on the front and rear facades and the east gable are clearly original, but the door in the west gable wall, opening into the lean-to, is cut-in. The first floor joists are dropped into sockets in the facade walls and are not pinned. Joists at either end and near the center of the building are dropped into dovetail slots, securely tying the frame together. The framing exposed in the first floor stair closet was whitewashed but never plastered. Early trim on the first floor includes beaded baseboard, beaded architrave trim with ovolo backband, and beaded window sills with a simple Federal nosing.

The renovation of the house now underway has exposed a number of interesting framing details, including clever dove-tailed joists that tie the front and rear walls together.
