T-73

## St. Joseph's Catholic Church

### **Architectural Survey File**

INVENTORY FORM FOR STATE HISTORIC SITES SURVEY

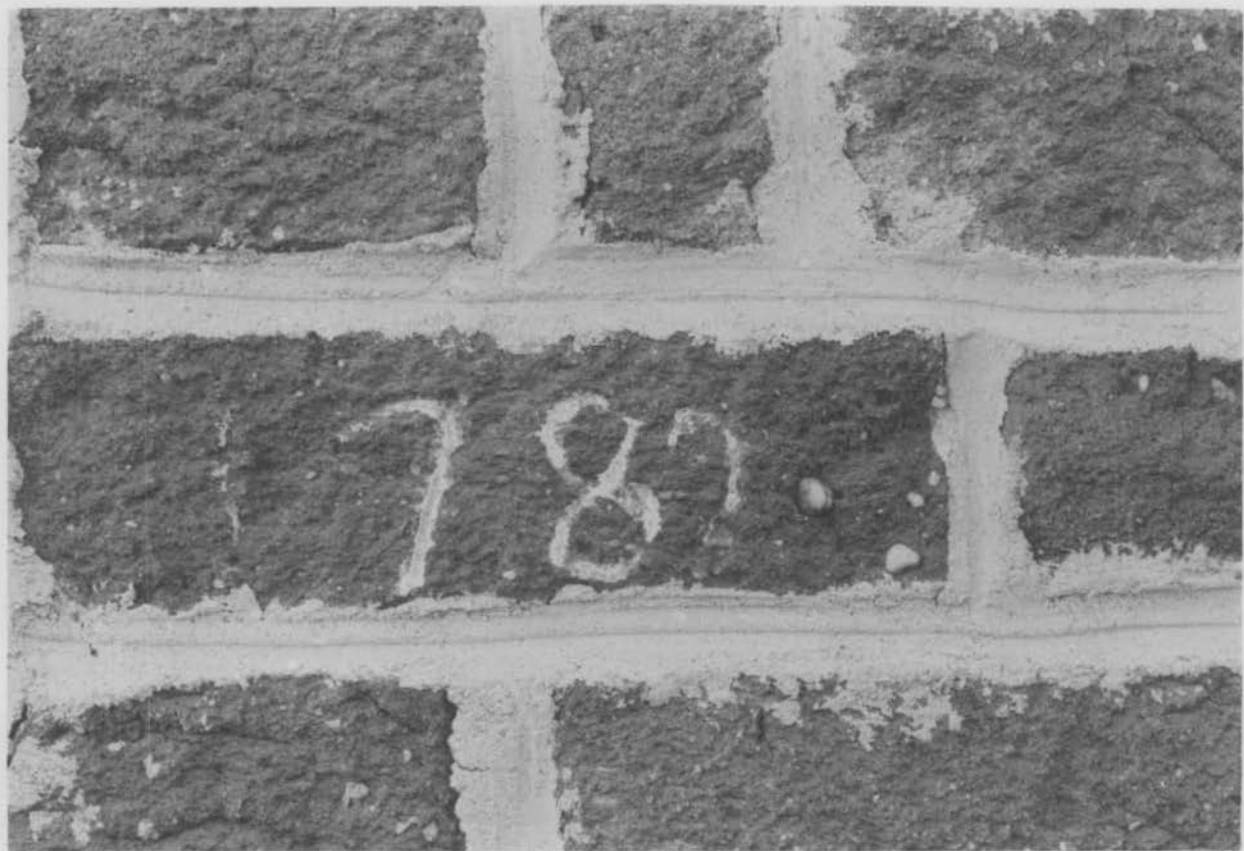
☞ N.W. elev.

In its present form, the church is an extension of a two story brick parsonage. The church is three bays long plus three semicircular additions creating a transept and upper arm of a cross. It is only one story in height and has a steeply pitched 'A' roof, conical on the three semicircular sections. Each of the latter sections has a single window with leaded stain glass sash. There is a chimney on the north side, otherwise the only other chimneys are in the parsonage. Three windows light the sides of the nave. The latter have semicircular arches.

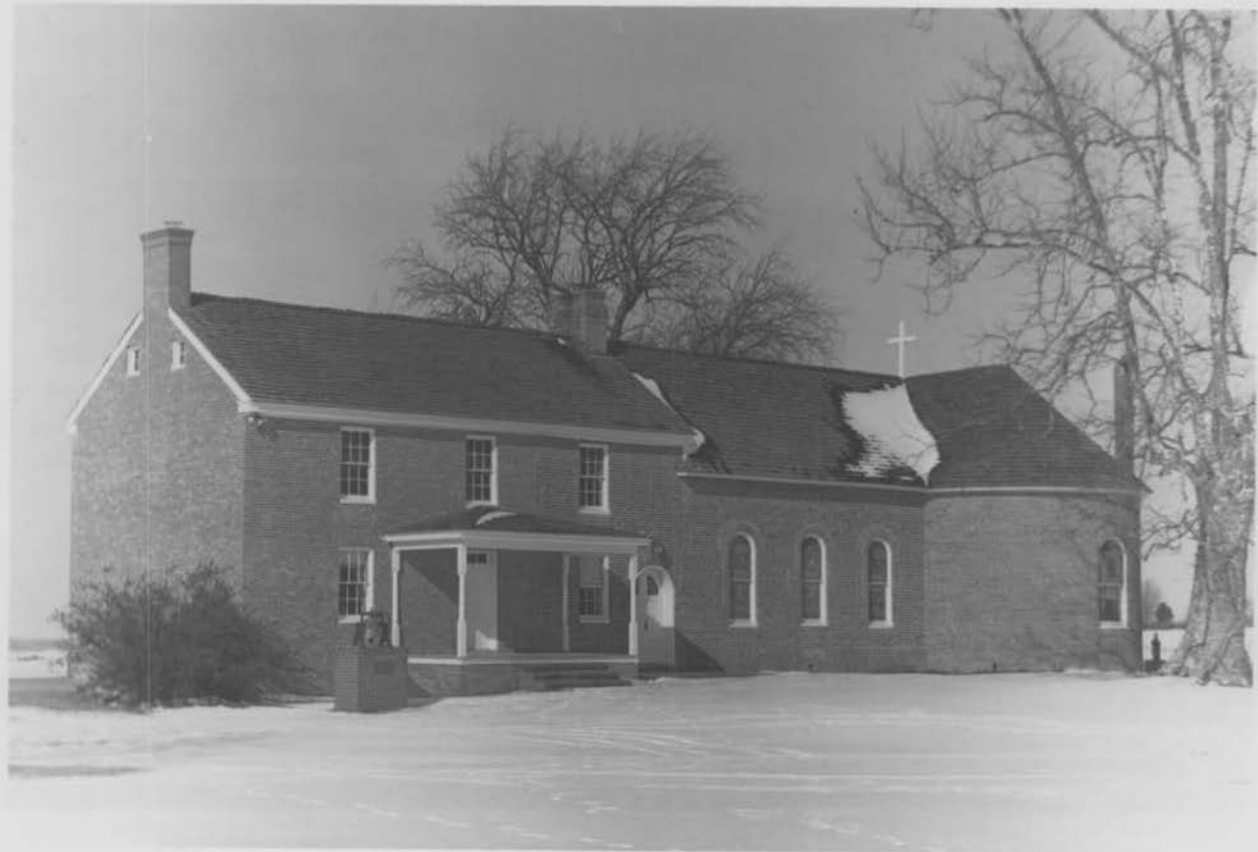
Photo # 1 of 2

St. Joseph Church and House seen from a South Eastern side of the building. The Photographer was facing North West.

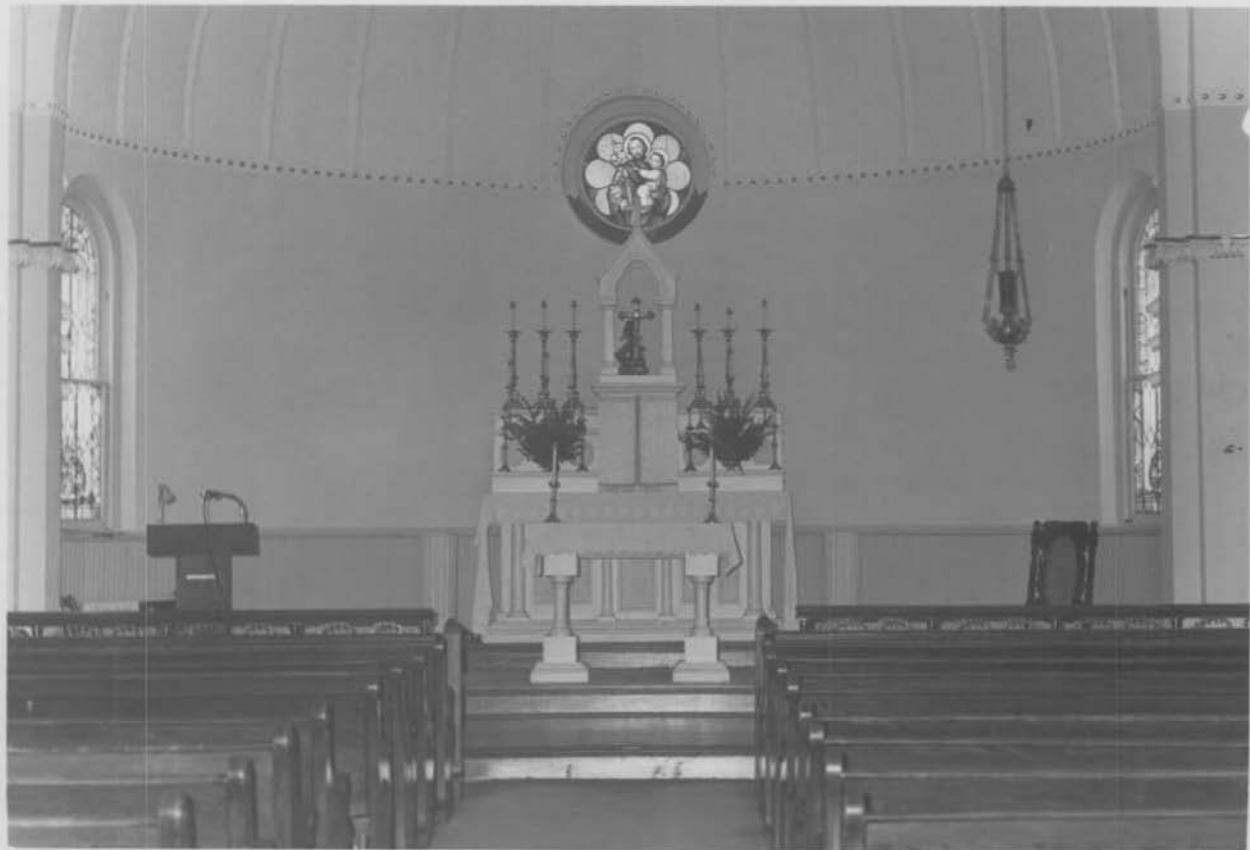
Photo 2 of 2

St. Joseph Church interior showing the Altar Section in the  
Cloverleaf section of the Church. The photographer was facing North
