T-765
Star of Bellevue Masonic Lodge
Bellevue
Private

Maryland Historical Trust State Historic Sites Inventory Form

historic STAR OF BELLEVUE MASONIC LODGE #86

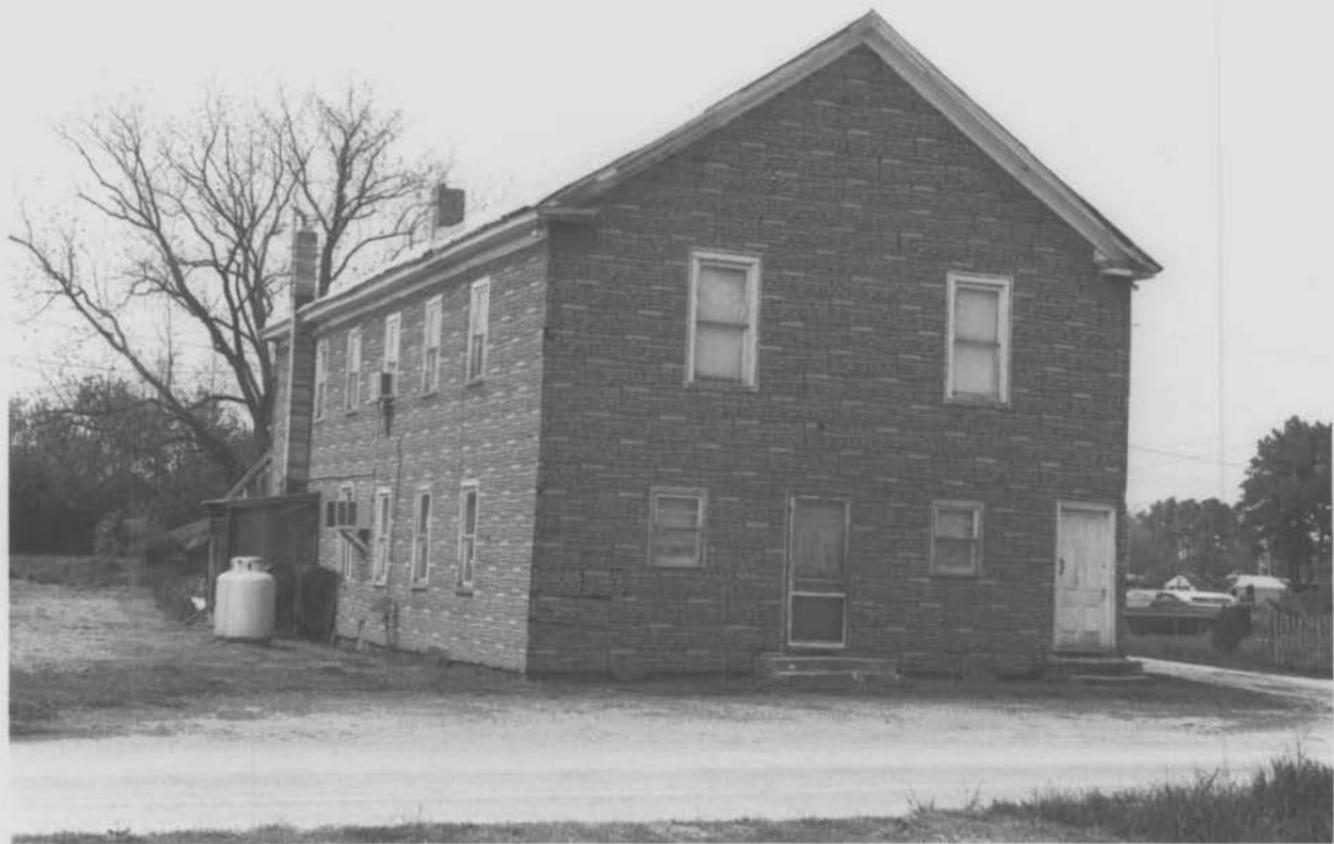
T-765

The southeast (main) elevation is an asymmetrical facade with an off-center front entrance as well as a side entrance flanked by small replacement windows. The second floor, on the other hand, is marked by two evenly spaced single-pane sash windows. The eaves to the roof are slightly extended with short returns at the base.

Southeast elevation
