T-772
Knights of Pythias Lodge
Bellevue
Private

Resource Name: KNIGHTS OF PYTHIAS LODGE

MHT Inventory Number: T-772

Maryland Historical Trust State Historic Sites Inventory Form

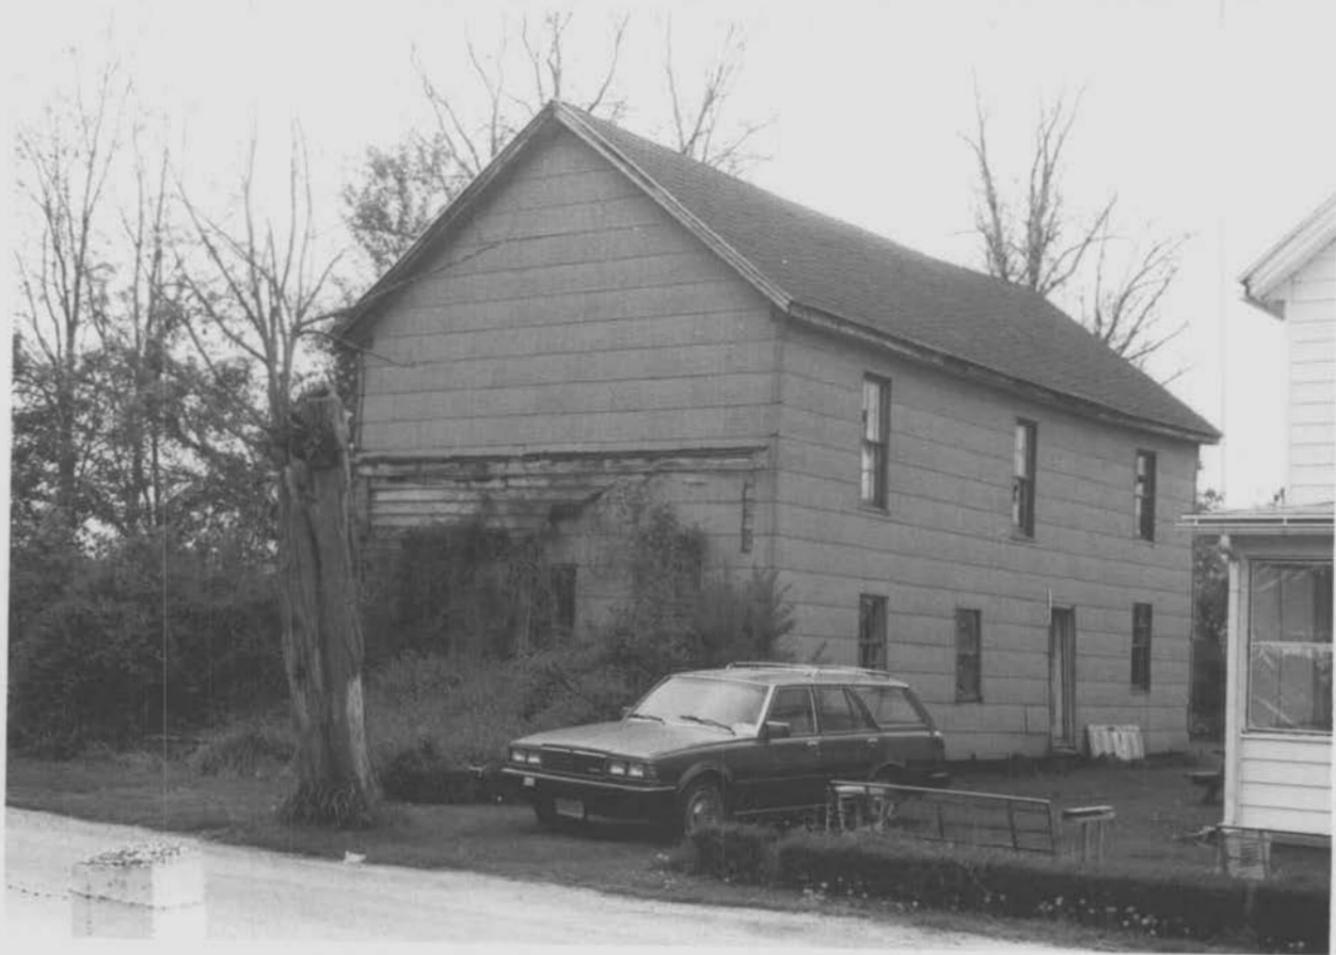
T-772

The southeast (main) elevation is a three-bay facade with a center entrance and flanking six-over-six sash windows. Fixed in the center entrance is a partially glazed front door, under the collapsed front porch. The second floor is blind wall, and the eaves to the roof are slightly extended.

Southeast elevation
