T-780  
Thomas Mills House  
Bellevue  
Private

# Maryland Historical Trust State Historic Sites Inventory Form

and/or common THOMAS MILLS HOUSE

Survey No. T-780

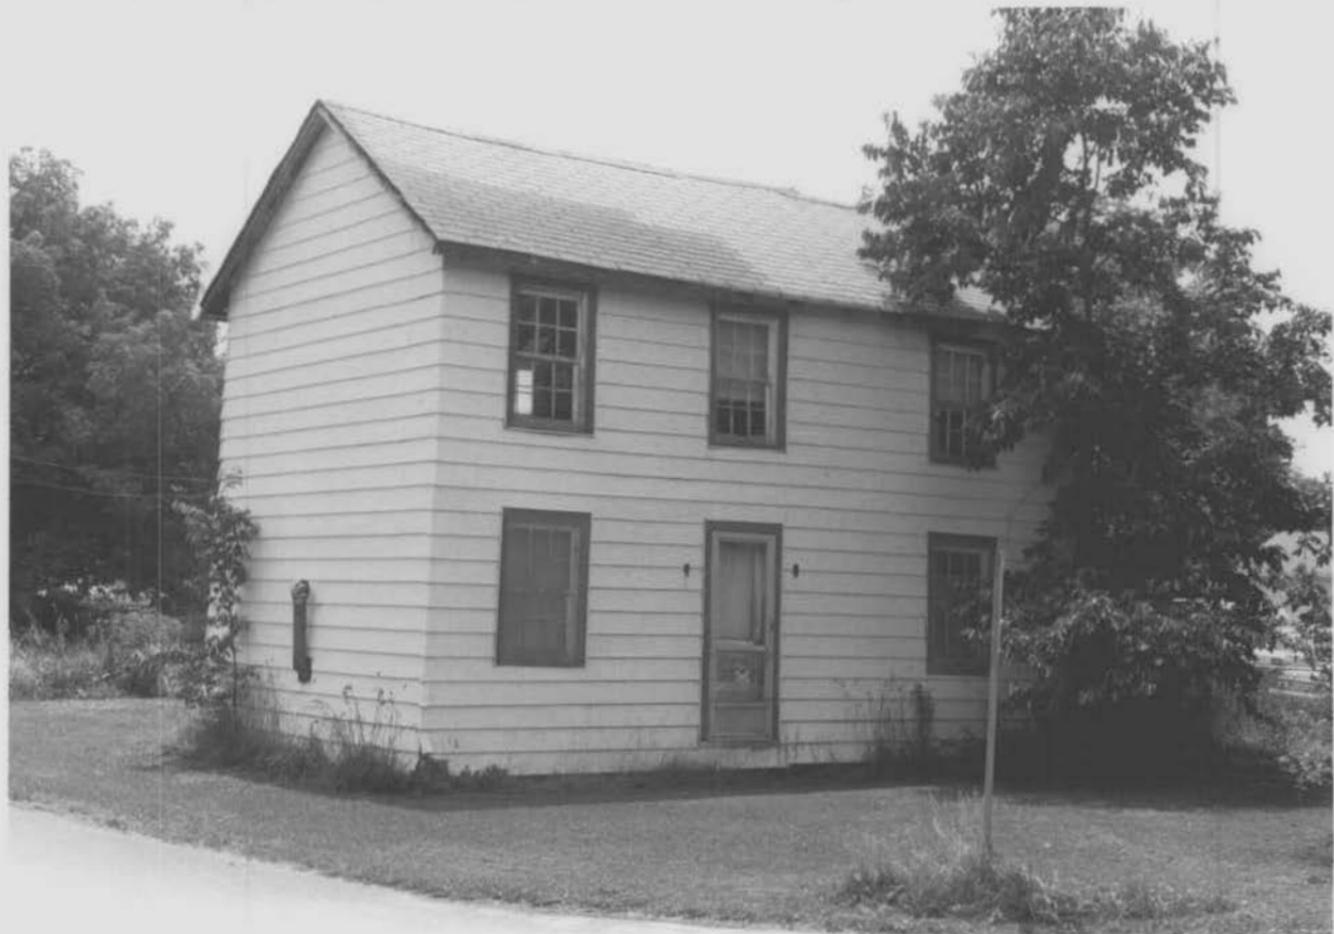
T-780

The northeast gable end is a blind wall surface with a stove flue protruding at the first floor level. The southwest gable end, on the other hand, is pierced by single six-over-six sash windows on each floor. The edge of the roof is slightly extended beyond the wall surface.

Northeast elevation

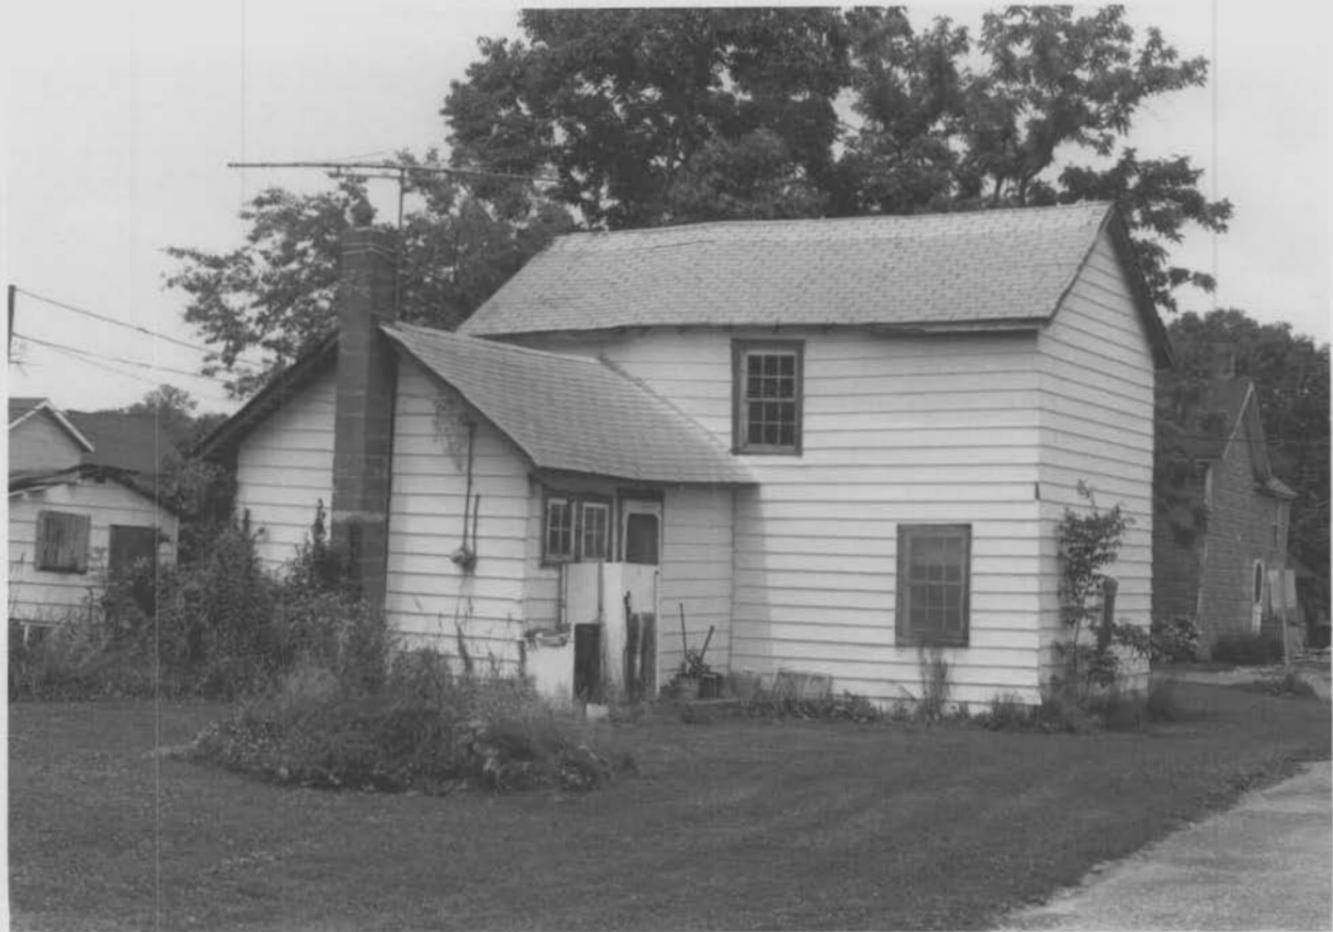
T-780

The southeast (rear) elevation is partially covered by the single story kitchen wing. A partially glazed side door allows access from the east, and an exterior block stack rises against the south end.

Southeast elevation
