T-806
Deshields United Methodist Church
Copperville
Private

Maryland Historical Trust State Historic Sites Inventory Form

historic DESHIELDS M. E. CHAPEL

and/or common DESHIELDS UNITED METHODIST CHURCH

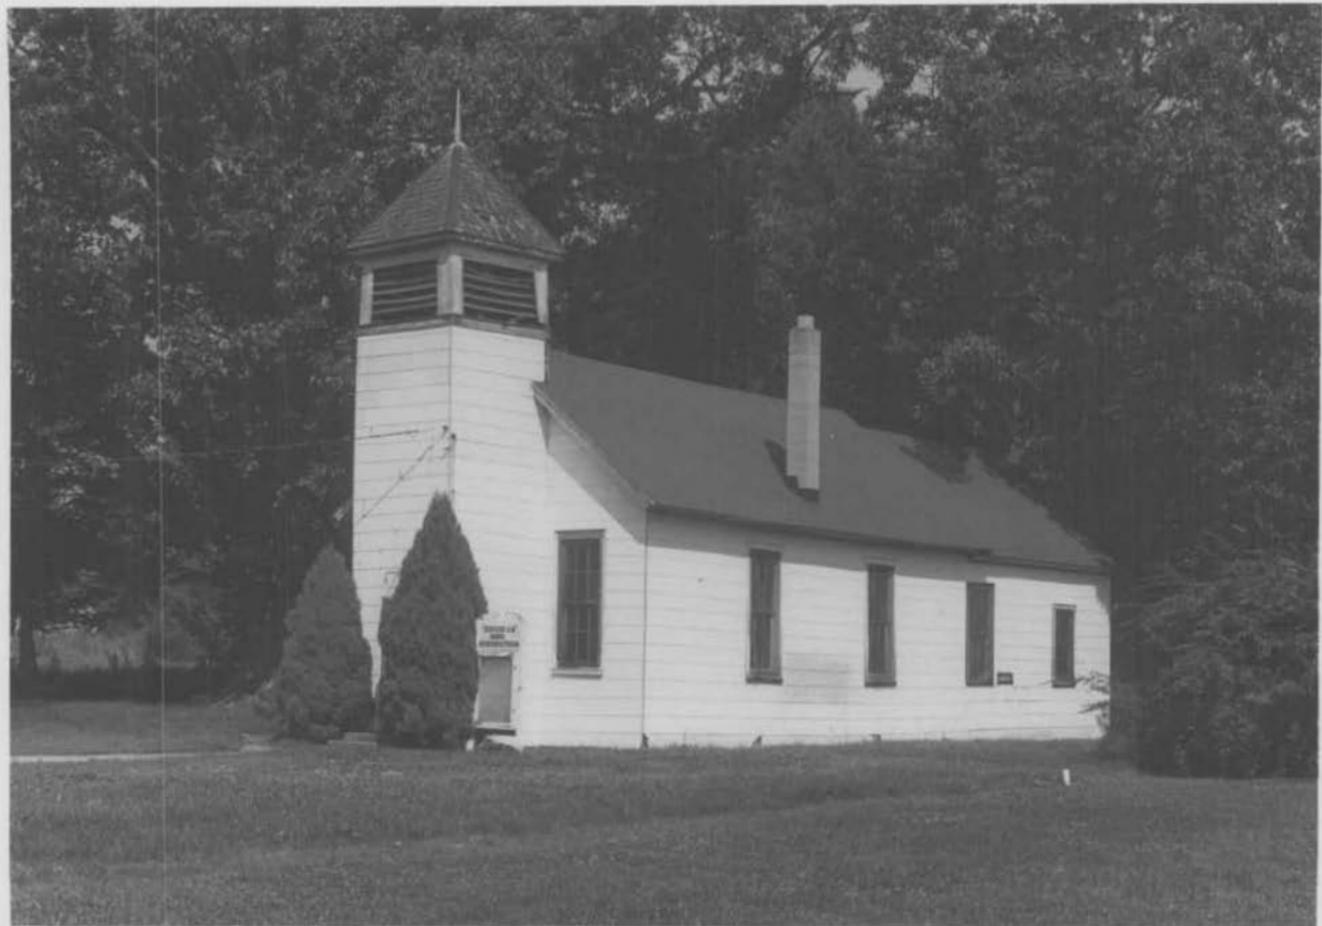
Southwest elevation

The northwest elevation is dominated by the entrance tower and flanking six-over-six colored glass windows. The belfry is finished with large louvered openings on each side, and a tapered wooden spire rises from the peak of the pyramidal roof. Fixed in the southwest corner of the foundation is the marble datestone that is inscribed, "Dashields M. E. Chapel, 1895."

Each side of the of the church is defined by two six-over-six colored glass sash windows that light the sanctuary.

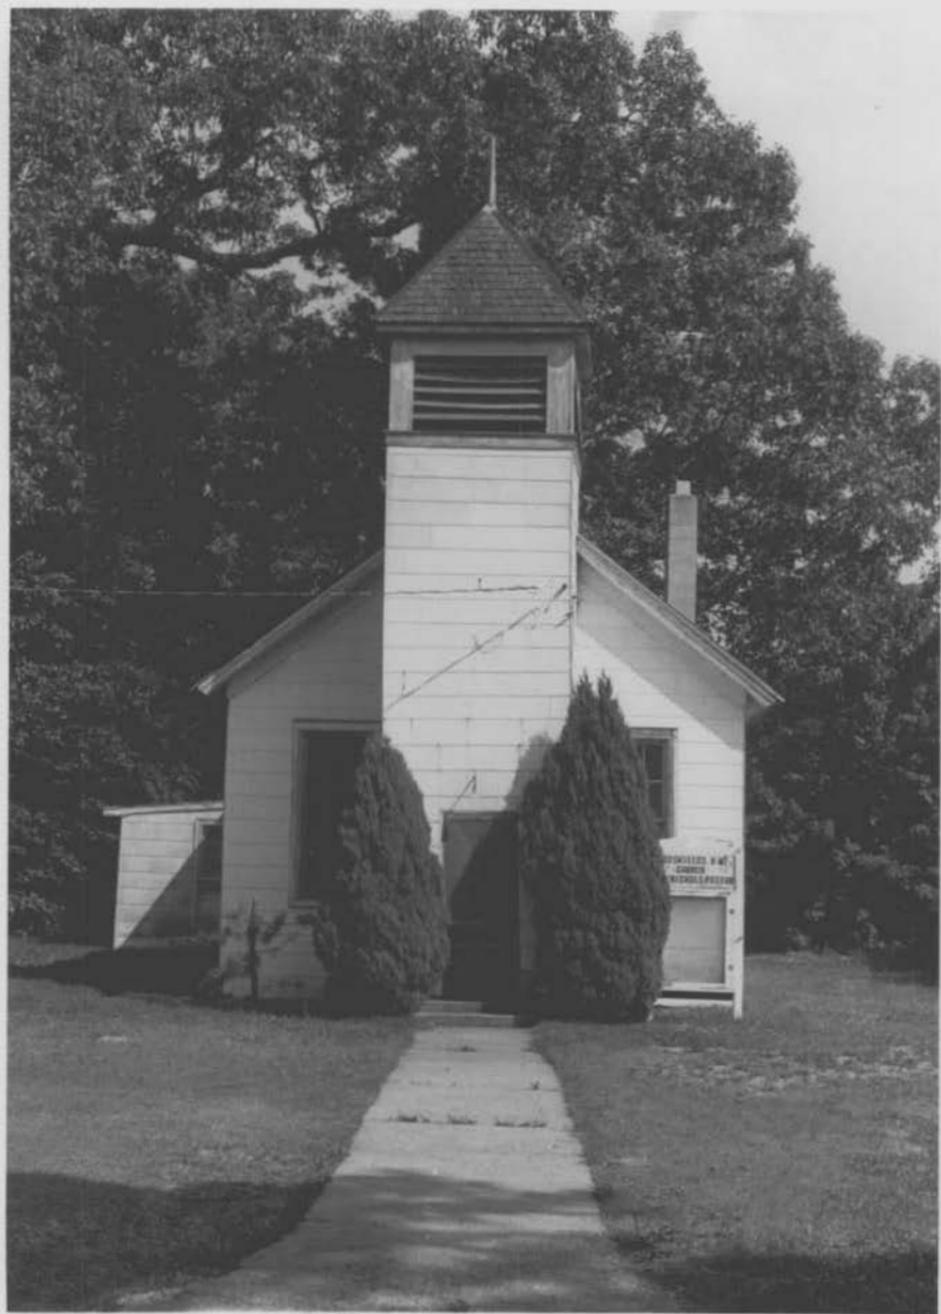
DESHIELDS UNITED METHODIST CHURCH
Copperville, Talbot County, Maryland
West elevation
6/90, Paul Touart, photographer
Negative/MD Historical Trust

Erected in 1895, the frame church is supported on a low brick pier foundation, and the building is sheathed with asbestos shingles. The steeply pitched gable roof is covered with asphalt shingles. Rising in the center of the northwest (main) elevation is a entrance and bell tower topped by a wood shingled pyramidal roof.
