T-807
Laura Miller House
Copperville
Private

Resource Name: LAURA MILLER HOUSE

MHT Inventory Number: T-807

Maryland Historical Trust State Historic Sites Inventory Form

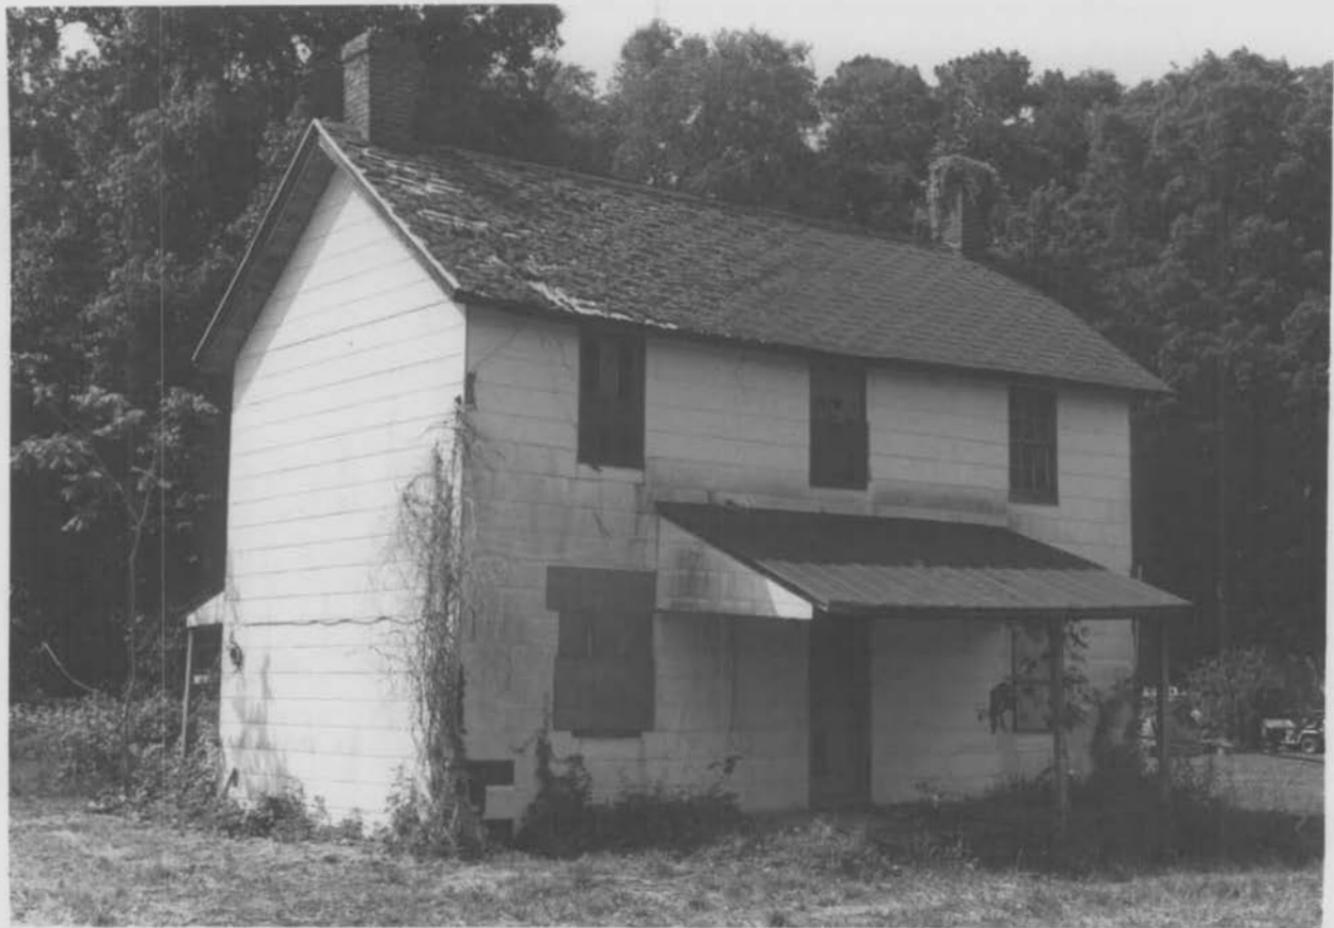
Southeast elevation

The southeast (main) facade is a three-bay elevation with a center four-panel door and flanking boarded over windows. The front door is sheltered by a single-bay porch supported on square posts. Lighting the second floor are three six-over-six sash windows.
