T-810
John Moody House
Copperville
Private

Resource Name: JOHN MOODY HOUSE

Maryland Historical Trust State Historic Sites Inventory Form

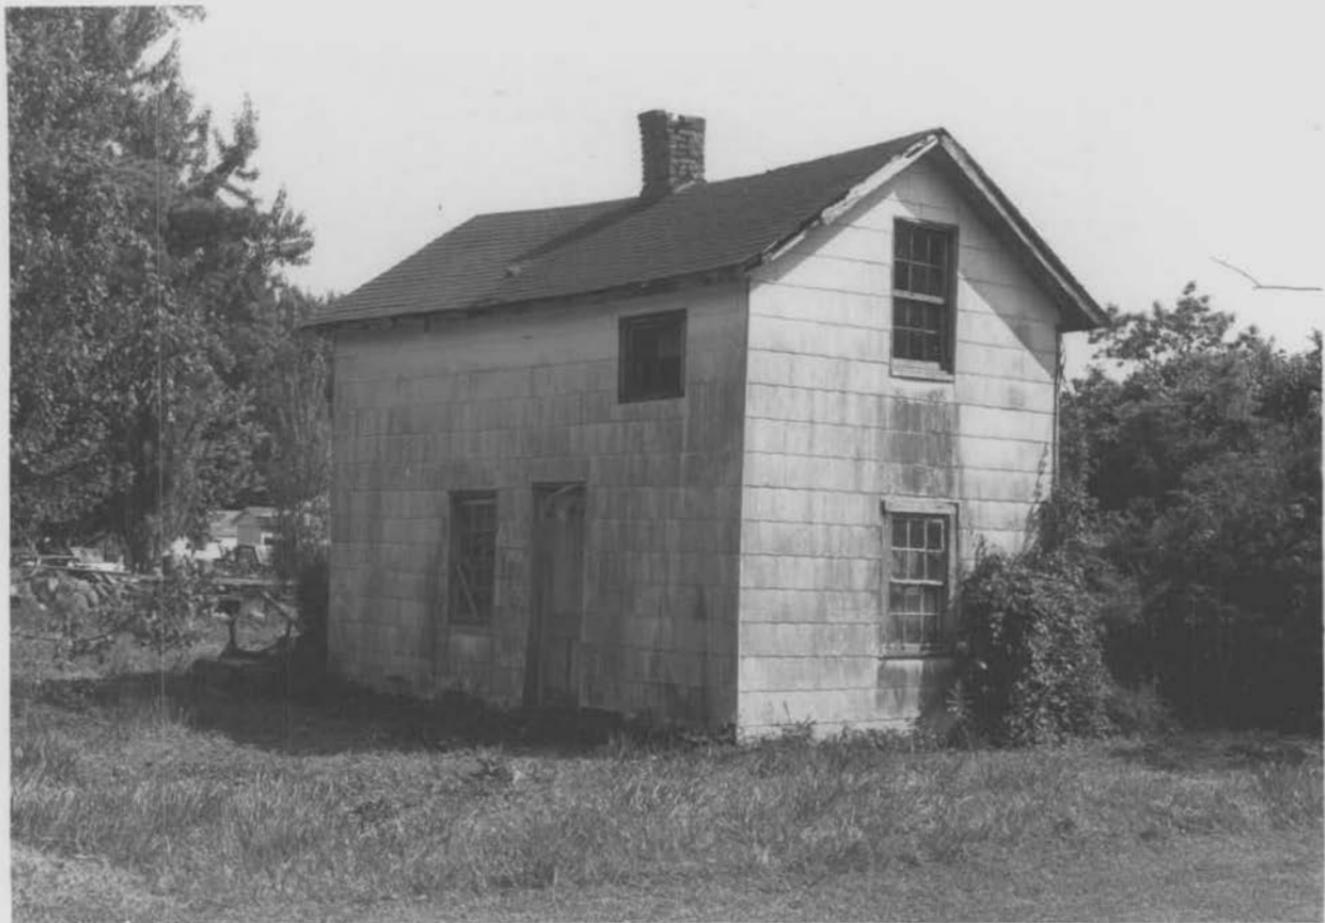
T-810

The northwest (main) elevation is an asymmetrical two-bay facade with a side entrance and a flanking six-over-six sash window. A shallow four-panel door fills the entrance. Fixed above the entrance is a small six-pane second floor window. The eave to the roof is extended and finished with a sloped soffit. Rising through the center of the house is an internal brick stove flue chimney.

Northwest elevation
