T-811
Harry Goldsborough House
Copperville
Private

c. 1900

MHT Inventory Number: T-811

Maryland Historical Trust State Historic Sites Inventory Form

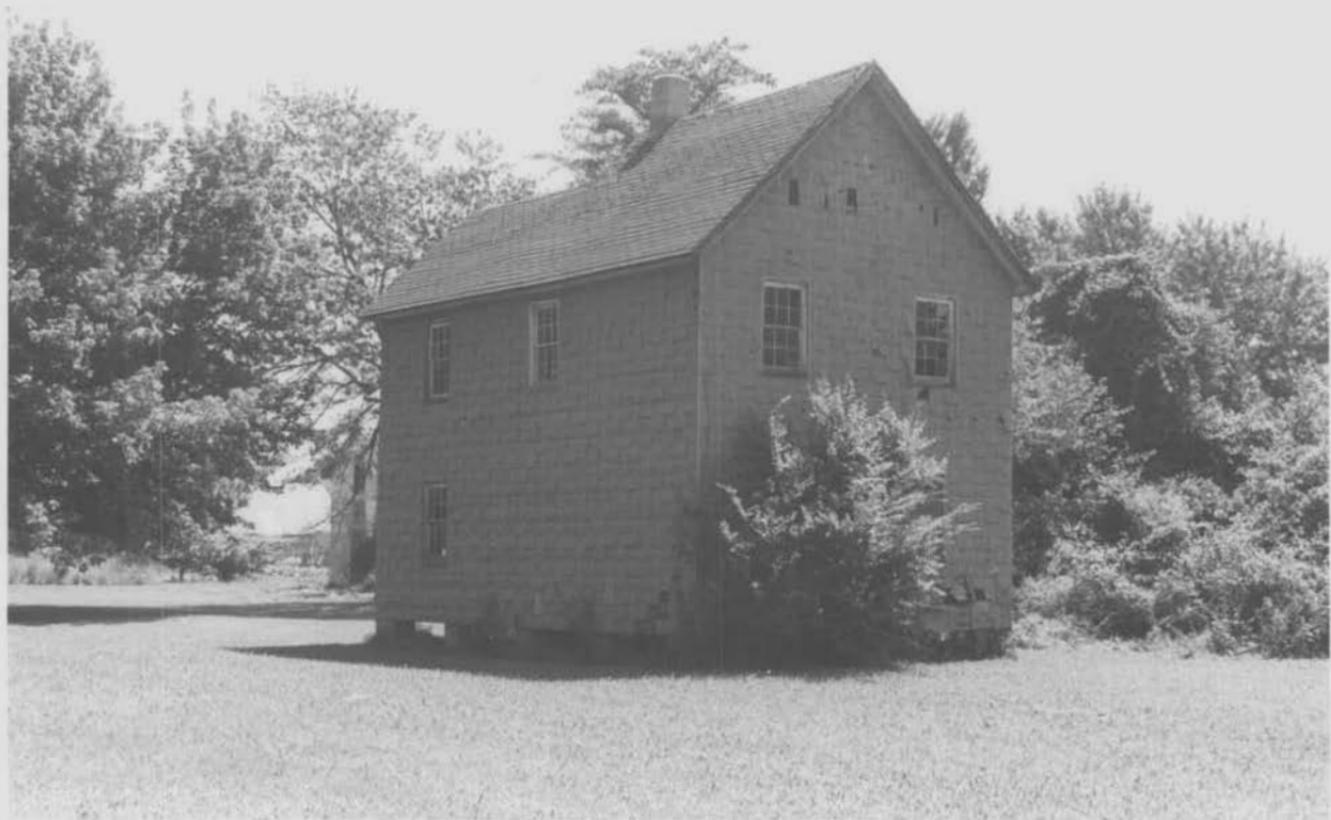
T-811

The southwest (main) elevation is a gable front facade with a side entrance and flanking six-over-six sash window. The second floor is lighted by two evenly spaced six-over-six sash windows, and the eave is slightly extended beyond the wall surface.

Southwest elevation

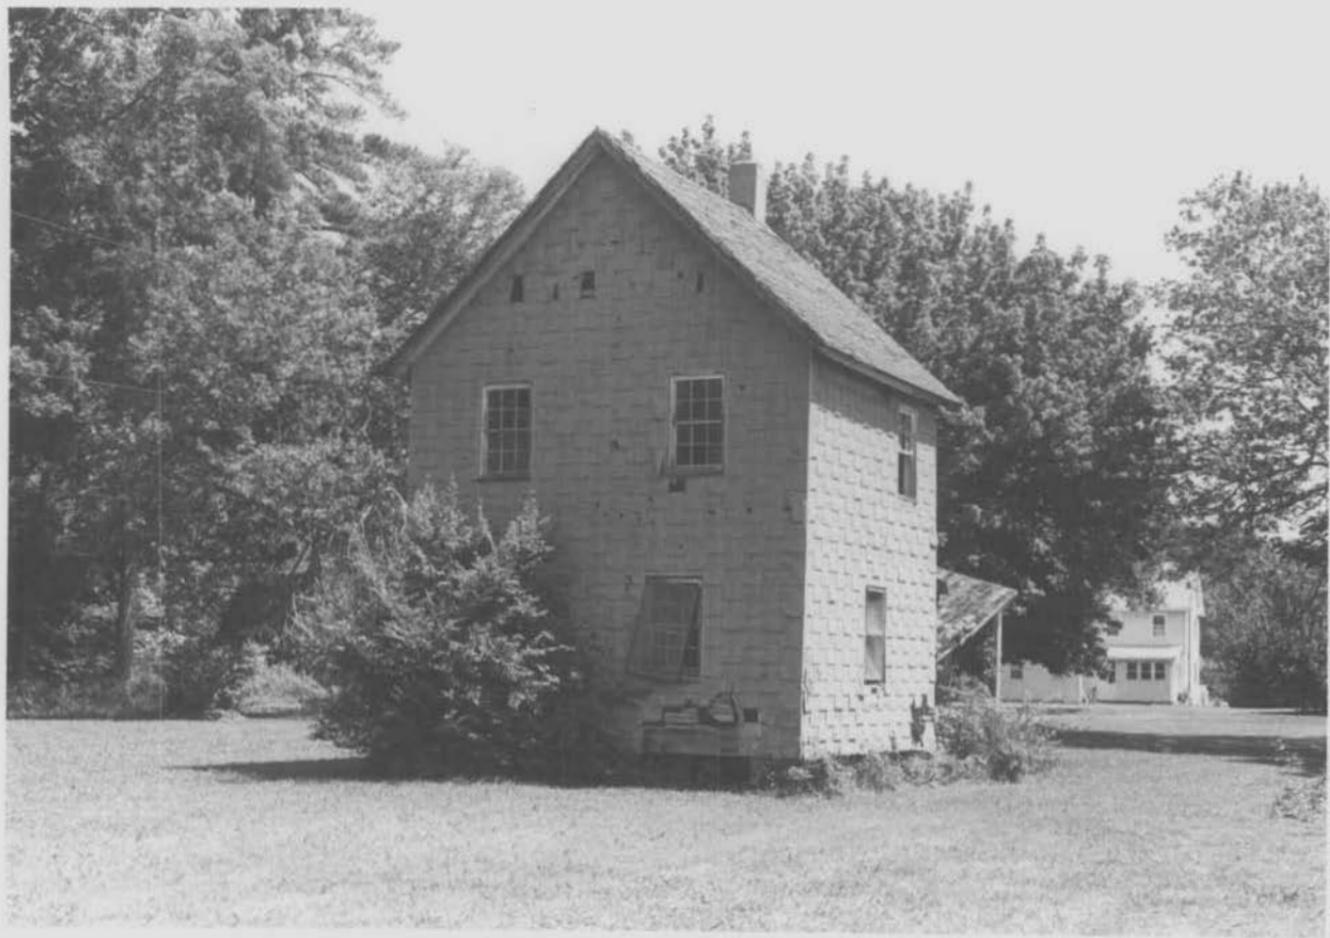
T-811

Southwest elevation
