T-812
Nancy Copper House
Copperville
Private

Resource Name: NANCY COPPER HOUSE

MHT Inventory Number: T-812

Maryland Historical Trust State Historic Sites Inventory Form

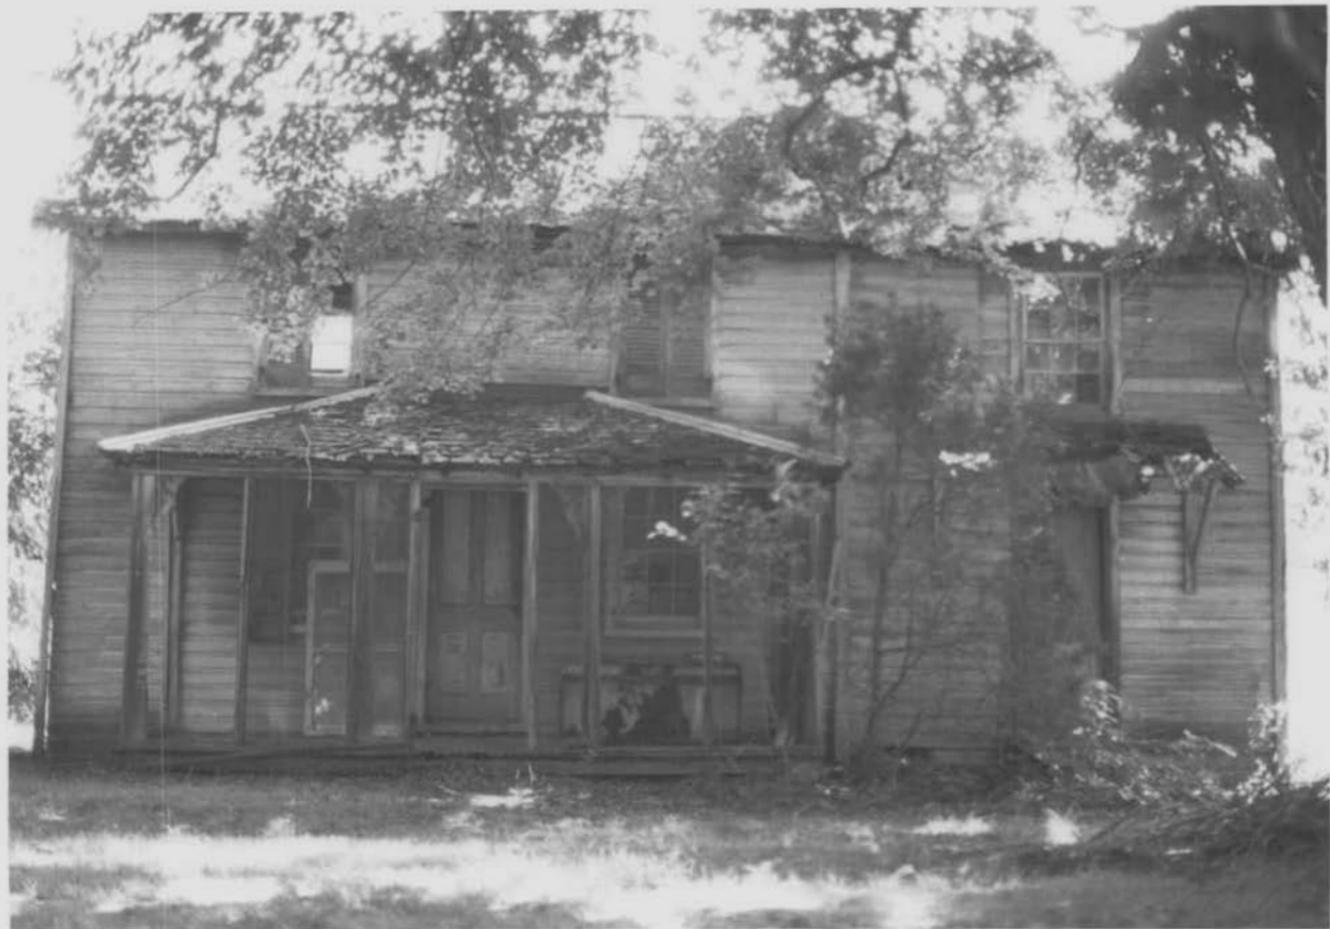
Southwest elevation

The southwest (main) facade of the original house is a slightly asymmetrical elevation with a center entrance and flanking six-over-six sash windows. A four-panel door along with the adjacent windows are sheltered by a hip roof turned post porch distinguished by sawn corner brackets. The windows retain louvered shutters. The second floor is lighted by a pair of six-over-six sash windows that also survive with louvered shutters. The east end kitchen wing is one bay wide with a four-panel door opening on the first floor and a six-over-six sash window on the second floor.
