Maryland Historical Trust State Historic Sites Inventory Form

and/or common Glendy Larrimore House

Survey No. T-826

T-826
Glendy Larrimore House
Tilghman Island Quadrangle

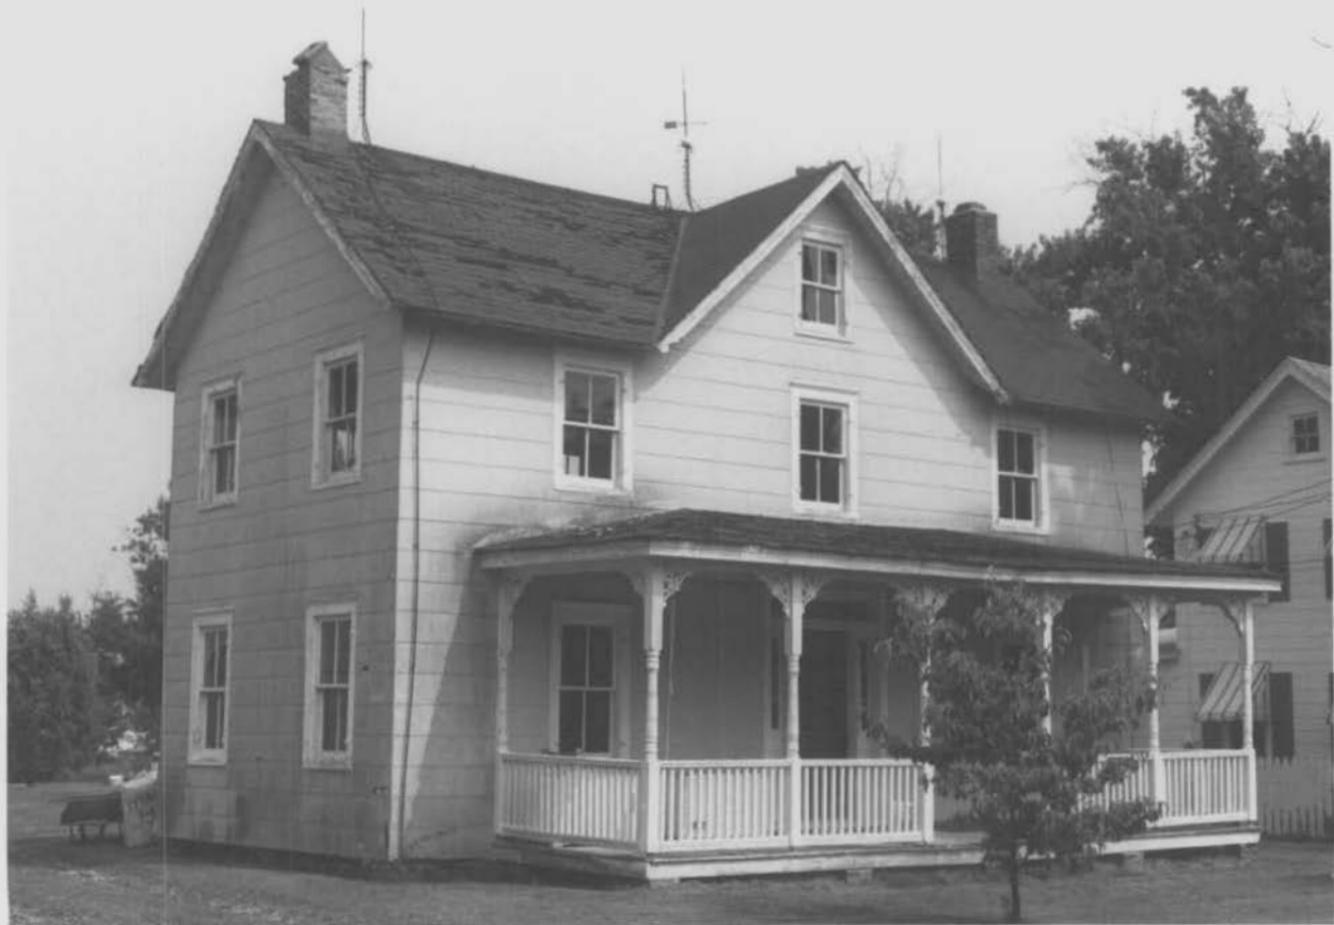
NORTHWEST ELEVATION.

The west (main) facade has a central sidelighted door with a three light transom and flanking two-over-two sash windows with wide surrounds and crown mouldings. The front door is original and has a glazed upper panel and decoratively carved lower panel. A porch extends across the full width of the first floor which has turned supports, decorative brackets, and a square post balustrade. The second floor is lit by three two-over-two sash windows. The open eave displays exposed rafter feet and the central cross gable at the attic story has a small two-over-two sash window inset.

The two bay north elevation has two-over-two sash windows on both the first and second floors. An interior chimney rises above the edge of the north gable end.
