# Maryland Historical Trust State Historic Sites Inventory Form

and/or common Joseph Jackson House

Survey No. T-863

The Joseph Jackson house is located on the west side of Route 33 and on the north side of Coopertown Road in the village of Tilghman on Tilghman Island, Talbot County, MD. The house faces south, with the principal gable oriented on an east/west axis.

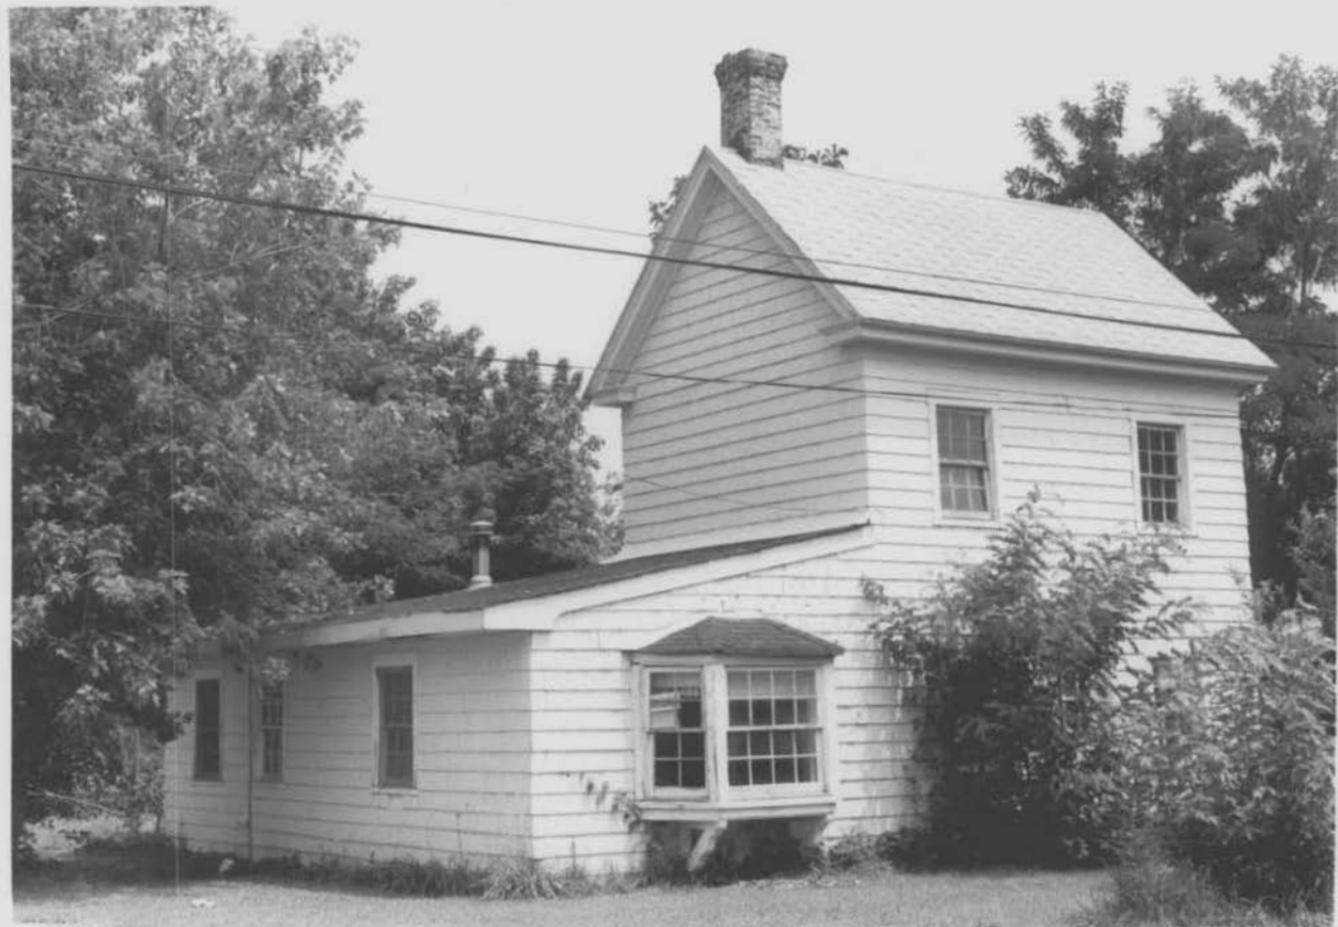
SW ELEVATION.

The south (main) facade has a central door with a colonial revival door surround. The door is flanked by one six-over-six sash window with wide surrounds on either side. There are two six-over-six sash windows with wide surrounds on the second floor. A one-story, shed roof addition extends from the western end of the building. The south facade of this addition has a colonial revival bay window.

The west elevation of the primary structure's gable end has a blind second story with an interior brick chimney stack and cornice returns. A first floor shed addition extends to the rear of the house. This addition is lit by three irregularly spaced six-over-six sash windows.
