Maryland Historical Trust
State Historic Sites Inventory Form

and/or common Sam Bullen house

Survey No. T-900

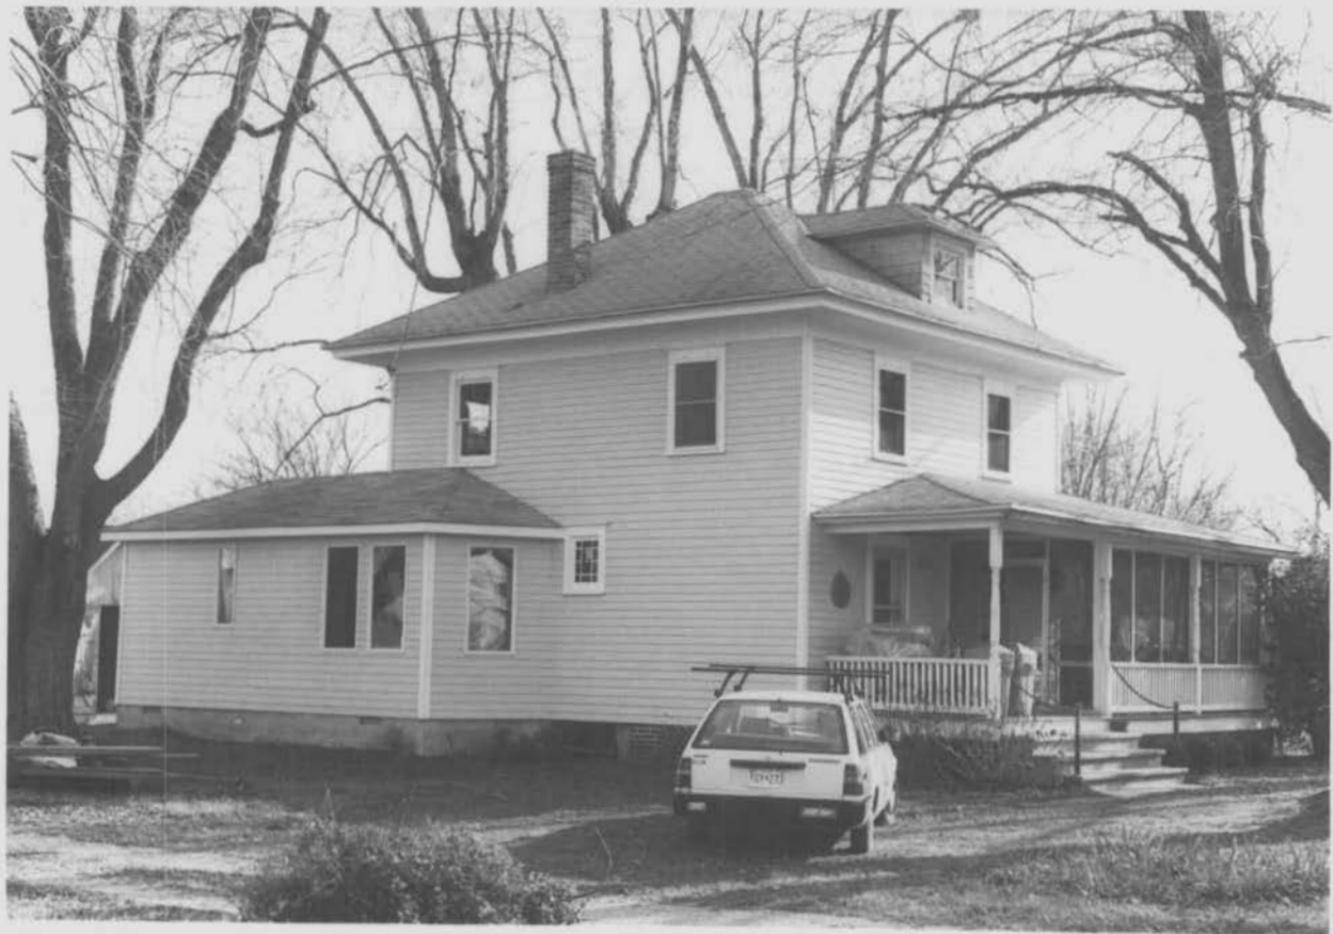
SW ELEVATION

The south (main) elevation has a full-width porch across the first floor with turned supports and a square baluster. The eastern half of this porch is screened and stretches around to east side of the house. The first floor is pierced by a one-light over one-panel entrance door and one one-over-one sash window, both of which have wide surrounds. The second floor is lit by two one-over-one sash windows with wide surrounds. A dormer window sheathed in wood shingles projects from the center of the roof lit by one one-over-one sash window.

The west elevation is lit by one rectangular, colored glass window. A one-story, shed roof addition extends to the north lit by four single light windows. The second floor is lit by two one-over-one sash windows with wide surrounds. An interior brick chimney pierces the roof.

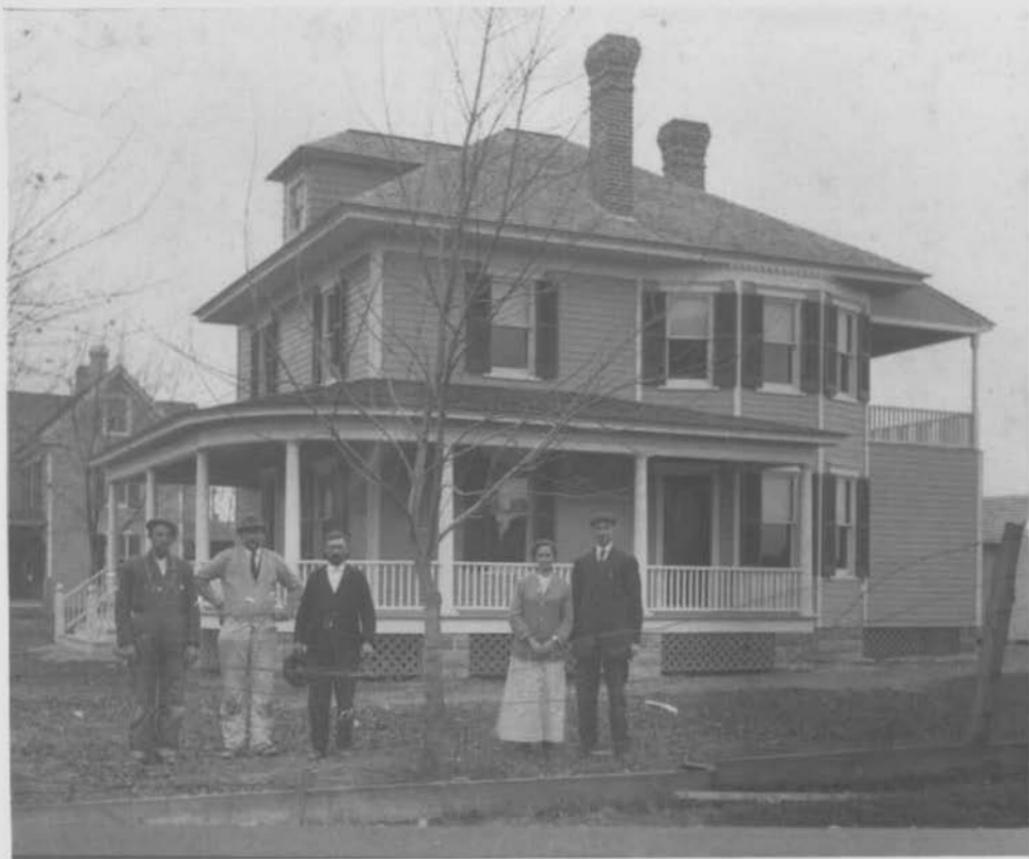
SOUTHEAST ELEV.

The east elevation has a screened porch across the first floor. The northern half of this porch is enclosed and lit by a set of two one-over-one sash windows. The north side of this enclosure is lit by one one-over-one sash window and the south side is pierced by an entrance door. A pair of french doors open onto the screened porch as this elevation's southern first floor bay. The second floor is lit by two one-over-one sash windows with wide surrounds.
