HAGERSTOWN LANDMARKS RECONNAISSANCE SURVEY

Maryland Inventory of Historic Properties # WA-HAG-167

Property Name/Address: Digby Products Building [Hagerstown Silk Mill], Park Driveway
at Key St., Hagerstown, Maryland

Maryland Historical Trust State Historic Sites Inventory Form

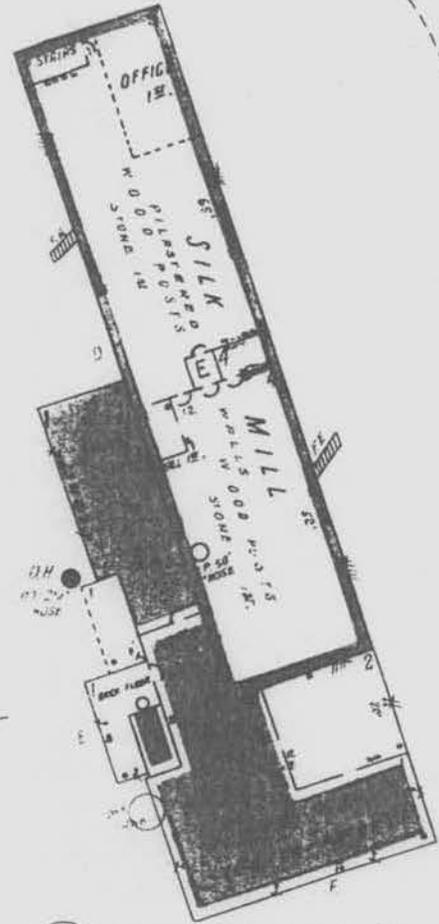
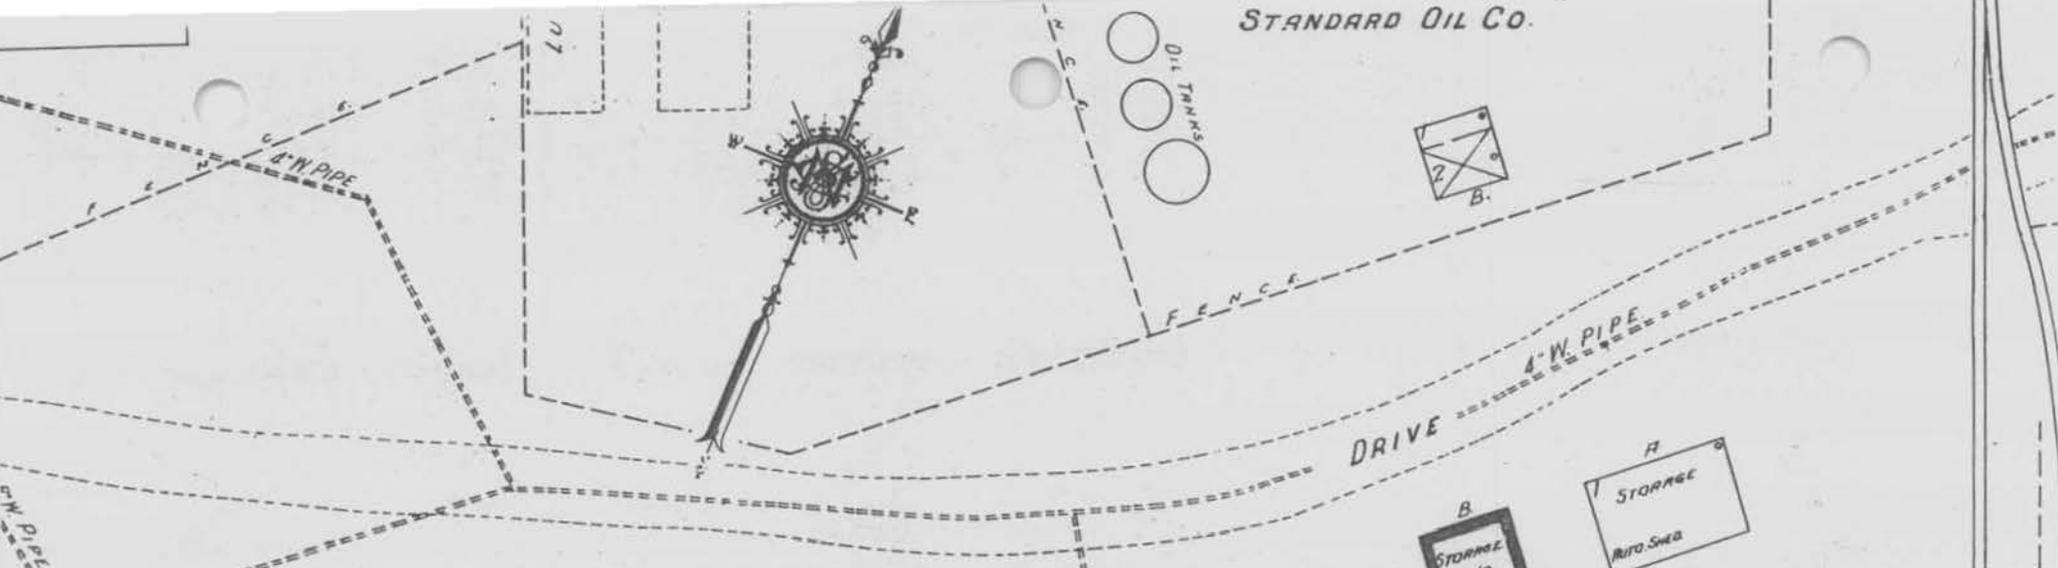
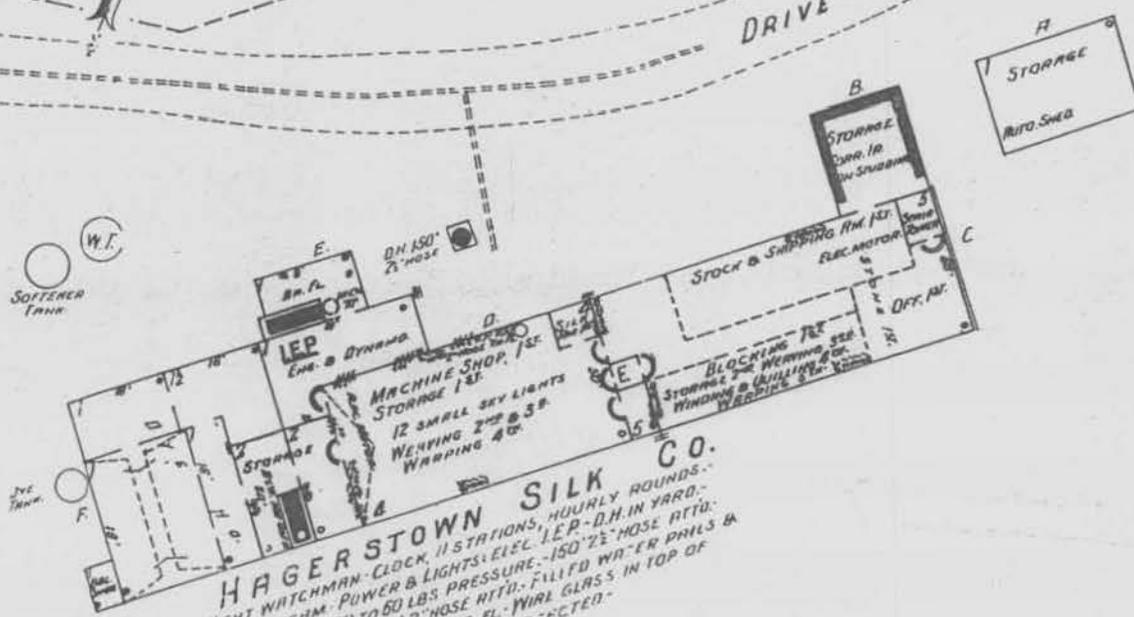
WA-HAG-167
Digby Products Co. [Hagerstown Silk Co.]
Sanborn Map Company
Fire Insurance Maps of Hagerstown, 1926

By 1918, the one-story southern projections had been removed, as had the iron-clad frame addition at the northwest corner; the use of space within the building remained as in 1910. The 1926 Sanborn Map shows a new masonry addition against the west wall of the southern portion of the mill, and other construction wrapping around the south end to encompass the area formerly occupied by the demolished structures.

NIGHT WATCHMEN, HERRICK CLOCK, ART. STAMP
POWER & TELEPHONE, CITY WATER, NO. 10
A. 100000 SAFETY PILLS & CHEMICAL EXTINGUISHERS.

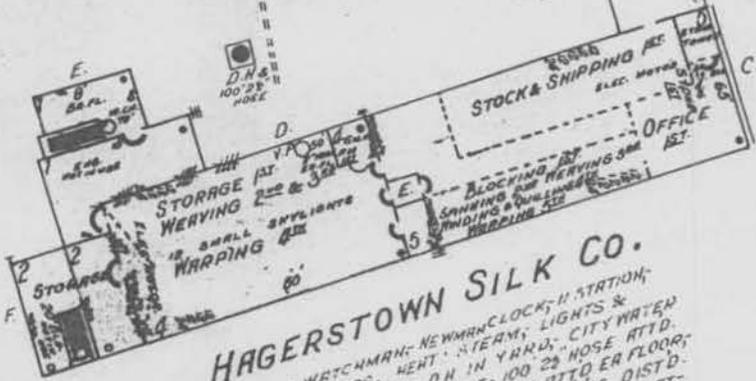
WA-HAG-167
 Digby Products Co. [Hagerstown Silk Co.]
 Sanborn Map Company
 Fire Insurance Maps of Hagerstown, 1910

The Sanborn Fire Insurance Map of July 1910 depicts the functional organization of the building. Both major sections of the building were in place by that date.

The northern section had office space in the northeast corner of the first floor, and a stair tower in the northwest corner; the remainder of the ground floor space in this section was taken up by a stock and shipping room and an area where blocking was carried out. The second floor was occupied by storage. Weaving was done on the

third floor, winding and quilling on the fourth, and warping on the fifth. An elevator, centrally located at the south end of this section, provided vertical communication. A one-story addition projecting from the northwest corner of the building, framed with studs sheathed in corrugated iron, provided storage.

The southern section of the building had a small silk room on the first floor; most of the ground floor area was occupied by a machine shop and storage. The second and third floors were given over to weaving operations, and the fourth floor, lighted by twelve small skylights, served for warping.

A series of lower, one- to two-story extensions projecting to the south and southwest housed mechanical equipment and storage. Tanks for water, softener, and dye were located to the south and southwest. A free-standing, one-story garage was located to the northwest of the building.

HAGERSTOWN SILK CO.
 NIGHT WATCHMAN - CLOCK, 11 STATIONS, HOURLY ROUNDS -
 HEAT - STEAM - POWER & LIGHTS - ELEV. - L.E.P. - D.H. IN YARD -
 CITY WATER 50 TO 60 LBS PRESSURE - 150' 2" HOSE ATT'D -
 V.P. IN MILL WITH 100' 2" HOSE ATT'D - FILLED WATER PAILS &
 CHEM. EXT'GNS. DISTRIBUTED EA. FL. WIRE GLASS IN TOP OF
 ELEVATOR - SHUT FL. OPENINGS PROTECTED -

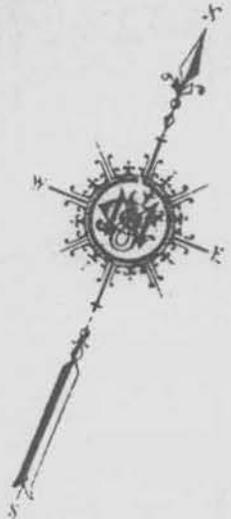
WA-HAG-167
Digby Products Co. [Hagerstown Silk Co.]
Sanborn Map Company
Fire Insurance Maps of Hagerstown, 1918

2-NIGHT WATCHMAN; NEWMAN CLOCK; 11 STATION;
HOURLY ROUNDS. HEAT STEAM; LIGHTS &
POWER ELECTRIC; DN IN YARD; CITY WATER
50 P.S.G. L.S. P.WESSURE; 100 22' NOSE ATTD.
V.P. IN MILL WITH 50 2' NOSE ATTD. EA FLOOR.
FILLED WATER PAILS & CHEM. EXTGRS. SHFT.
EA FLOOR ON TOP OF ELEVATOR SHFT;
FLOOR OPENINGS PROTECTED

WT ELEV 100
ON IRON TOWER
CAPCY 20,000
GALS.

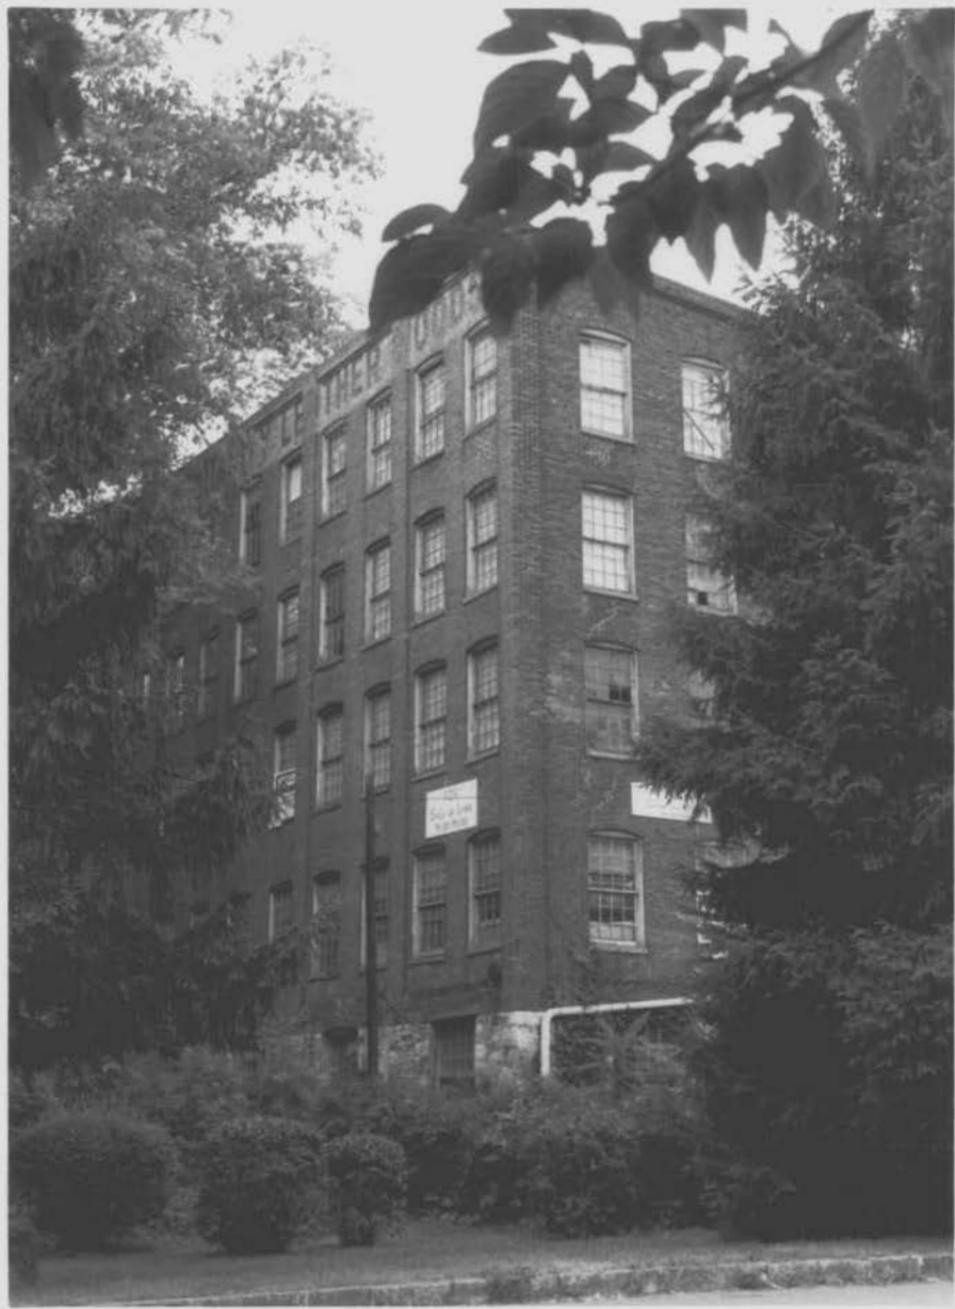
VIEW FROM NORTHEAST

The Digby Products building (originally the Hagerstown Silk Company) is a large brick and stone industrial structure built ca. 1900, located at the intersection of Key Street and Park Driveway in City Park. The principal elevation faces southeast (called east), overlooking the driveway at the northwest corner of the park.

The building is constructed of brick above a first story of stone, and comprises two principal sections. The two sections correspond closely in the character of their masonry and detailing, suggesting that they were built nearly contemporaneously. The 13-bay-wide, gable-roofed southern section is the earlier of the two; it has a total height of four stories. Before 1910, a five-story shed-roofed addition was constructed against the former north gable end of this section; the north portion is 16 bays wide by five bays deep. The facade bays are defined by large sash windows, grouped in pairs between pilasters; sash are generally 12/12, except on the top floor of the southern section where they are 12/8. Openings are headed with a segmental arch formed from a double course of rowlock bricks. At the ground-floor level, a single large opening is centered between each pair of pilasters. The northernmost bay of the southern section has a transomed entrance with a bronze door at basement level; the upper stories are blank. An evident construction seam marks the transition between the two sections at this point. The first story is constructed of uncoursed limestone rubble masonry, roughly dressed at the openings.

The north elevation is five bays wide; two groups of two bays each are set off by pilasters, flanking a blank bay. A two-story, two-bay, flat-roofed cinderblock addition projects from the northwest corner.
