HAGERSTOWN LANDMARKS RECONNAISSANCE SURVEY

Maryland Inventory of Historic Properties # WA-HAG-186

Property Name/Address: 121 East Franklin St., Hagerstown, Maryland

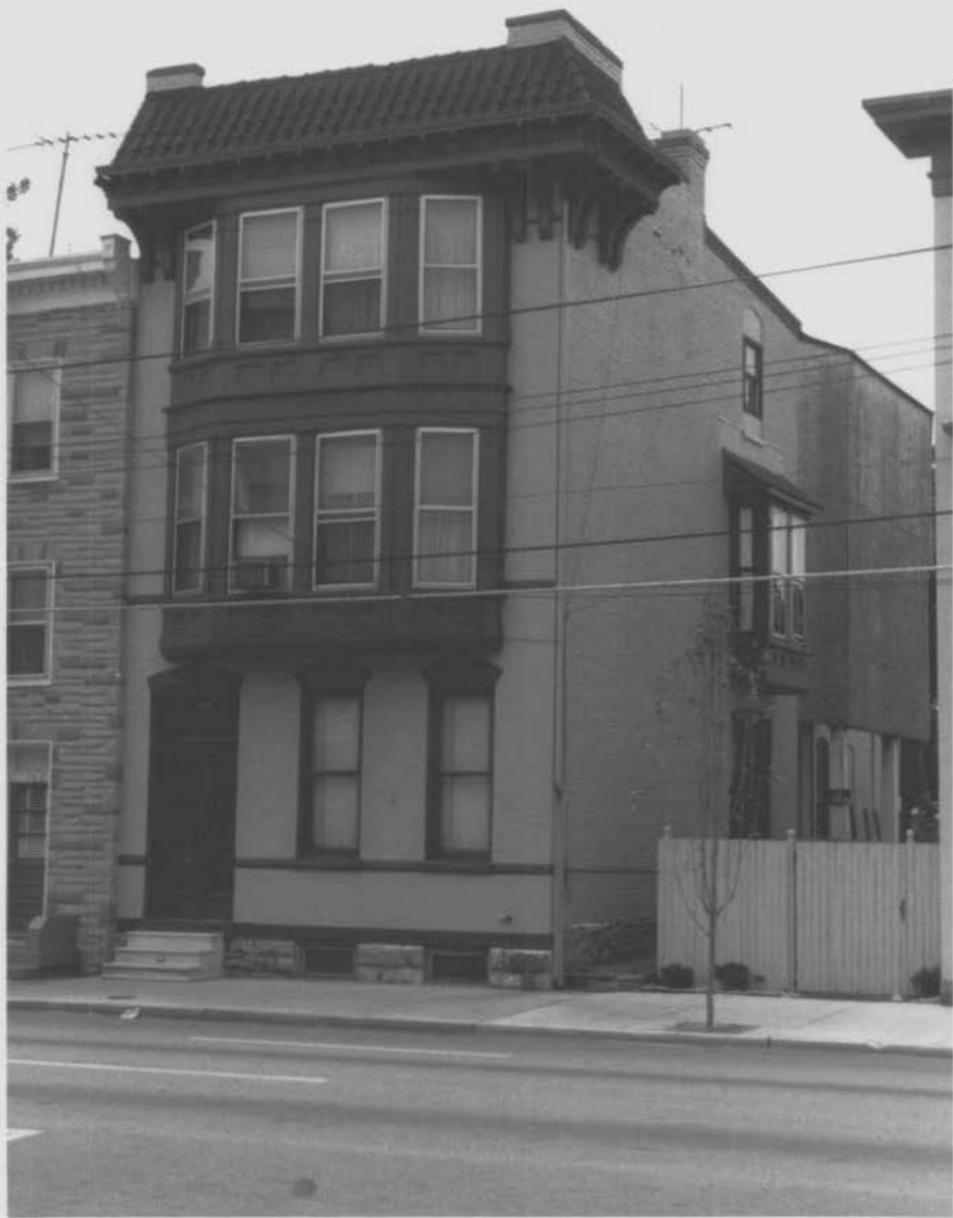
WA - HAG - 186

VIEW FROM NORTHWEST

Description/Significance: An eclectic ca. 1890 three story townhouse constructed of brick on a stone foundation. The north facade is three bays wide; the entrance is located in the easternmost bay; glazed double doors set in a segmental arched opening with a decorative keystone element open into a small vestibule. The other first floor openings are detailed similarly, and hold tall 1/1 windows. A broad projecting bay spans the facade at the second and third stories; on each level, it holds four windows separated by fluted pilasters, with paneled spandrels below the sills. A bold overhanging cornice with brackets and modillions wraps around the west corner; above this cornice is a section of metal roofing imitating Spanish tile. The building is flush with its neighbor on the east; the west elevation is exposed, and is distinguished by an oriel on the second story.
