## HAGERSTOWN LANDMARKS RECONNAISSANCE SURVEY

Maryland Inventory of Historic Properties # WA-HAG-194

Property Name/Address: 277 South Potomac St., Hagerstown, Maryland

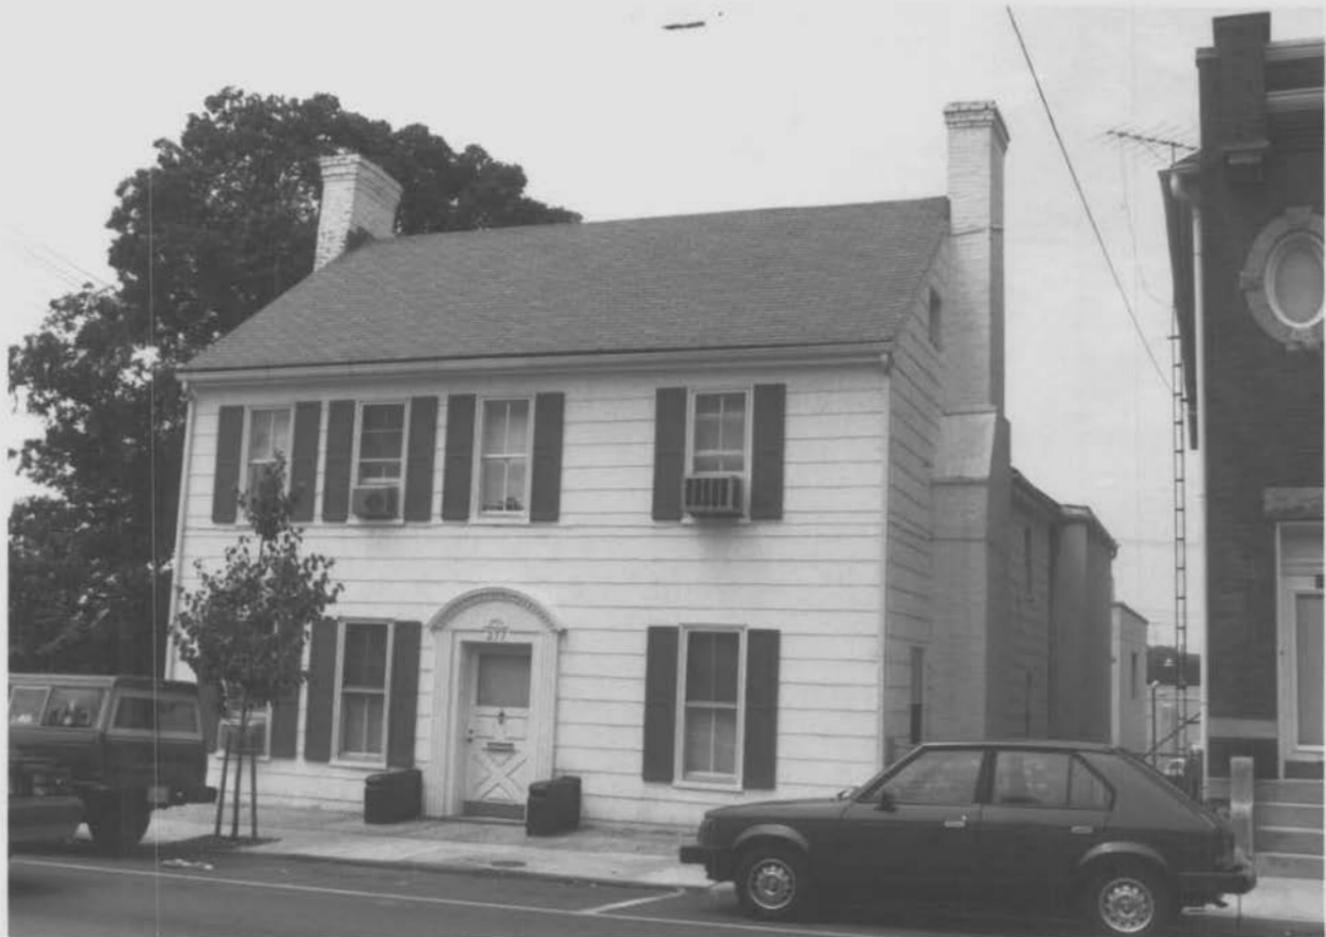
WA-HAG-194

Description/Significance: A late 18th century frame or log house with a Flemish bond brick exterior chimney. The two-story building appears to have been constructed in at least two stages; its present configuration is four bays wide by one room deep, with a lower ell to the rear. The exterior is finished in modern materials, but the early form appears to remain largely intact.<sup>1</sup>

VIEW FROM NORTHEAST
