MARYLAND HISTORICAL TRUST
STATE HISTORIC SITES INVENTORY FORM
Capsule Summary
Survey No. WA-HAG-195

Maryland Inventory of Historic Properties # WA-HAG-195

Property Name/Address: 113 Summit Ave., Hagerstown, Maryland

and/or common Antietam Fire Hall (preferred)

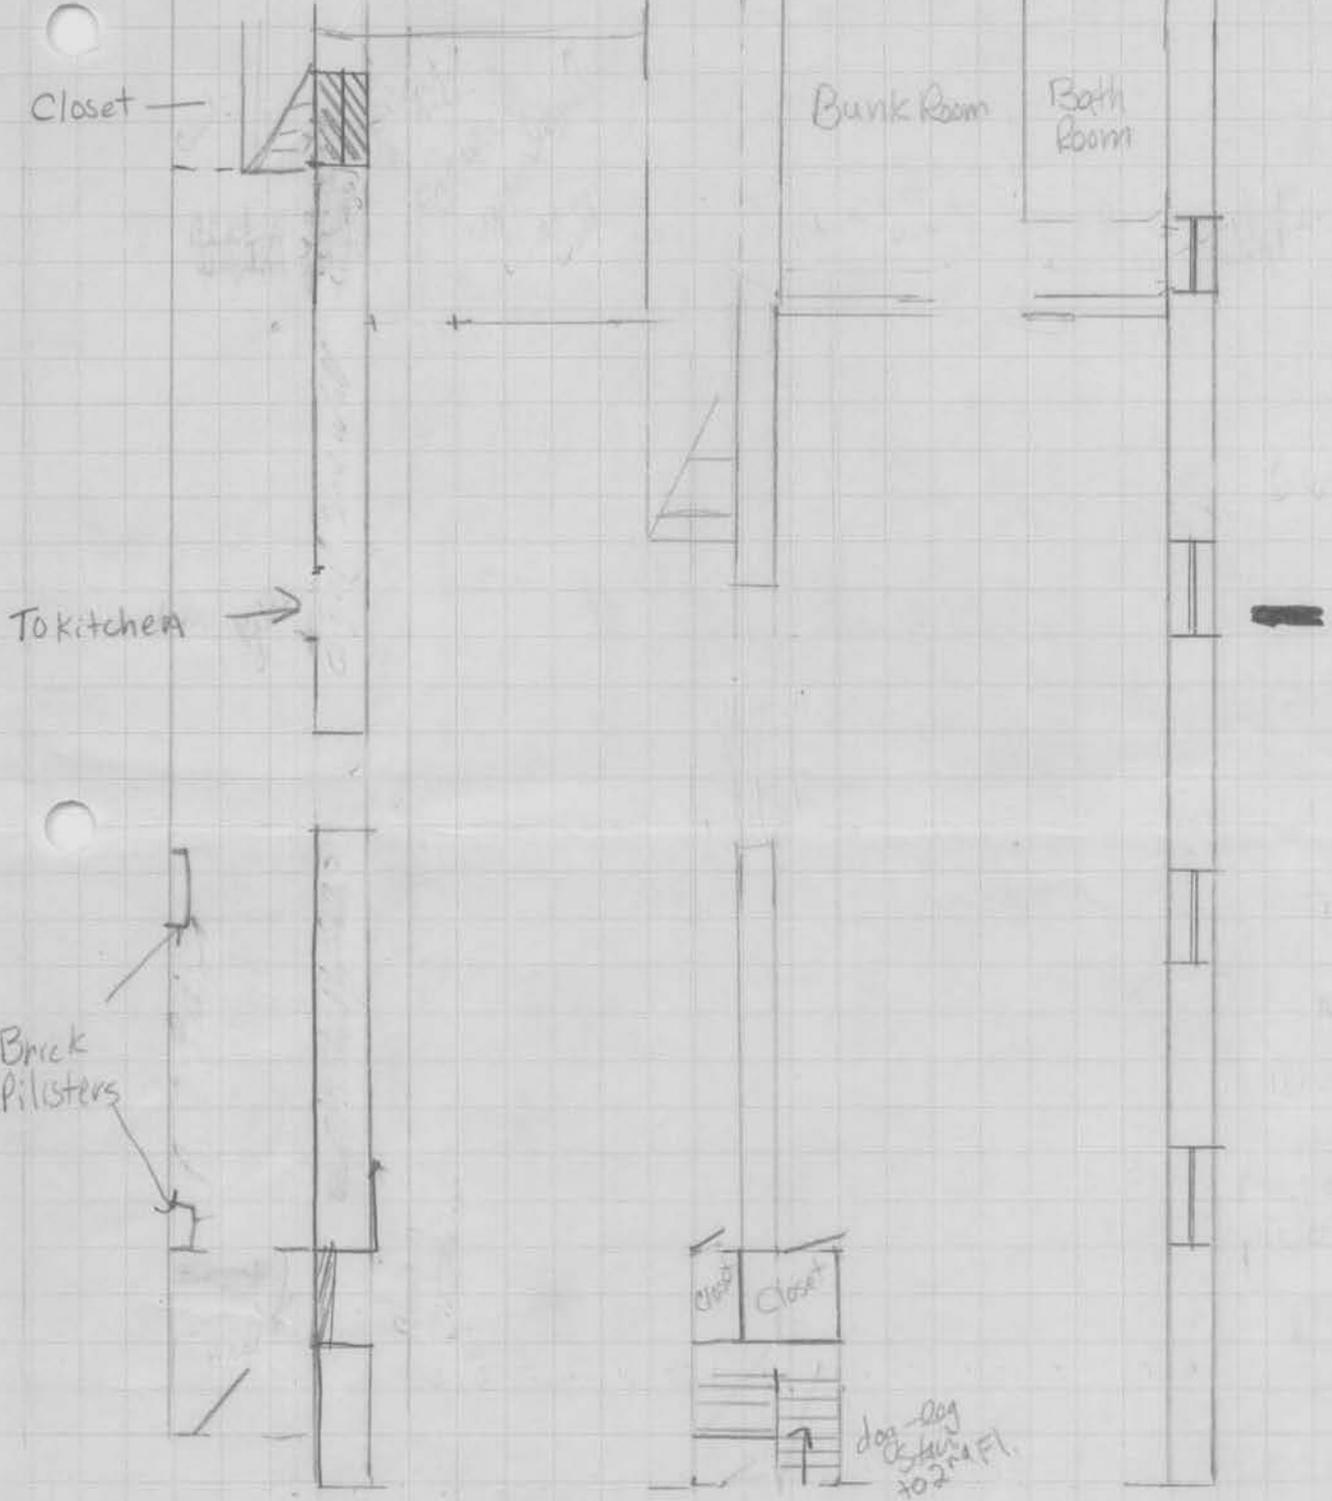
1st Floor (Hillside)

The interior floor arrangement of the Antietam Firehouse does not reflect the exterior two story structure. The first floor, currently occupied by the fire department, has three main levels of construction and a cellar. The ground level is divided into three sections: the north bay, south bay, and the south extension. The north and south bays, at one time were separated by a fire wall because the north bay was rented out to a printing company¹⁴. The wall between the two bays is currently open near the rear. The north bay houses Engine No. 2 in the front. The back part consists of a sitting area and equipment area. The bunk room and bathroom are in separate rooms beyond. The north wall has three windows within the bay and one window in the bunk room. The remains of an electric harness system for the horses still hangs from the ceiling¹⁵. The south bay is similar but has a stair leading to an office on the upper level and a separate wooden stair leading from the office to a third level in the south extension. The south wall of the bay has a blocked door near the street entrance and a door leading to the south extension near the rear of the bay. Both bays have closets under the outside stair at the east end which possibly once housed cellar stairs. Both have modern rectangular shaped tile on the floor, and ceilings constructed of modern material. The walls are glazed ceramic tile half way up and painted plaster above. The plain, stained wood architraves around the doors and windows are probably original to 1920.

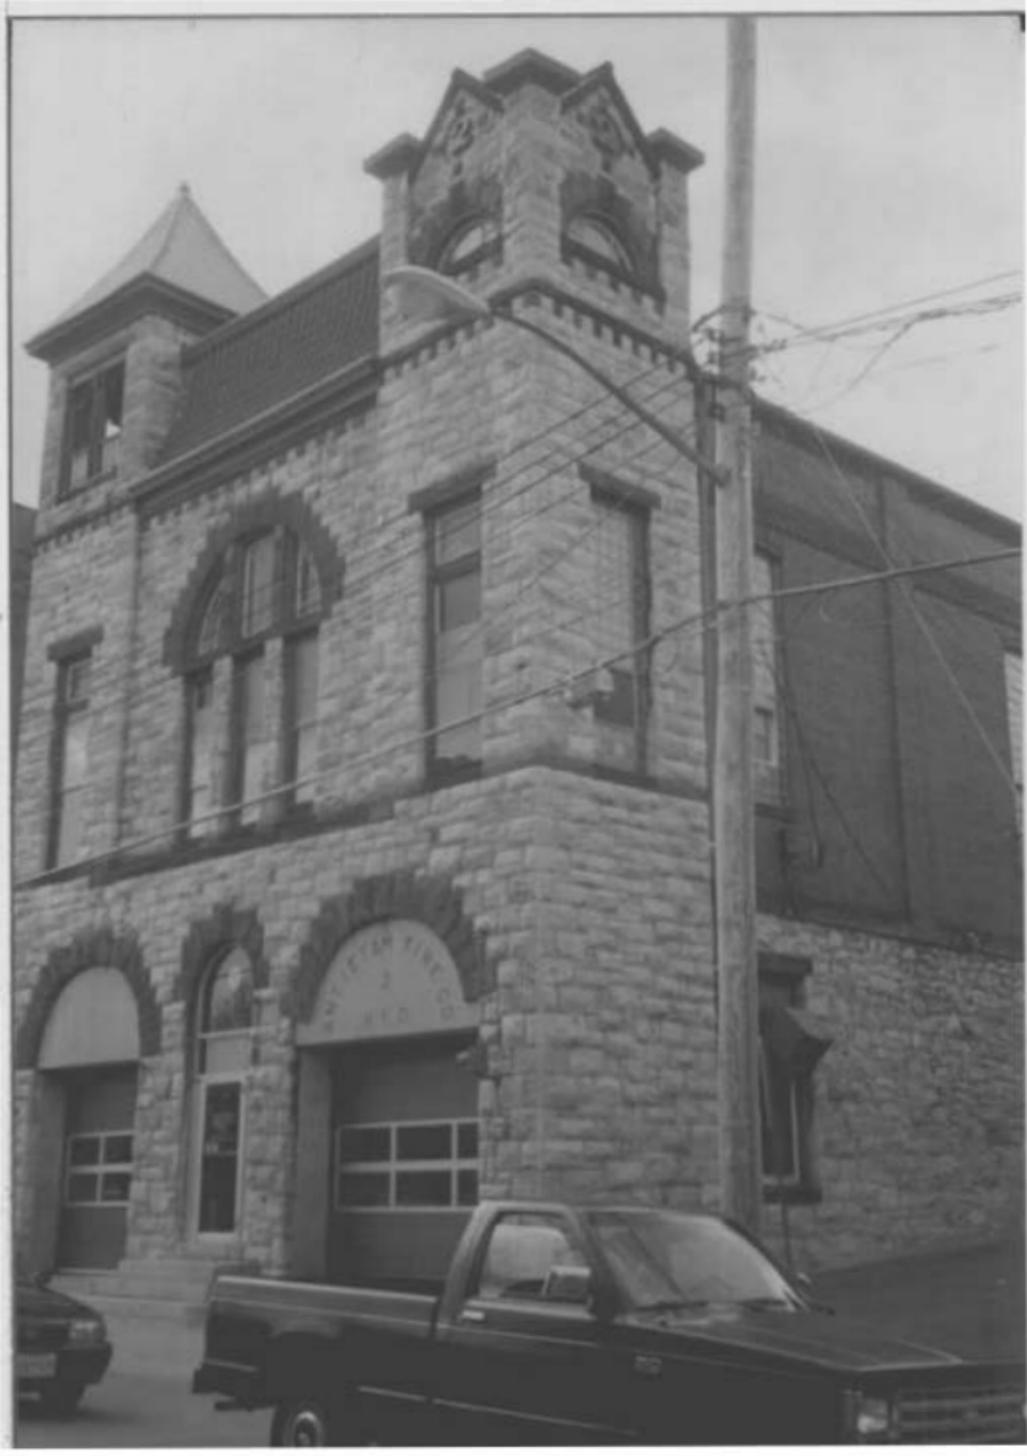
NE Elevation

The principal facade faces east towards the street and consists of three bays. The central door way is "flanked by equipment doors with openings forming a round arch with red stone voussoirs".⁷ A turn of the century picture shows wood infill over the equipment doors. A modern one story entrance with a glass door was added on the south side of the facade. The door on the right side of the facade was once the entrance to Coffman's Cafe according to an early

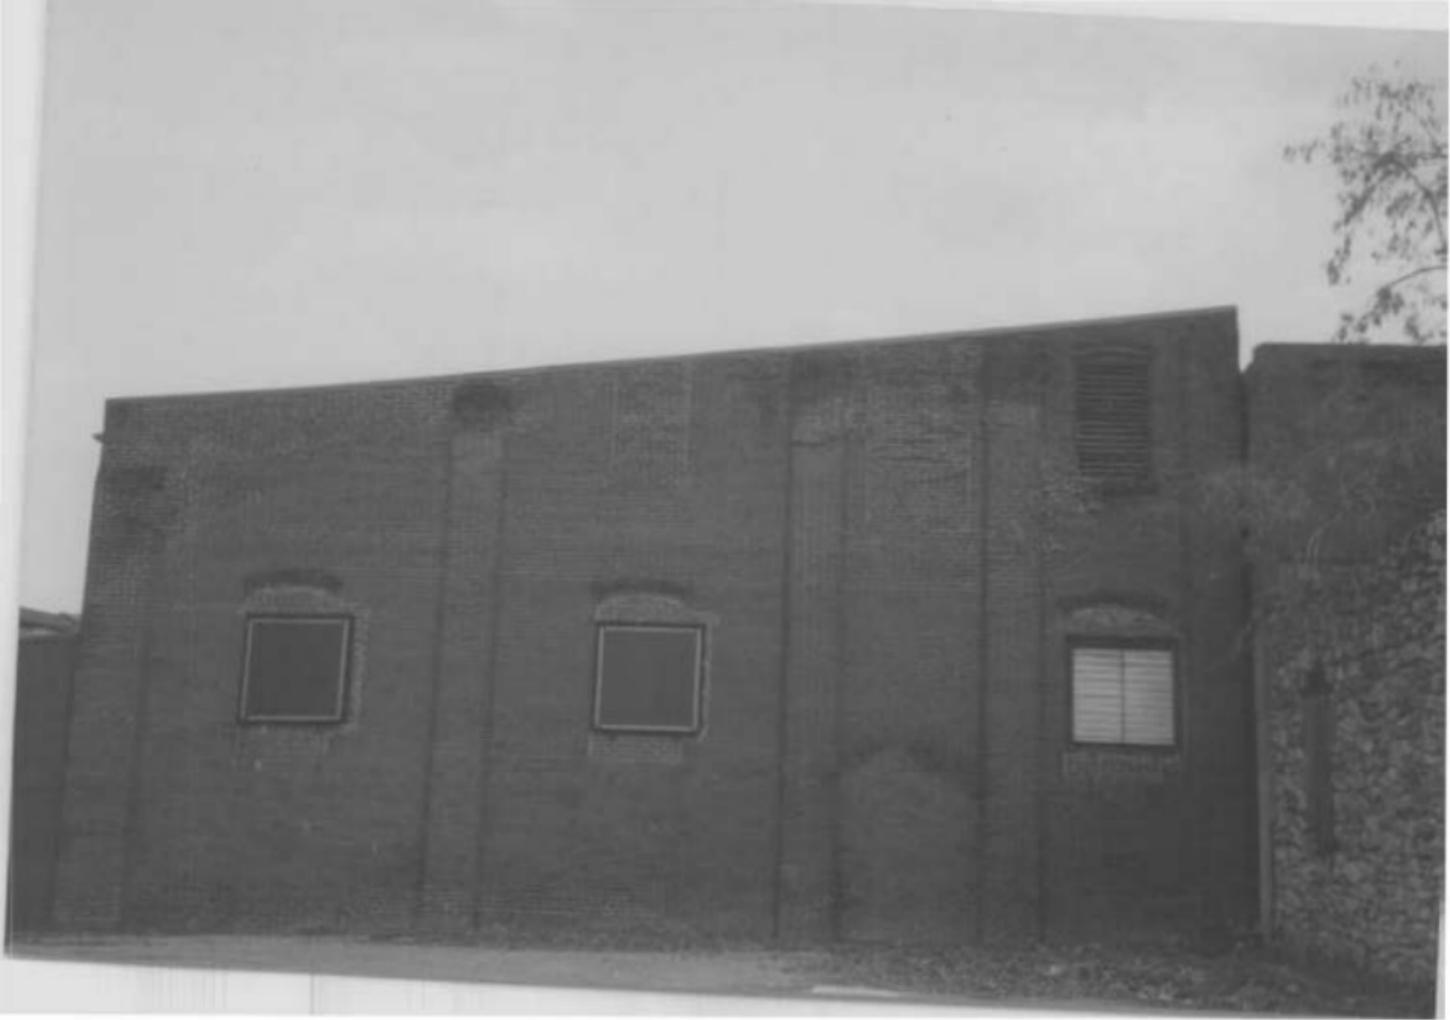
Western Elevation

The west facade, or back of the building, is one and a half stories due to the hillside and roof slant. Five brick pilasters separate the facade into four unequal sections. The windows on the ground level are blocked in with brick and wood. Double row segmental arches can still be seen. There are shadows of two blocked up windows in the half story and a louvered vent beneath a segmental arch at the highest point of the roof, at the south end.

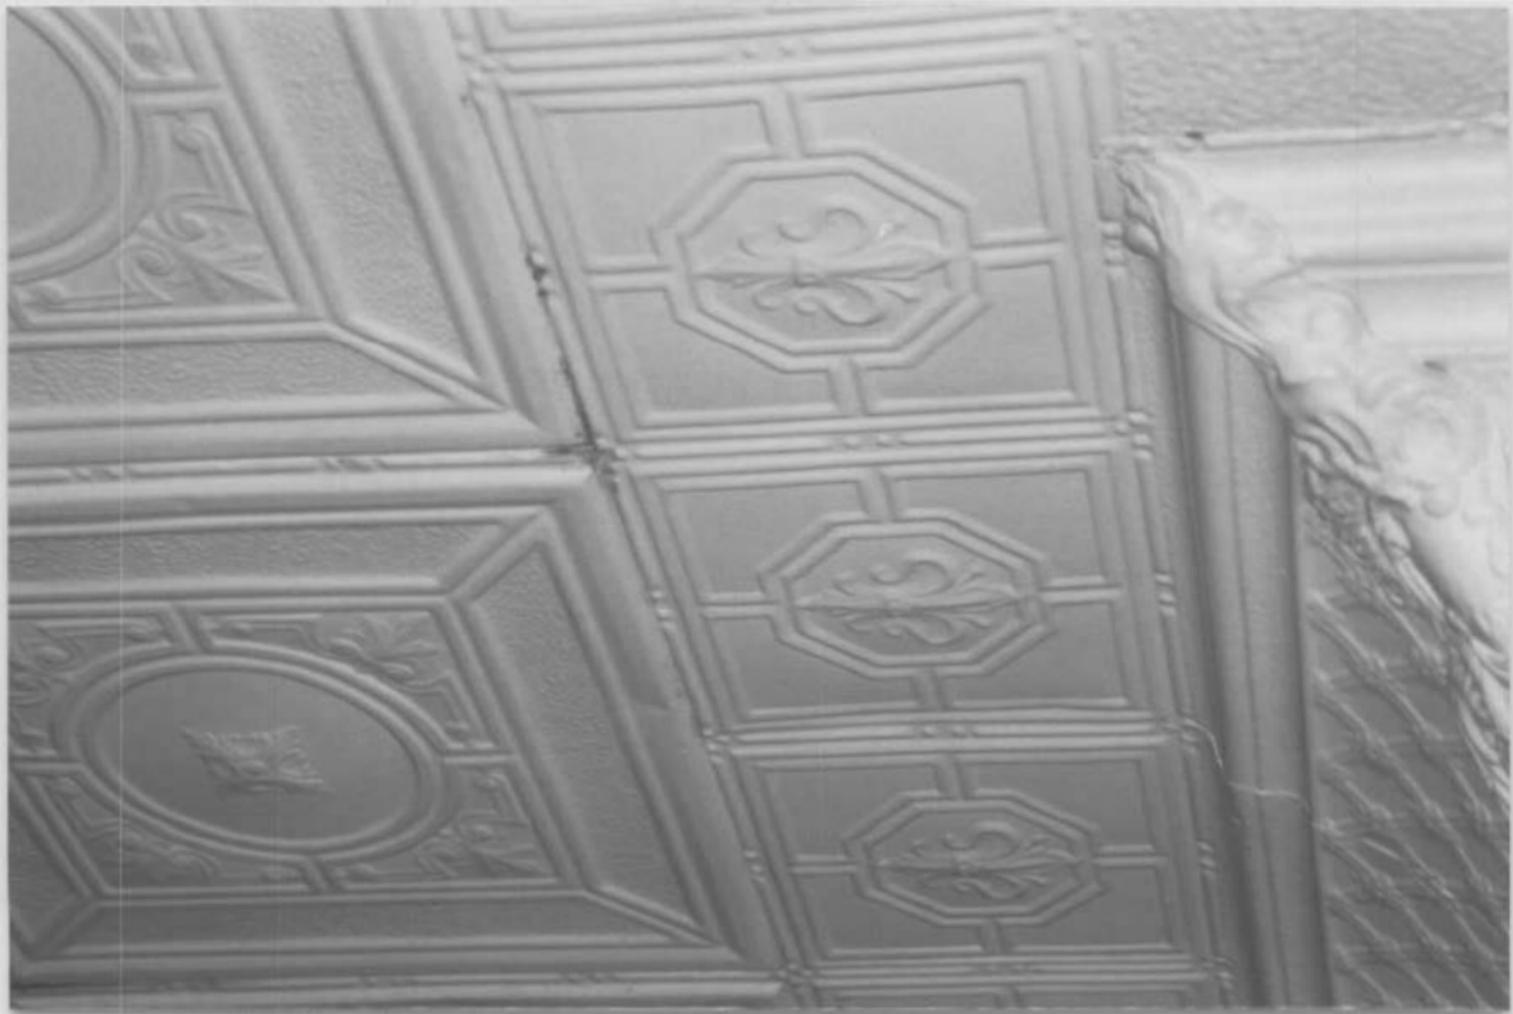
antireform Fire Station
Washington Co MD
Carol Appenzeller
10/96
Detail - 2nd Floor Ceiling
21/24

The Meeting/Recreation Room still has the original patterned metal ceiling that was possibly the ceiling that the two bays originally had. The room has a linoleum tile floor, two windows in the north wall, and three doors in the west wall that are approximately two feet above the floor level without steps.

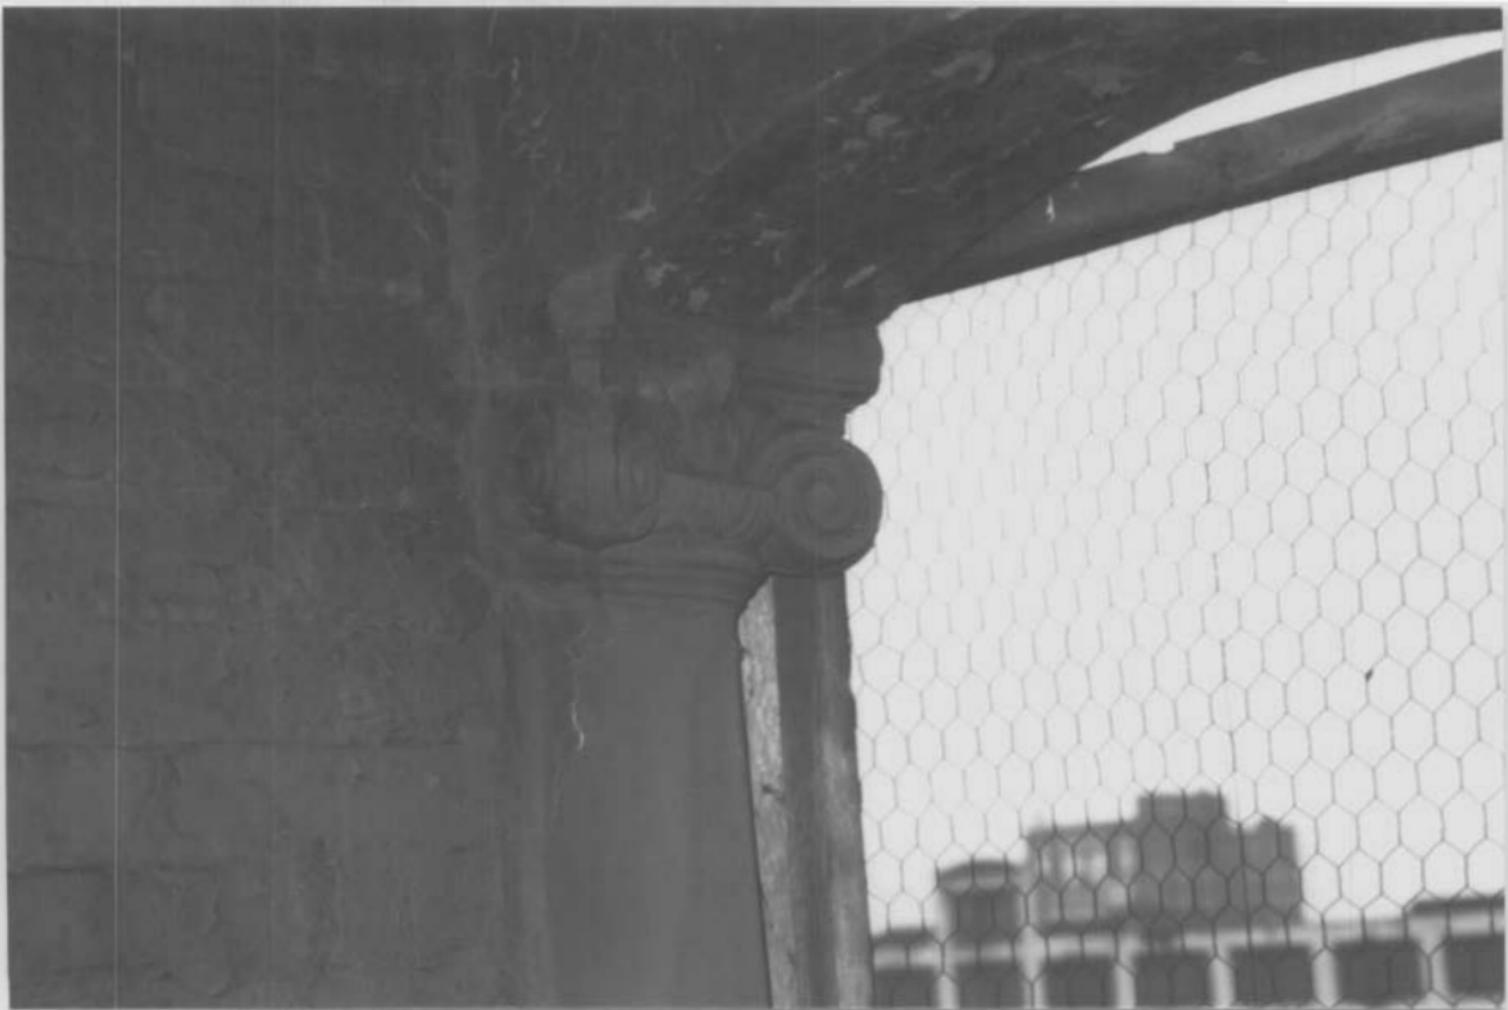
Interior detail - South
tower

The attic space is approximately five and a half feet high and runs the full length of the building. It gives access to the tower area. On the back side of the south tower a heavily charred beam is still supporting the masonry.
