HANCOCK, WASHINGTON COUNTY, MARYLAND

Survey # WA-HAN-061, B75 Approximate date Ca. 1900
Street Address 176 West Main Street
Town, State Hancock, Maryland
private X, public

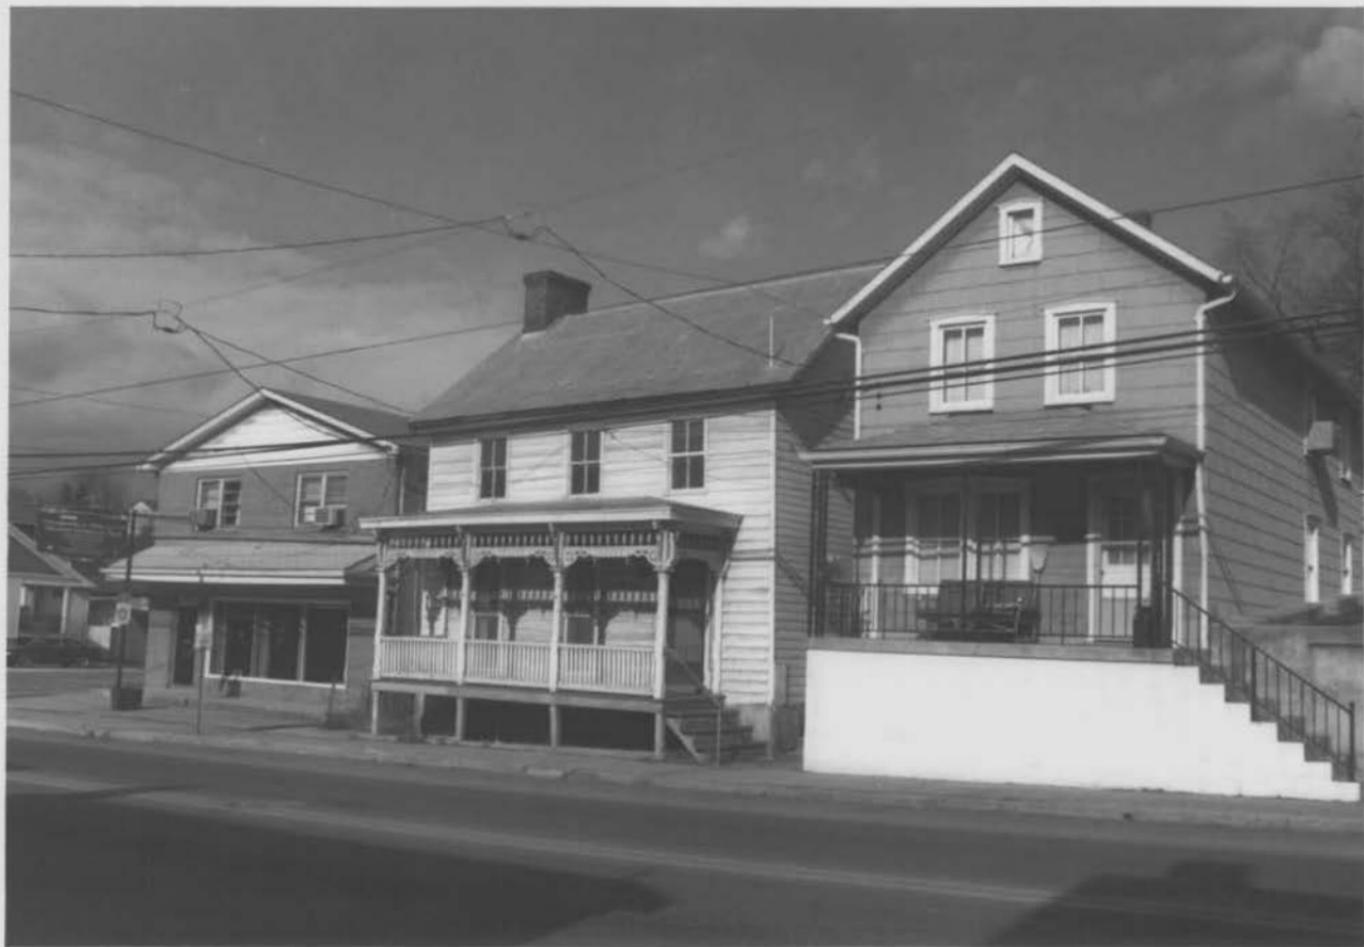
Photo# 43

This is a two story frame house with a gable front. It is a two bay structure with two over two window pane units. Across the front is a porch with recent metal railings and posts. The house has been covered with asbestos siding and sits on a rubble stone foundation. The house does appear on the 1908 Sanborn map, and reflects Hancock's building boom of the early 20th century.
