WA-I-222

Middlekauff-Martin Farm

Paramount Vicinity

INVENTORY FORM FOR STATE HISTORIC SITES SURVEY

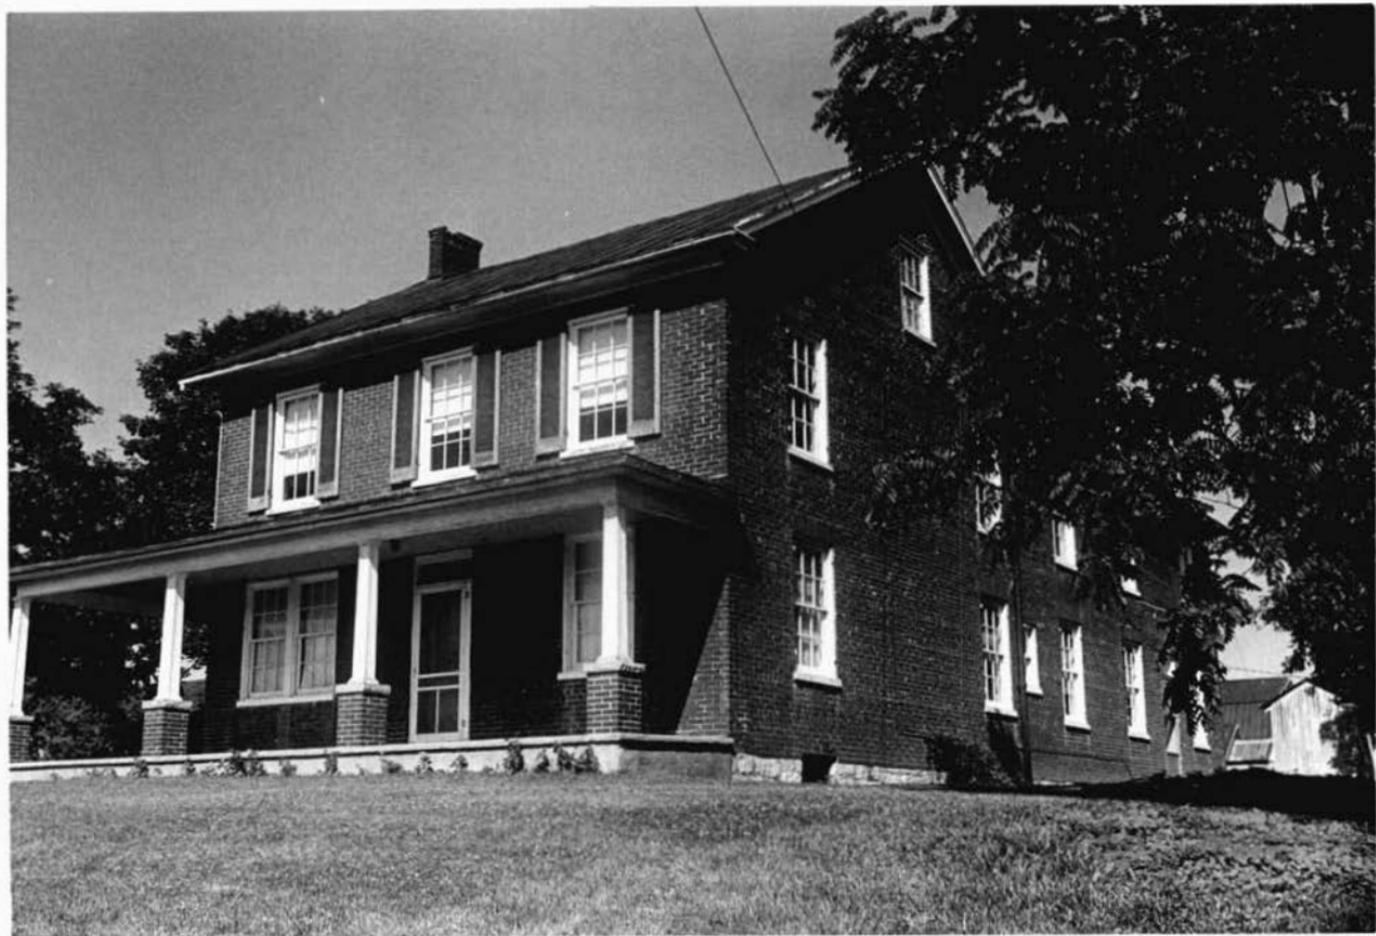
104-5-10
104-5-10
104-5-10

The dwelling is a two story, three bay brick structure set on low limestone foundations. A two story, four bay ell, also of brick construction extends to the rear or west. A recessed double porch supported by square wooden posts extends along the south elevation of the ell. Its lower level has been enclosed. Bricks forming the walls are laid in American or common bond with generally seven courses of stretchers between header rows. Flat arches of brick are present above the openings.
