ABSTRACT
WA-I-230
Shuck Farm (Barn)
Hagerstown Vicinity
private

INVENTORY FORM FOR STATE HISTORIC SITES SURVEY

Shuck Farm (Barn)

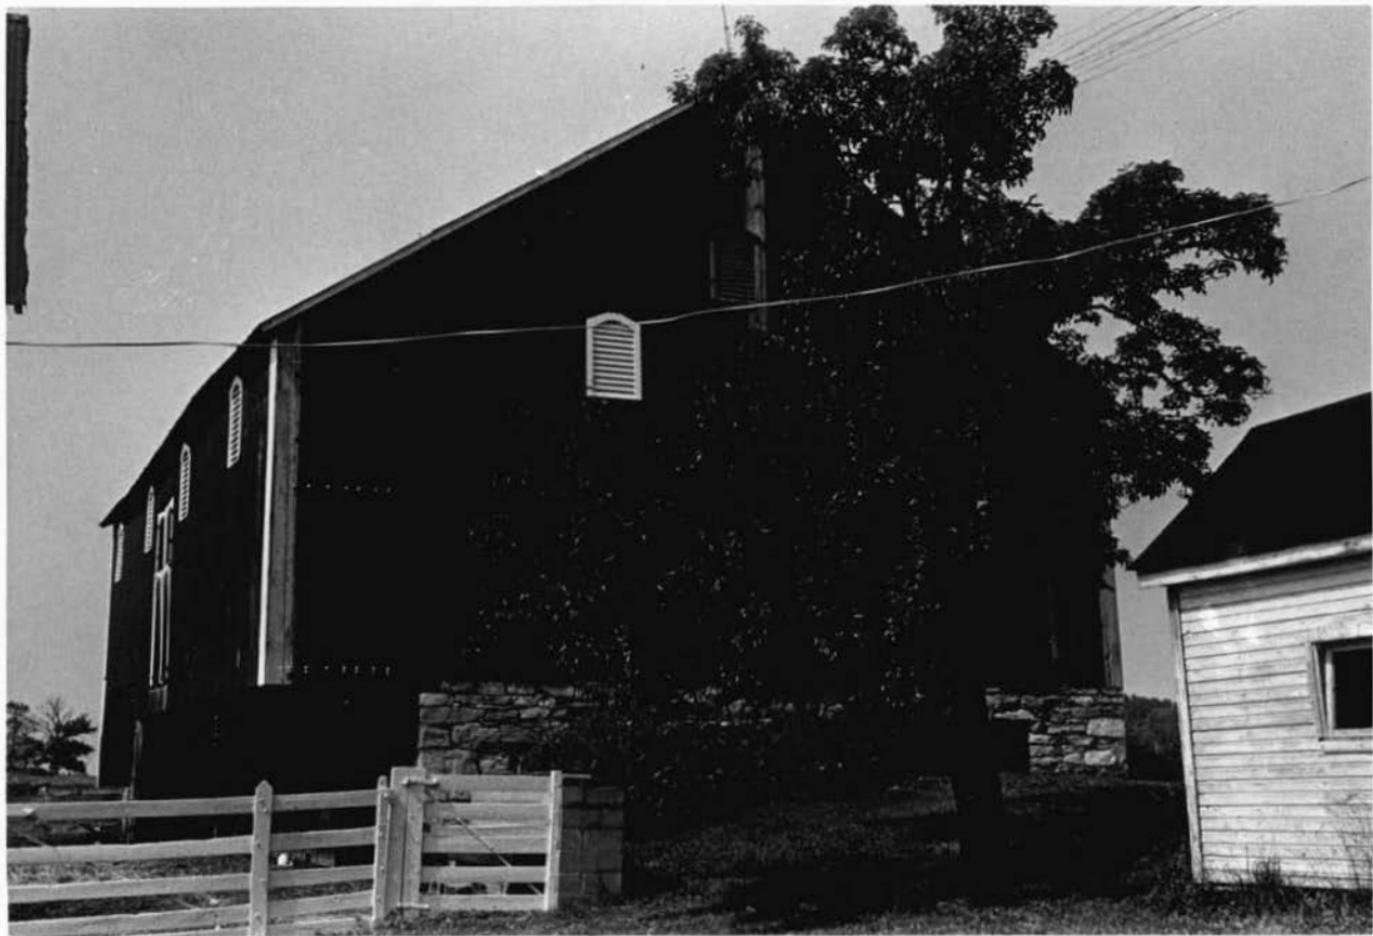
N.E.

The barn is a large frame structure resting on coursed fieldstone foundations. Typical of livestock barns in the area, it is built into a bank so that the foundations at the front elevation are a full story in height. At the rear of the barn a dirt ramp gives access to the upper structure or storage area. Like many barns in the region it has an eastern exposure with the front of the exposed foundations protected by a deep overhang of the upper structure, known as a forebay.

The upper part of this barn is sheathed with vertical boards painted red with white trim. Louvered ventilators are set high in the walls, under the eaves and in the gables. The ventilators have applied trim with arched tops. Centered in forebay are two pairs of doors, one above the other. Large doors open onto the barn floor from the rear of the building as well. The southern end of the barn accommodates a wagon shed.
