WA-I-246

Brick House (No Longer Standing)

Paramount Vicinity

INVENTORY FORM FOR STATE HISTORIC SITES SURVEY

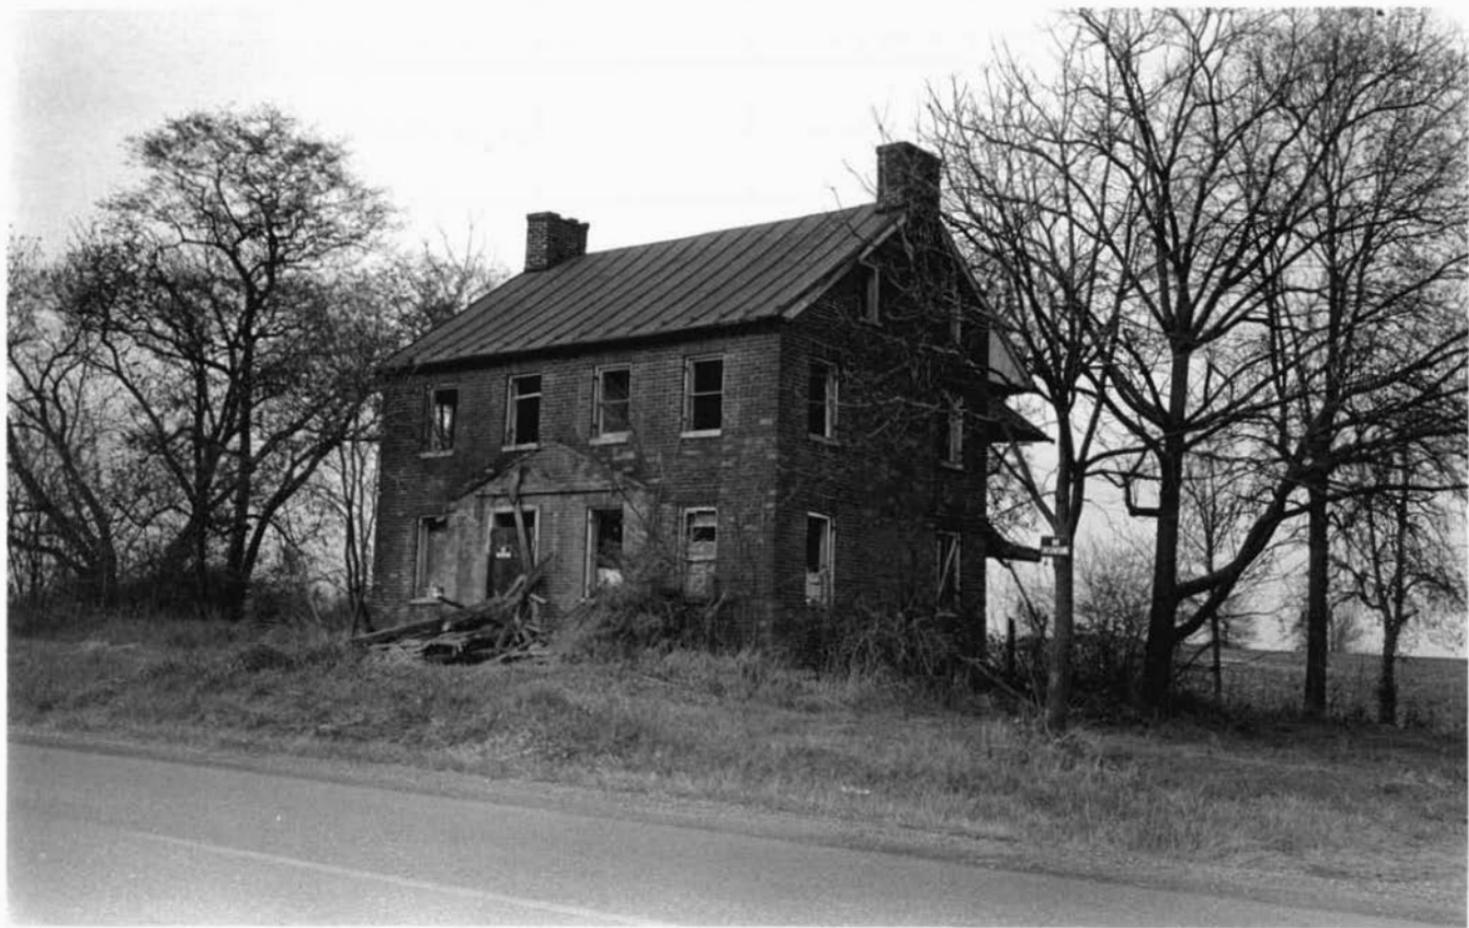
BRICK HOUSE
(demolished)

The house was a two story, four bay structure with a two story, three bay ell extending to the rear or north.

The walls which rested on low fieldstone foundations were constructed with American or common bond at all elevations. Flat arches of brick were present above the window and door openings. Other decorative brick work included a course of alternately projecting bricks at the eaves of the front elevation giving the appearance of dentils.

Windows and doors appeared to have been spaced evenly in the front elevation. The windows had narrow frames. At the time the house was photographed, part of the nine over six sash remained in a first story window. The size of the second story openings suggests that six over six sashes were used. The frames had hinge pins suggesting that shutters were present at one time.

The main entrance was located in the second bay from the west end of the front elevation. The opening was trimmed with a symmetrically molded architrave having decorated corner blocks.
