WA-I-304

Log House and Barn, Mt. Tabor Rd.

INVENTORY FORM FOR STATE HISTORIC SITES SURVEY

Log House and Barn - Mt. Tabor Road

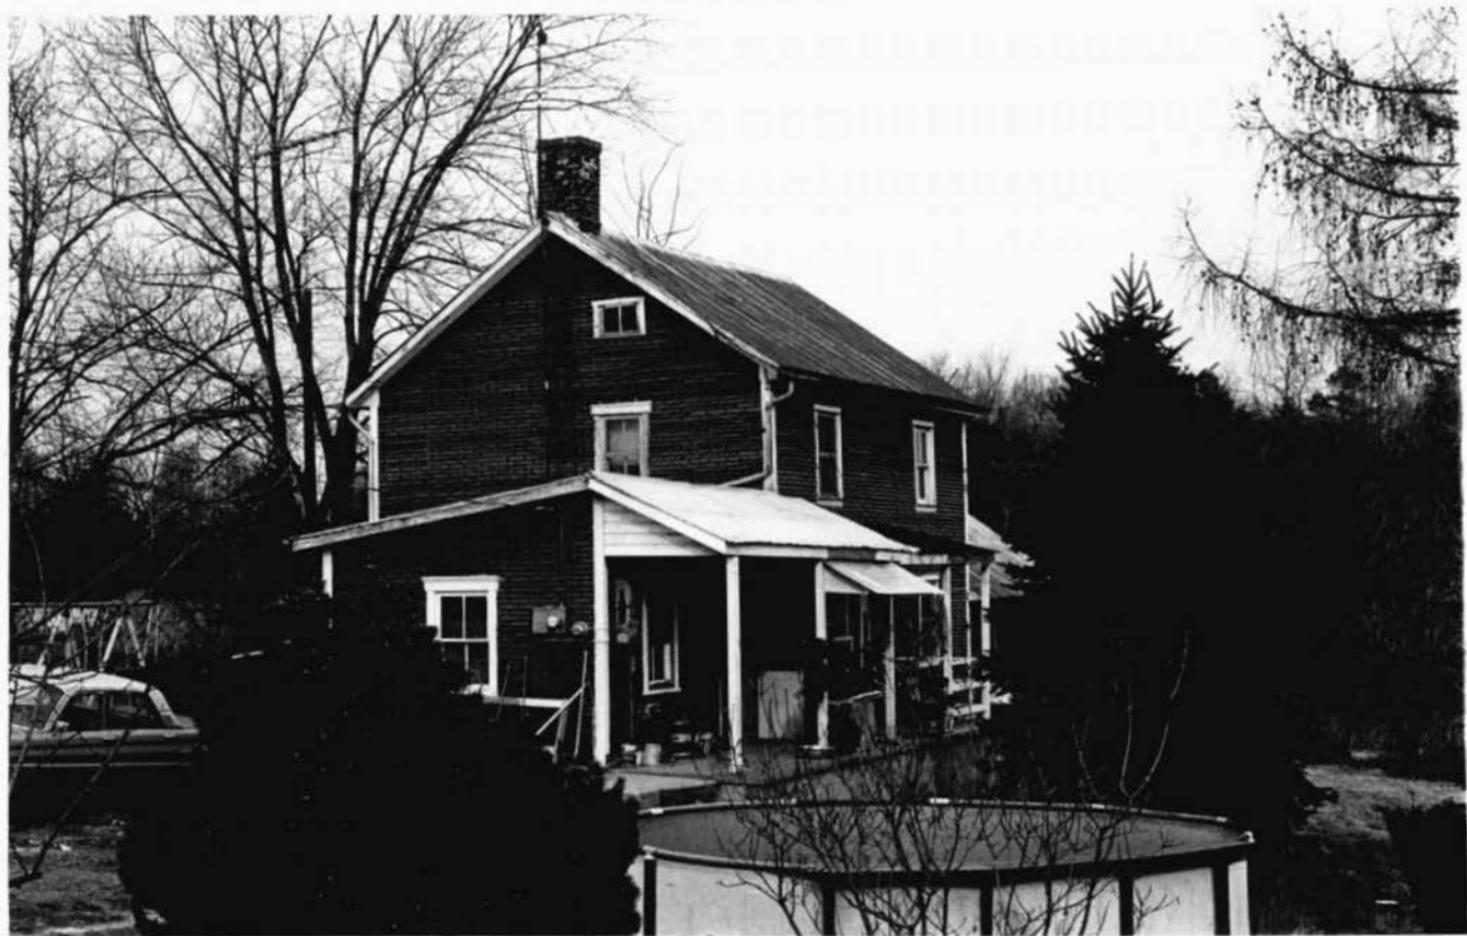
LOG HOUSE, MT. TABOR RD.

The house is a two story, three bay structure sheathed with composition siding. It has two windows at the second story of the front elevation while three openings are present at the first story level. A two bay, one story shed roofed frame addition is attached to the south end wall. Another one story addition is attached to the north wall.

Windows have two over two pane double hung sashes and are trimmed with turn of the century period architraves with a back band across the top piece. The main entrance is located in the middle bay of the front elevation.

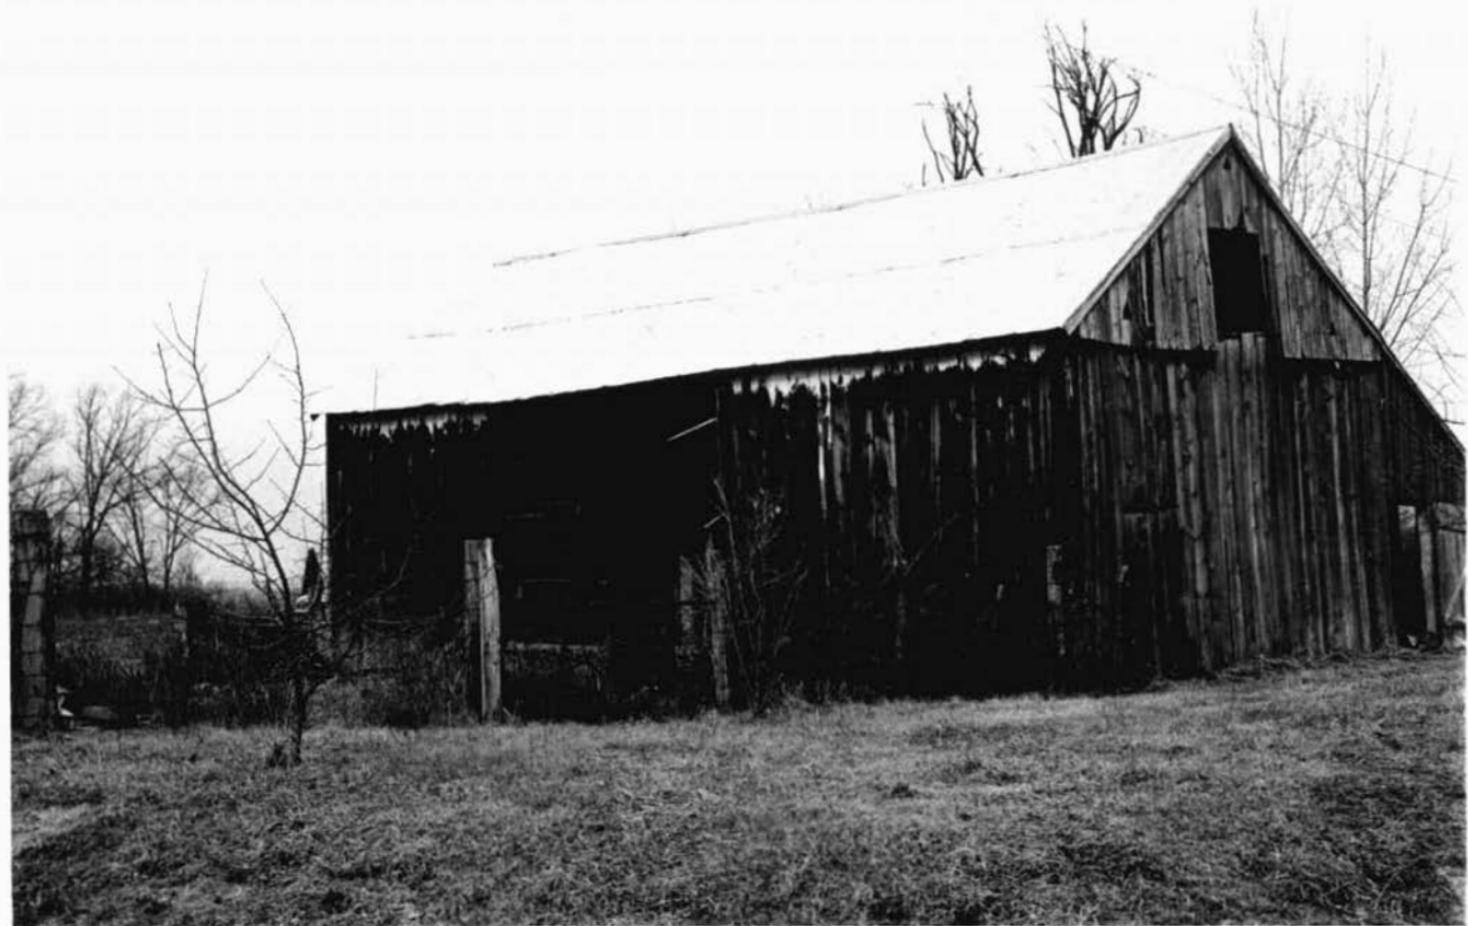
LOG BOOK, MT. TABOR RD.

Just south of the house is a two pen log barn sheathed with vertical board siding. Where logs are exposed, "V" notched corner joining is evident.
