WA-I-509      Brick House

Hagerstown vicinity

# Maryland Historical Trust State Historic Sites Inventory Form

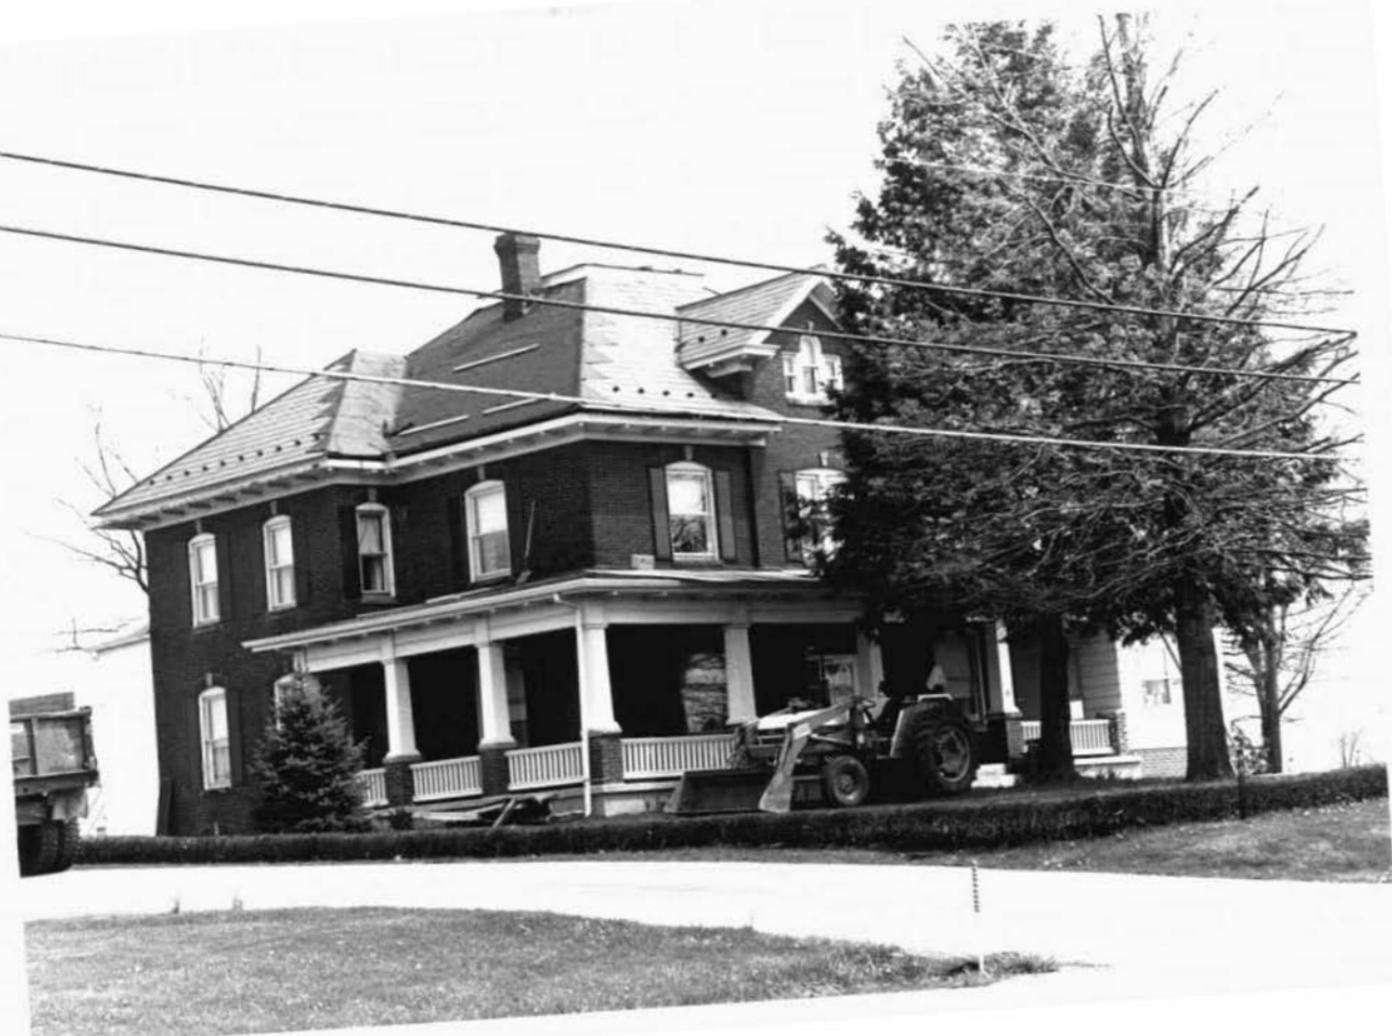
1. Brick House WA-I-509
2. Washington County, Maryland
3. Joe Getty
4. May 1983
5. Maryland Hist. Trust, Annapolis, Md.
6. North & West Elevations; camera facing southeast
7. 1/1
