WA-I-510 Frame House

Early 20th century

Hagerstown Vicinity

Maryland Historical Trust State Historic Sites Inventory Form

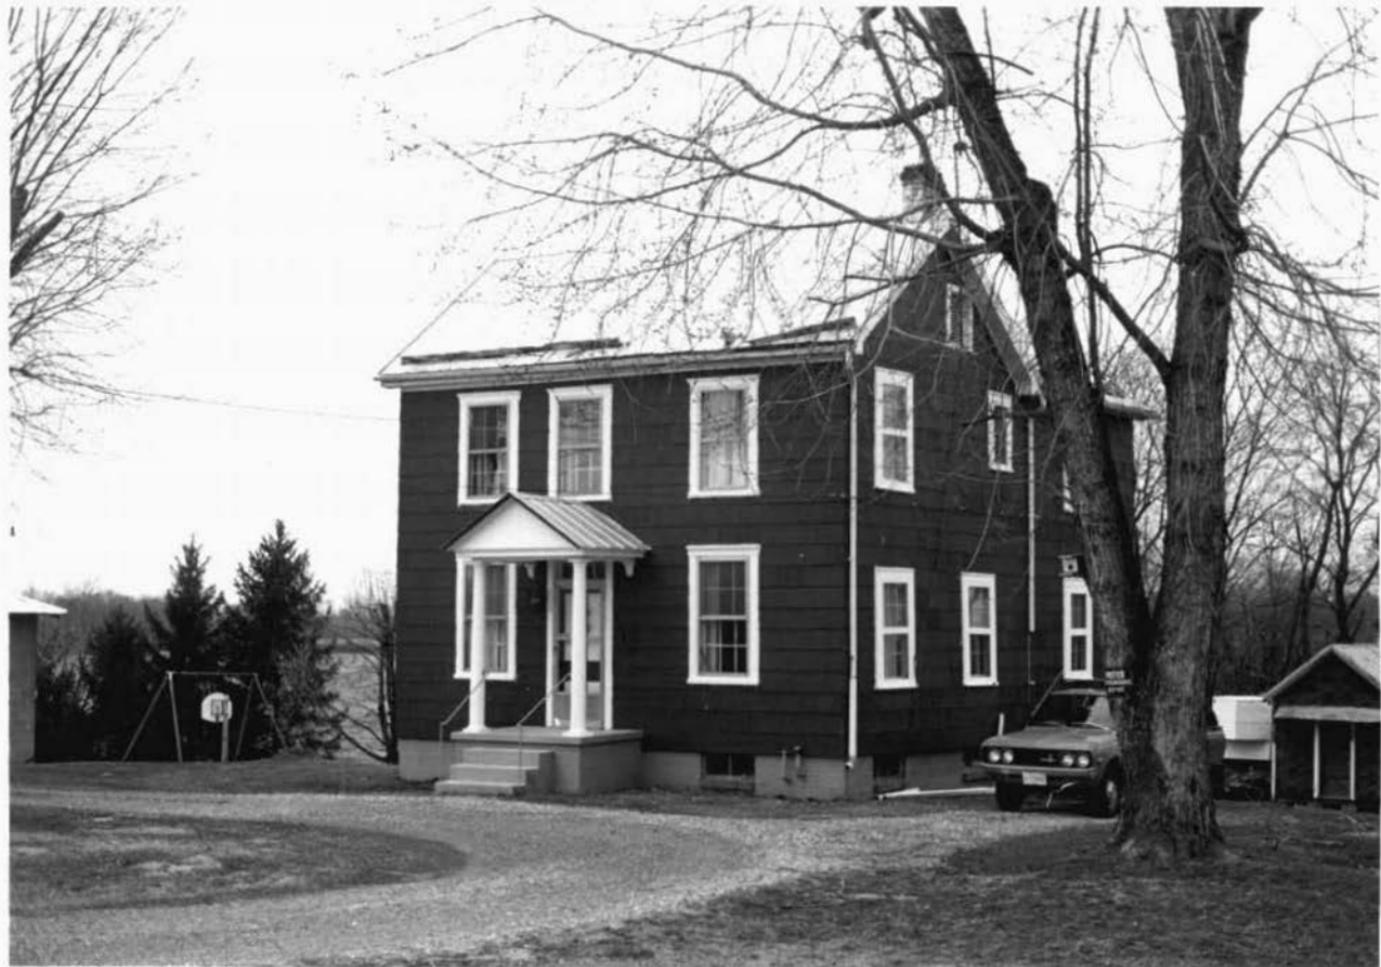
1. Frame House WA-I-510
2. Washington County, Maryland
3. Joe Getty
4. May 1983
5. Maryland Hist. Trust, Annapolis, Md.
6. East & North Elevations; camera facing
south west
7. 1/1
