Survey # WA-I-678

Street Address 38 E. Poplar Street

Town, State Funkstown, Maryland 21734

MARYLAND COMPREHENSIVE PRESERVATION PLAN DATA

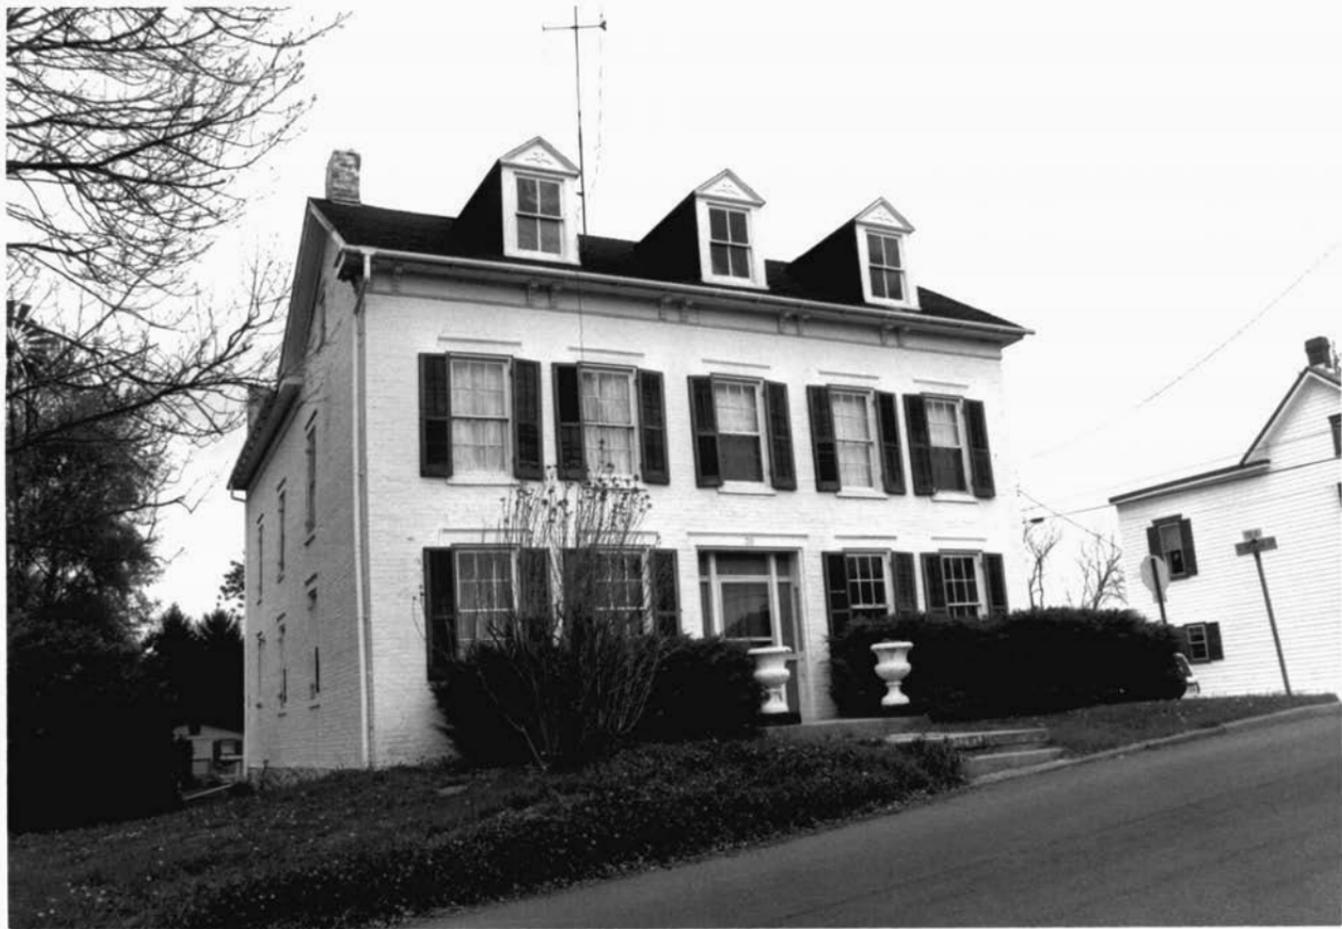
#153 (1 of 1)

Located on the northwest corner of Poplar and High Streets is this two story, five bay L-shaped brick house. It is constructed entirely with common bond brickwork. The house is essentially Greek Revival in appearance with a symmetrical facade, wide wood lintels over the doors and window and a frieze band. Pairs of brackets on the frieze reflect the influence of the Italianate style. Windows have six over six pane sash. Three dormers with pedimented gables extend from the south slope of the roof. The main entrance is in the center bay and includes a broad transom and sidelights. The house appears to date from the 1850s or early '60s.
