Survey # WA-I-775
Street Address 13911 Village Mill Drive
Town, State Maugansville, Maryland 21767
private , public

Approximate date Ca. 1930

MARYLAND COMPREHENSIVE PRESERVATION PLAN DATA

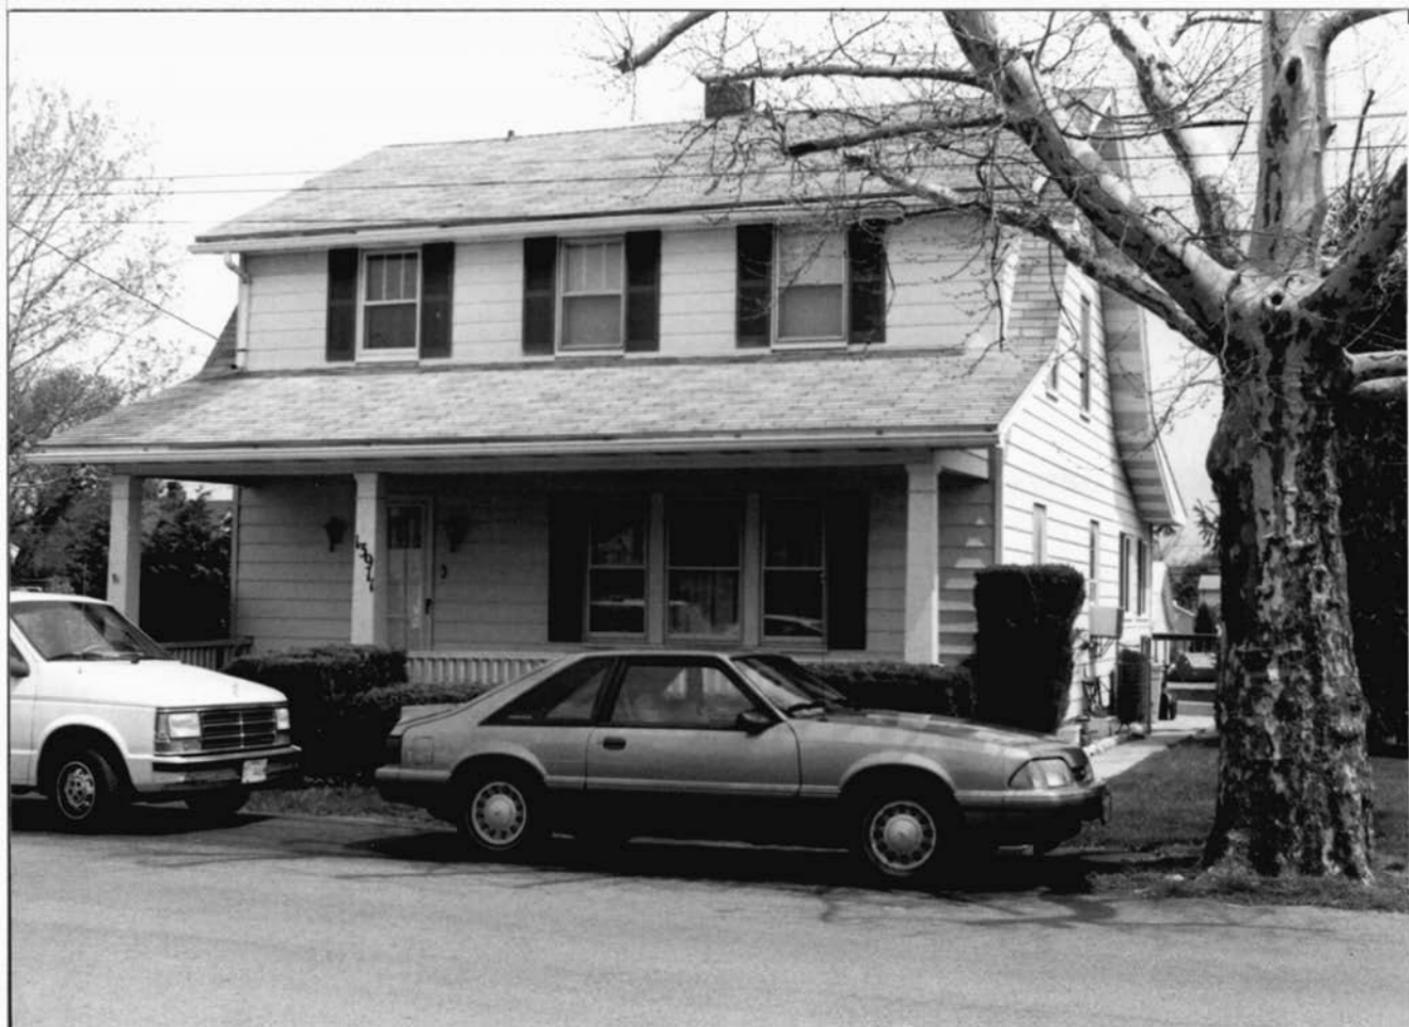
Photo Reference: Photo # 52

This Dutch Colonial house is located on the east side of Village Mill Drive. It is a one and a half story, three bay frame building, covered with aluminum siding. It has the characteristic gambrel roof and shed dormer. At the first story front, the fenestration consists of a door and a three part window. Windows have three vertical lights in the upper sash, with single panes below. A porch supported by tapered square posts extends across the front. The date attribution for this house is based on the period of popularity for the Dutch Colonial style. This is one of the later examples within the period of study for this survey.
