Survey # WA-I-797
Street Address 13823 Village Mill Drive
Town, State Maugansville, Maryland 21767
private X , public ____

Approximate date Ca. 1920

MARYLAND COMPREHENSIVE PRESERVATION PLAN DATA

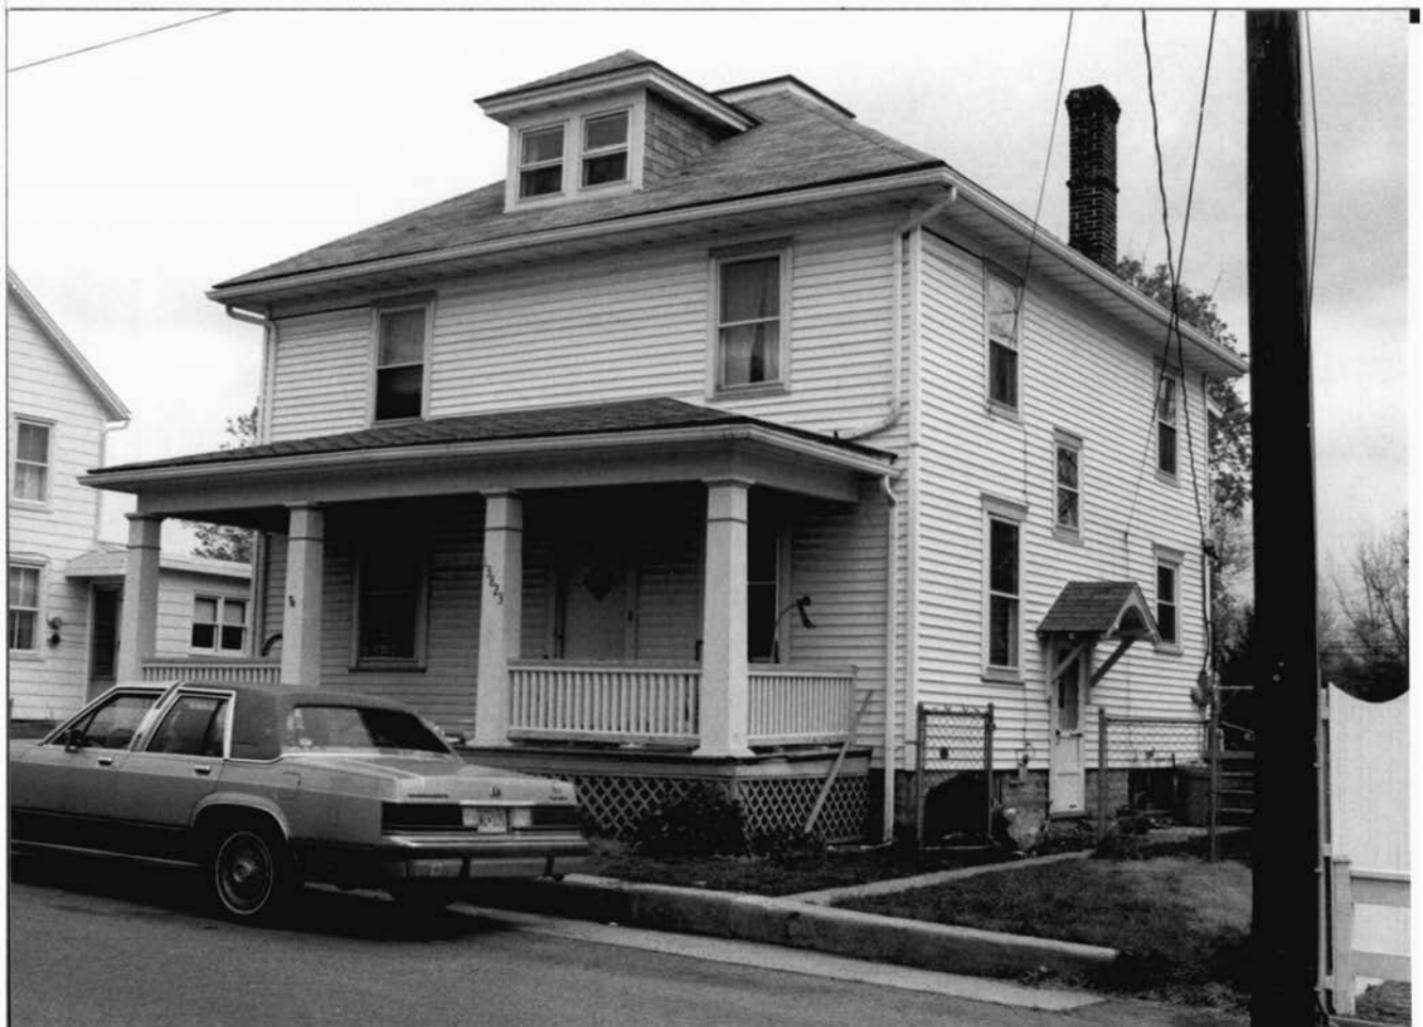
Photo Reference: Photo # 74

On the east side of Village Mill Drive is this frame foursquare style house resting on rock-faced concrete block foundations. It has the characteristic foursquare features of a hipped roof and dormer and square plan. It has three bays across the front with a central entrance. At the second story level there are two windows. Windows have single pane sash and those at the first story front are slightly larger than the others. A porch across the front is supported by large square columns. A side entrance is sheltered by a gabled hood with brackets. A corbeled chimney extends from inside the south wall. Foursquares were very common from 1910-1925, and this example is no exception. It is indicative of Maugansville's main development period.
